Service Bulletin

Bulletin No.: 21-NA-188

Subject: Radio Software Version V158 Update

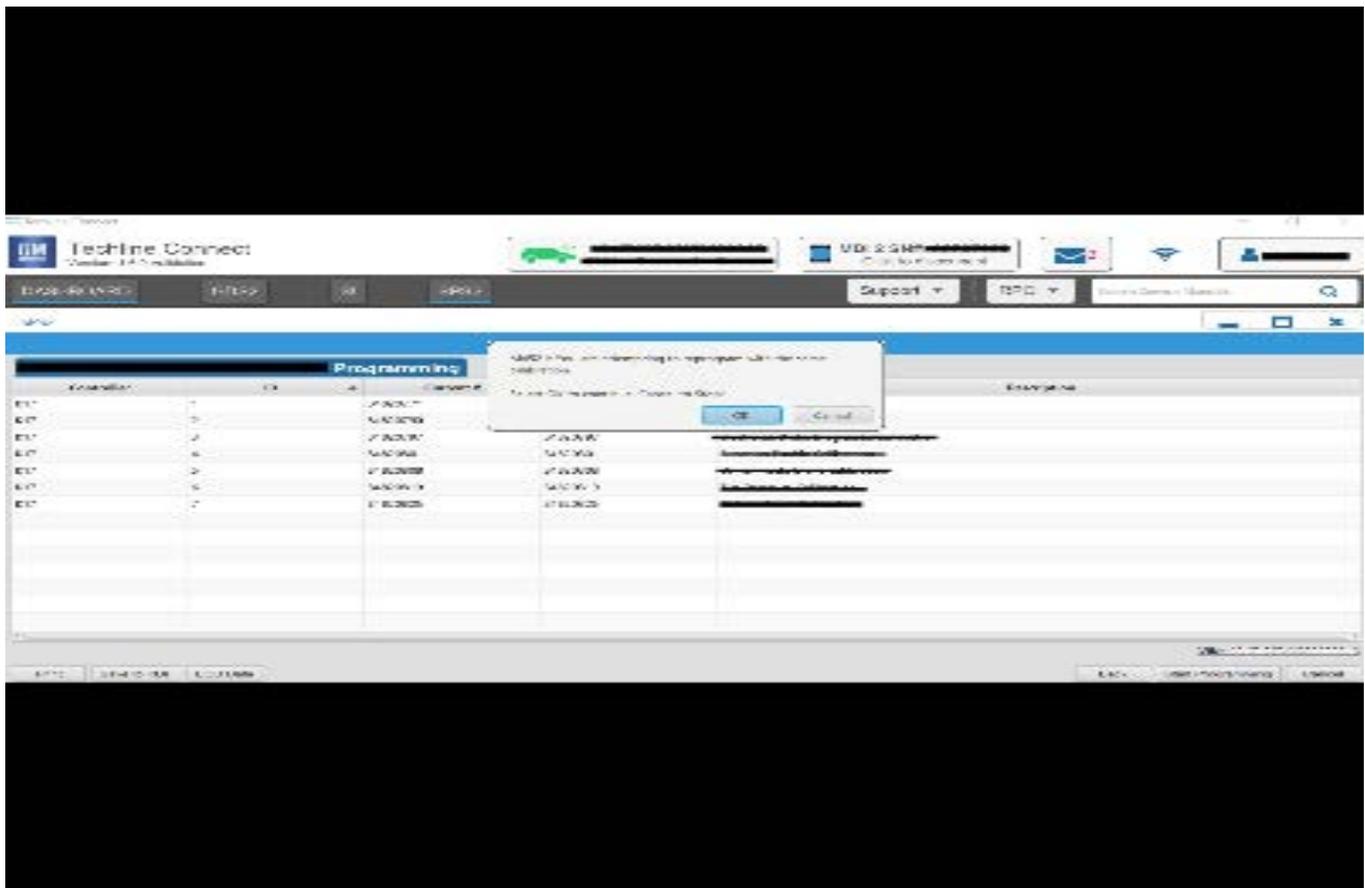
5644477

Important: Techline Connect screen shown above.

Important: If the same calibration/software warning is noted on the TLC or SPS Summary screen, select OK and follow screen instructions. After a successful programming event, the WCC is located in the Service Programming System dialogue box of the SPS
