GLOBAL SAFETY FIELD INVESTIGATIONS
DCS6213
URGENT - DISTRIBUTE IMMEDIATELY

Subject: N222358700 - Service Update
Mass Air Flow Drift

Models: 2022 Cadillac XT4
Equipped with 2.0L, 4-cylinder engine (RPO LSQ)

N222358700 Mass Air Flow Drift

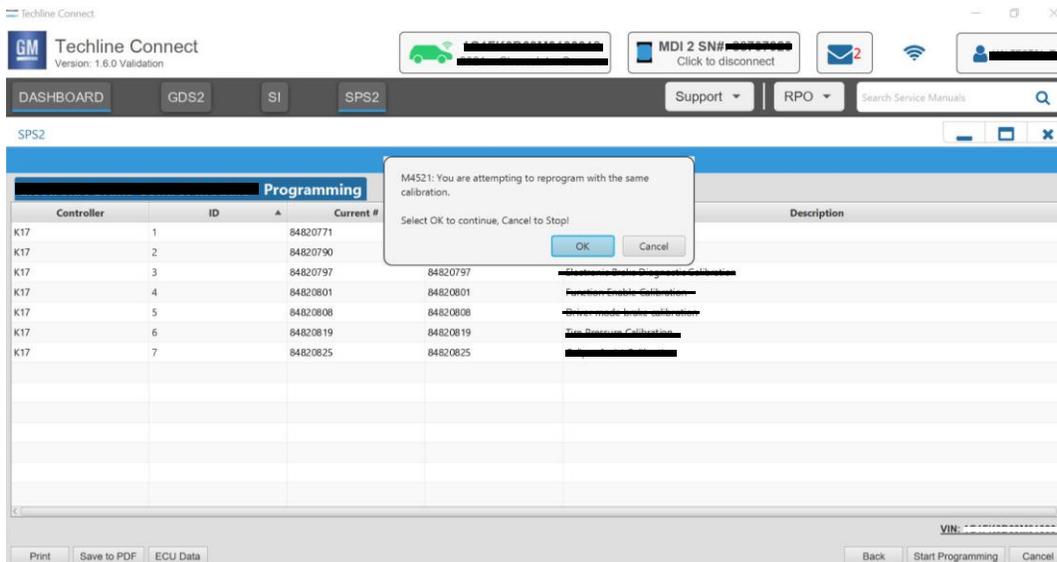
5644477

Important: Techline Connect screens shown above.

Important: If the same calibration/software warning is noted on the TLC Summary screen, select OK and follow screen instructions. After a successful programming event, the WCC is located in the Service Programming System dialogue box of the SPS Summary screen. No further action is required. Refer to the Warranty section of the bulletin.
