# Preliminary Information

## PIP5705 DFM/AFM Vibration Or Drone Models

| Condition | A vehicle may have a concern of a vibration or drone around 40 MPH and 1200 RPM under a light load. |
| Cause | Debris in the transmission mount |

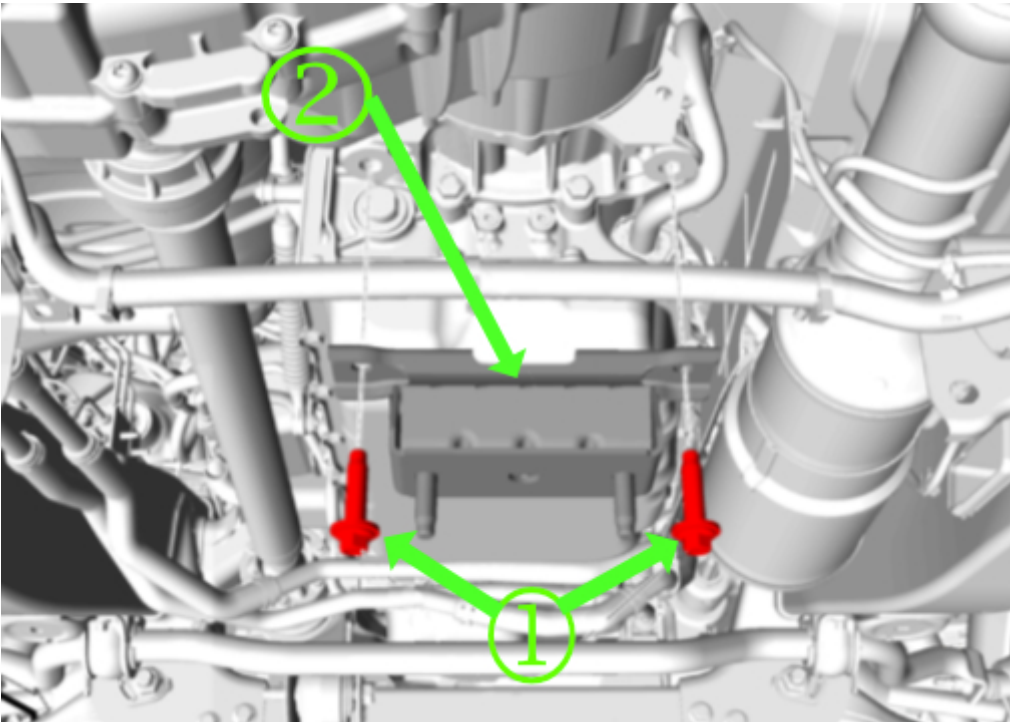
If this type of vibration is found remove and inspect the transmission mount for debris.

If debris is found, clean the mount, reinstall and evaluate for the concern.
