MAS003117 (MSC 22-22)

Campaign 497

Service Campaign 497 M15X – Phone Box Lid potential failure of the mechanism opening

DATE: JUNE 14 2022

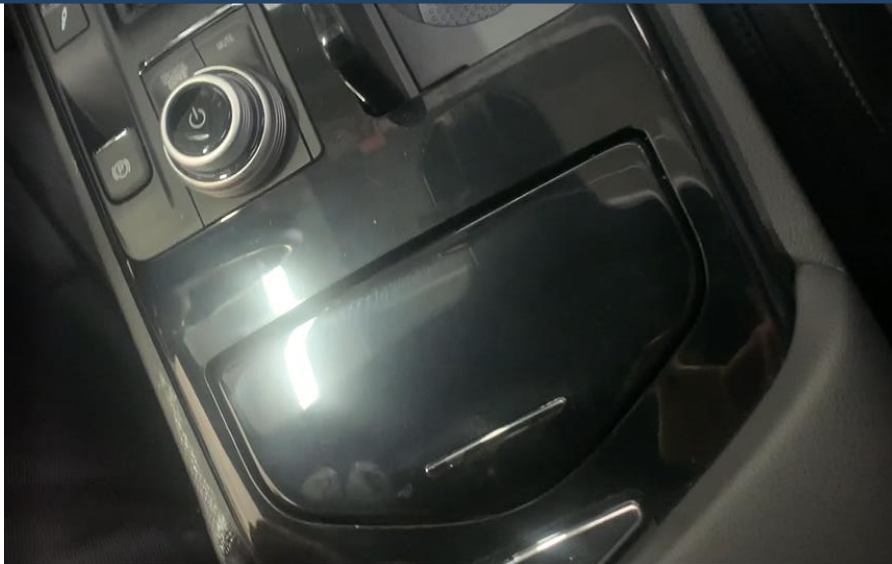
Certain Maserati Sedans listed in MODISCS+ are involved in a Service Campaign concerning the check of the Phone Box Lid opening mechanism.

The inspection procedure consists of a 21 opening/closing cycles. Only in case after the cycle the lid cannot be opened anymore due to a failure into the internal mechanism breakage, the phone box must be replaced.

If the Phone Box Lid opening and closing is **NOT OK**, the phone box must be replaced:

Description	QTY	Code
Phone Box	1	PN 670186915
