MAS003104 (MSC 22-23)

Campaign 505

Service Campaign 505 M15x-M161 - Customer Protection Action

DATE: JUNE 30 2022

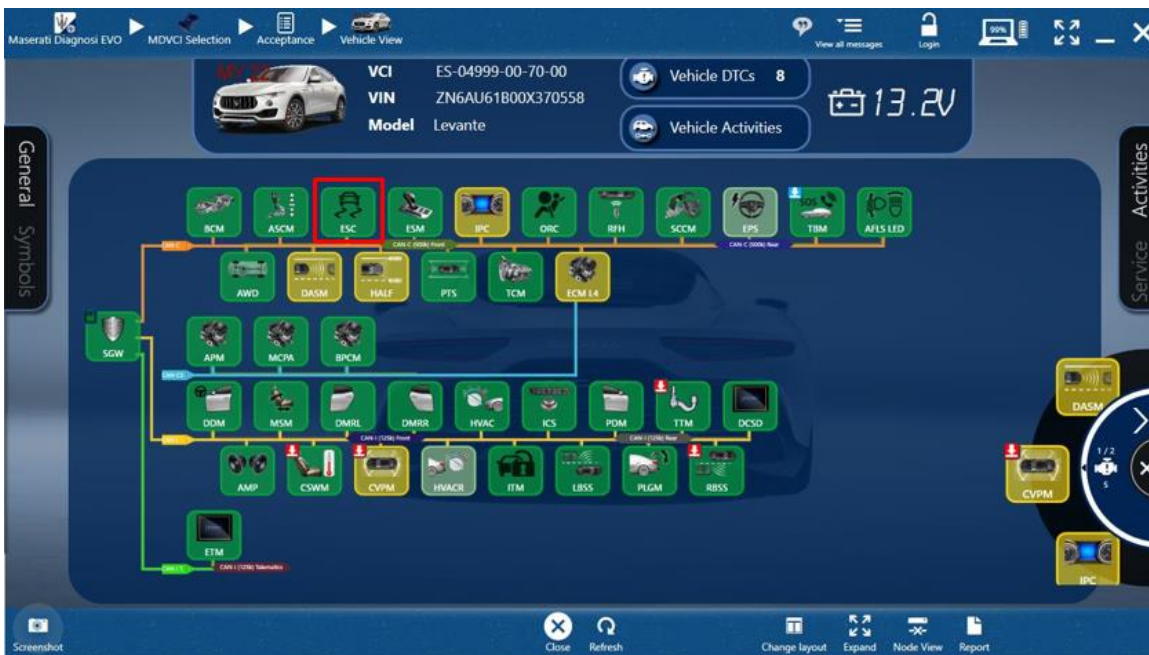
1. Connect the MD EVO to the vehicle using the VCI2.
2. ECU Selection:
 - From Vehicle View, select the **ESC module** in the red box

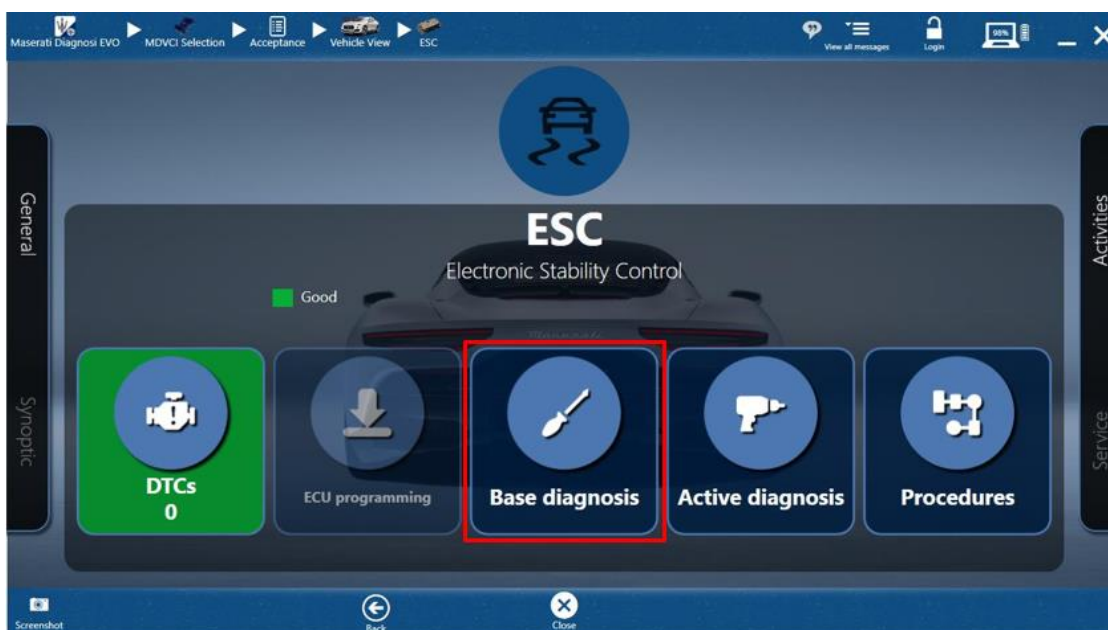
3. From ECU View select **Base Diagnosis** in the red box.

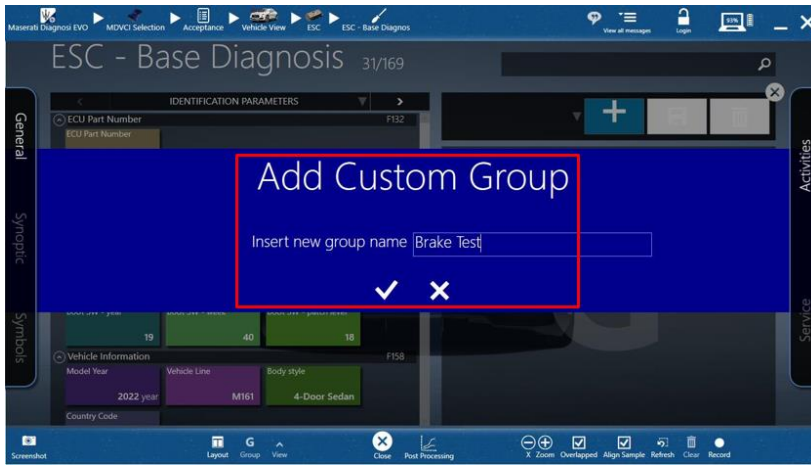
4. From **Base Diagnosis** add Custom Group e.g. Brake Test as depicted in the red box.

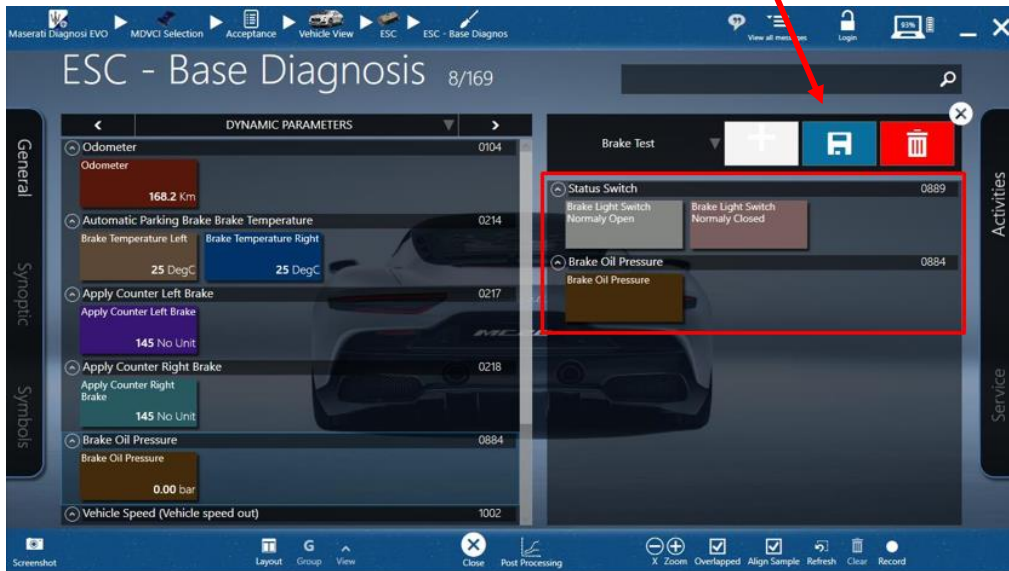
5. From **Base Diagnosis** select the following monitoring parameters and **Save**:

- Brake Light Switch Normally Open 0889.
- Brake Light Switch Normally Closed 0889.
- Brake Oil Pressure 0884.
