GROUP	MODEL
BOD	2021-2022MY Sorento (MQ4a) w/BSD
NUMBER	DATE
308	July 2022

## TECHNICAL SERVICE BULLETIN

### SERVICE ACTION: REAR CORNER RADAR UNIT BODY SEALER INSPECTION & REPAIR (SA503)

This bulletin provides information to inspect both rear (LH & RH) corner radar unit mounting body sealer surface on some 2021-2022MY Sorento (MQ4a) vehicles equipped with rear Blind Spot Detection (BSD) System, produced from November 30, 2021 through June 30, 2022, which may have excess body sealer applied during assembly causing improper mounting angle of the rear corner radar unit. An improperly mounted rear radar unit may cause the vehicle to exhibit a MIL 'ON' with DTC C270954. Follow the procedure outlined in this publication to inspect and, if necessary, file down the seam sealer behind the bracket. Before conducting the procedure, verify that the vehicle is included in the list of affected VINs.

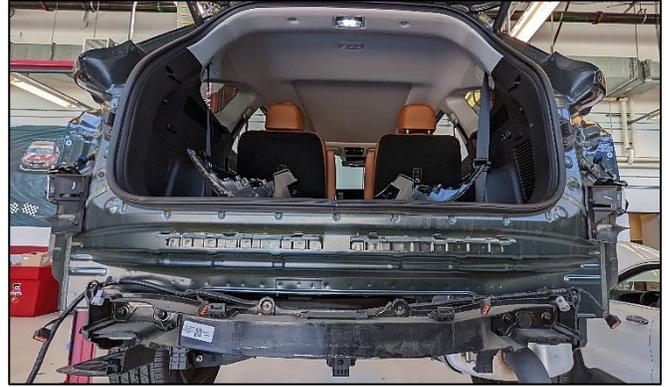
Note that the rear corner radar bracket mounting area is 'flat' over the body sealer. Excessive body sealer (NG) will cause the radar angle to aim improperly, resulting in a MIL 'ON' with DTC C270954.

1. Remove the rear bumper cover by referring to "Body (Interior and Exterior) → Rear Bumper → Rear Bumper Assembly → Repair procedures" in the applicable Shop Manual on KGIS.

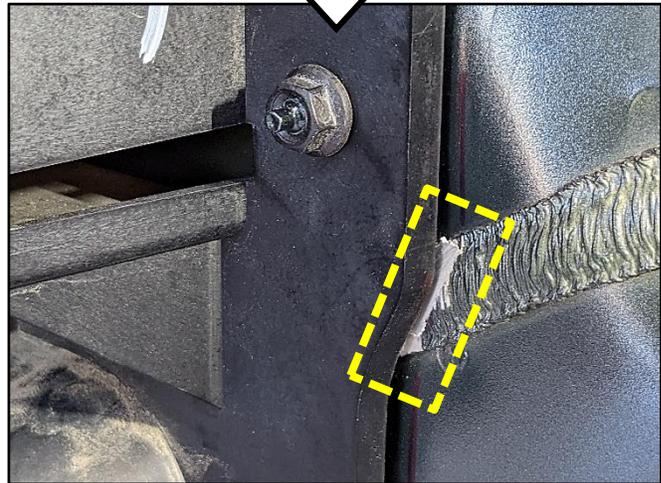
Be careful not to scrape/scratch the painted surface surrounding the repair area. Exposed metal will cause rust to develop over time.

- 5a. Using a small sander/grinding pad, reduce any excess body sealer until the rear corner radar bracket mounting surface is no longer obstructed by excess sealer.
- 5b. Repeat for the opposite side as needed.

Apply masking/duct tape to the painted surface surrounding the repair area and wrap a couple of layers of tape around the three (3) exposed studs.
