GROUP	MODEL
ENG	Multiple Models Listed
NUMBER	DATE
237	July 2022

TECHNICAL SERVICE BULLETIN

SUBJECT: OIL PRESSURE SWITCH (OPS) REPLACEMENT

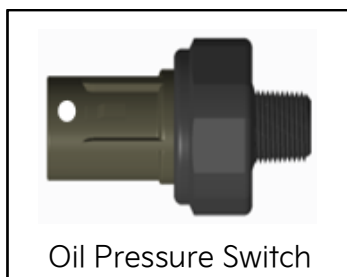
This bulletin provides information regarding the replacement of the Oil Pressure Switch associated with the 'Warranty Extension Program' (WTY026) on some 2014-2018MY vehicles listed in the table below, for repairs that may be necessary to address an Oil Pressure Switch leak in the eligible vehicles listed below from 10 years/100,000 miles to 15 years/150,000 miles, whichever comes first, starting from the date the vehicle was first put into service. This warranty extension is to address the Oil Pressure Switch leaking condition at no cost to the customers during this extended warranty period. Follow the procedure outlined in this publication to replace the OPS.

1. Open the hood and remove the engine cover.
2. Using a videoscope such as SST JSP97305 Snake Scope II or similar tool inspect the Oil Pressure Switch (OPS) (A) for oil leakage.
