**SERVICE BULLETIN**

**APPLICABILITY:** 2012-21MY Forester  
 2012-21MY Impreza  
 2015-20MY WRX

**NUMBER:** 02-131-12R  
**DATE:** 07/18/12  
**REVISED:** 07/11/22

**SUBJECT:** Oil Seepage Diagnosis and Repair Procedures

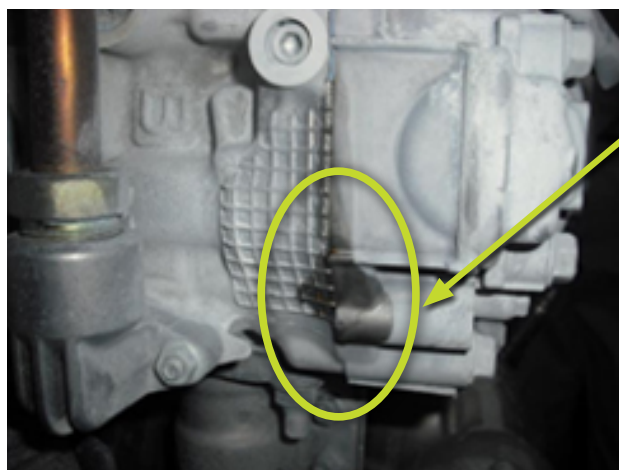
**Cam carrier seepage seen from top left and lower right side of engine**

If oil seepage is verified coming from between the cam carrier and the cylinder head as shown in the photos below, remove the cam carrier. Clean the machined sealing surfaces thoroughly and then re-seal using Liquid Gasket ThreeBond 1217H (SOA868V9610) or equivalent\*. As shown in the photos below, the o-rings between the cam carrier and the cylinder head will need to be replaced as they are not re-usable. This would also be a good time to clean the Active Valve Control System (AVCS) filter screens which are contained in the cam carriers. **NOTE:** The filter screens are one-time use and must be replaced if they need to be removed. The replacement filter part# is 14451AA050.

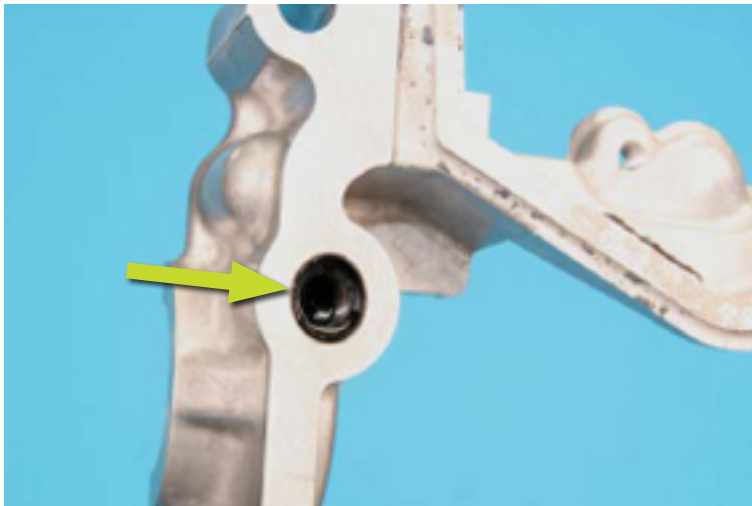
**Cam carrier o-rings requiring replacement**
