## **Mack Particulate Matter (PM) Sensor Troubleshooting Guide - US14+OBD16 And Newer Emissions**

# SCR Fittings, One Box, Replacement

# Exhaust Particulate Sensor, Repair

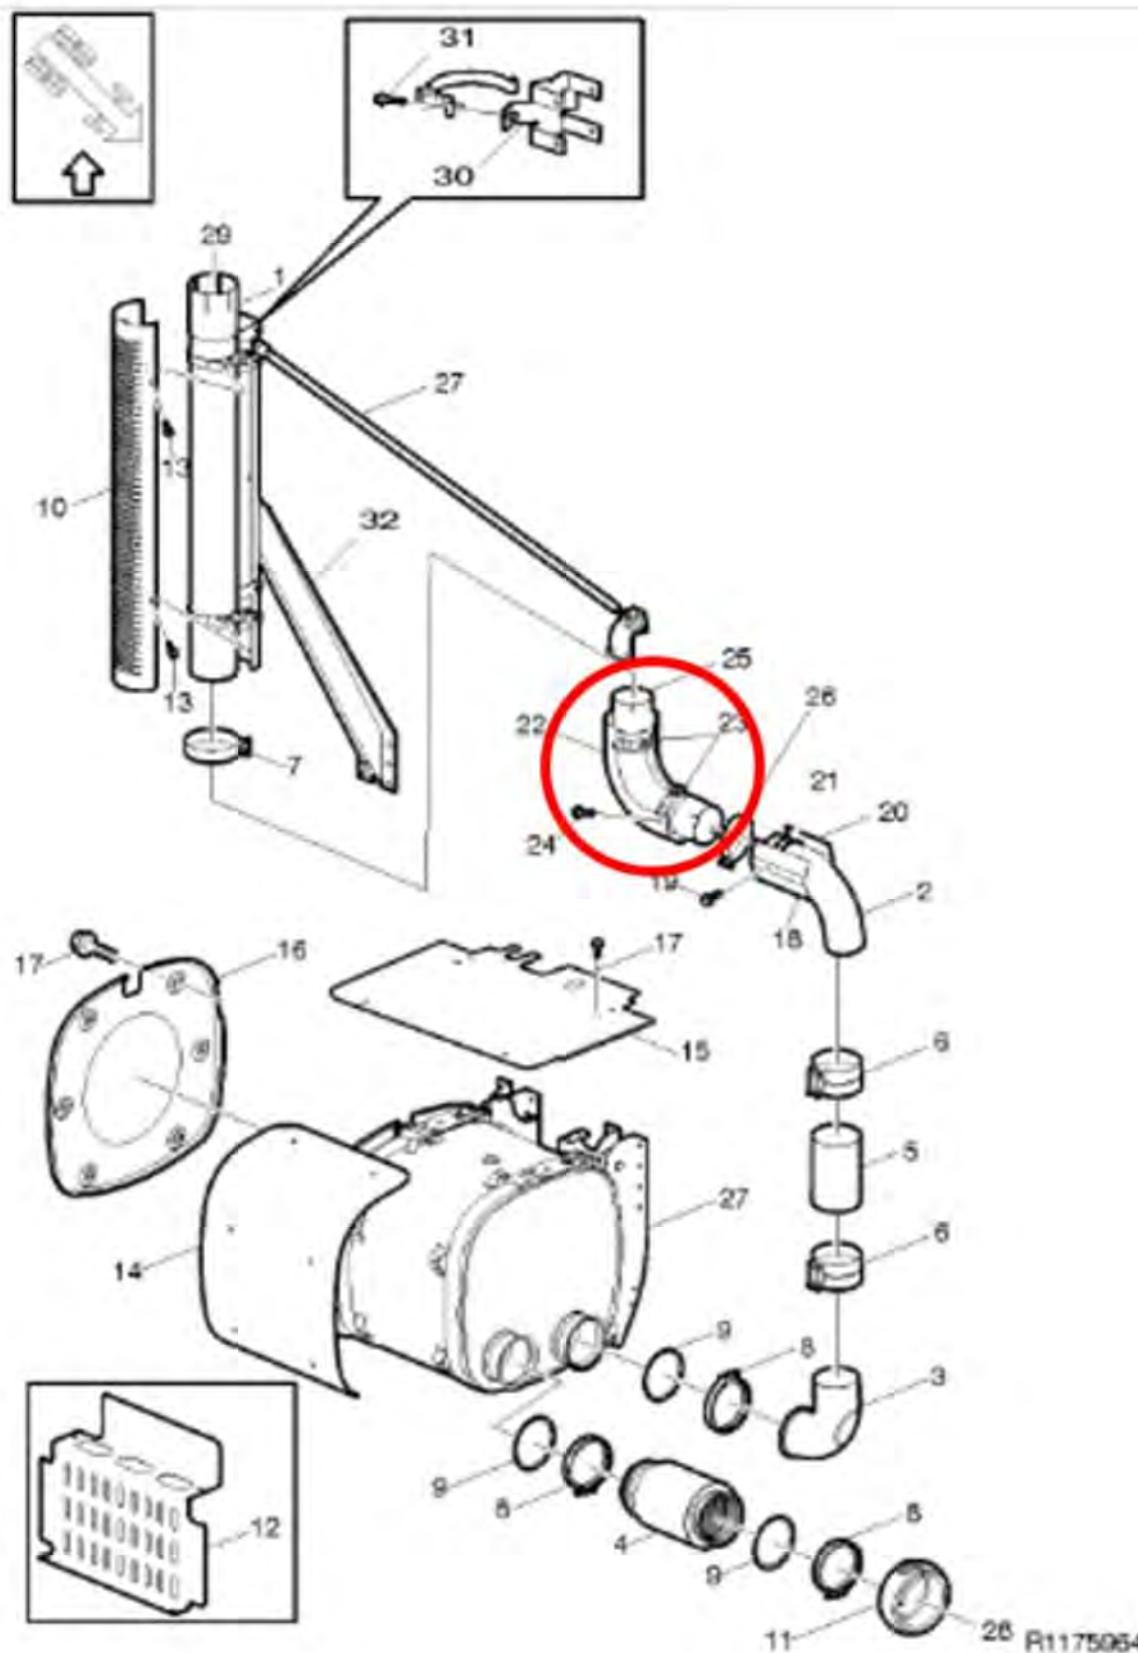
### Repair 1

Model	Cab Type	Exhaust Configuration	Pipe 1
VNL	Day Cab	Single Outlet Right Side Outboard	(Not Bright) 23154798 (Bright) 23154799

Note: If the original flex pipe has previously been replaced, you will need a new elbow in addition to the new flex pipe.

Model	Cab Type		Elbow
VNL	Day Cab	Single Outlet Right Side Outboard	21274193

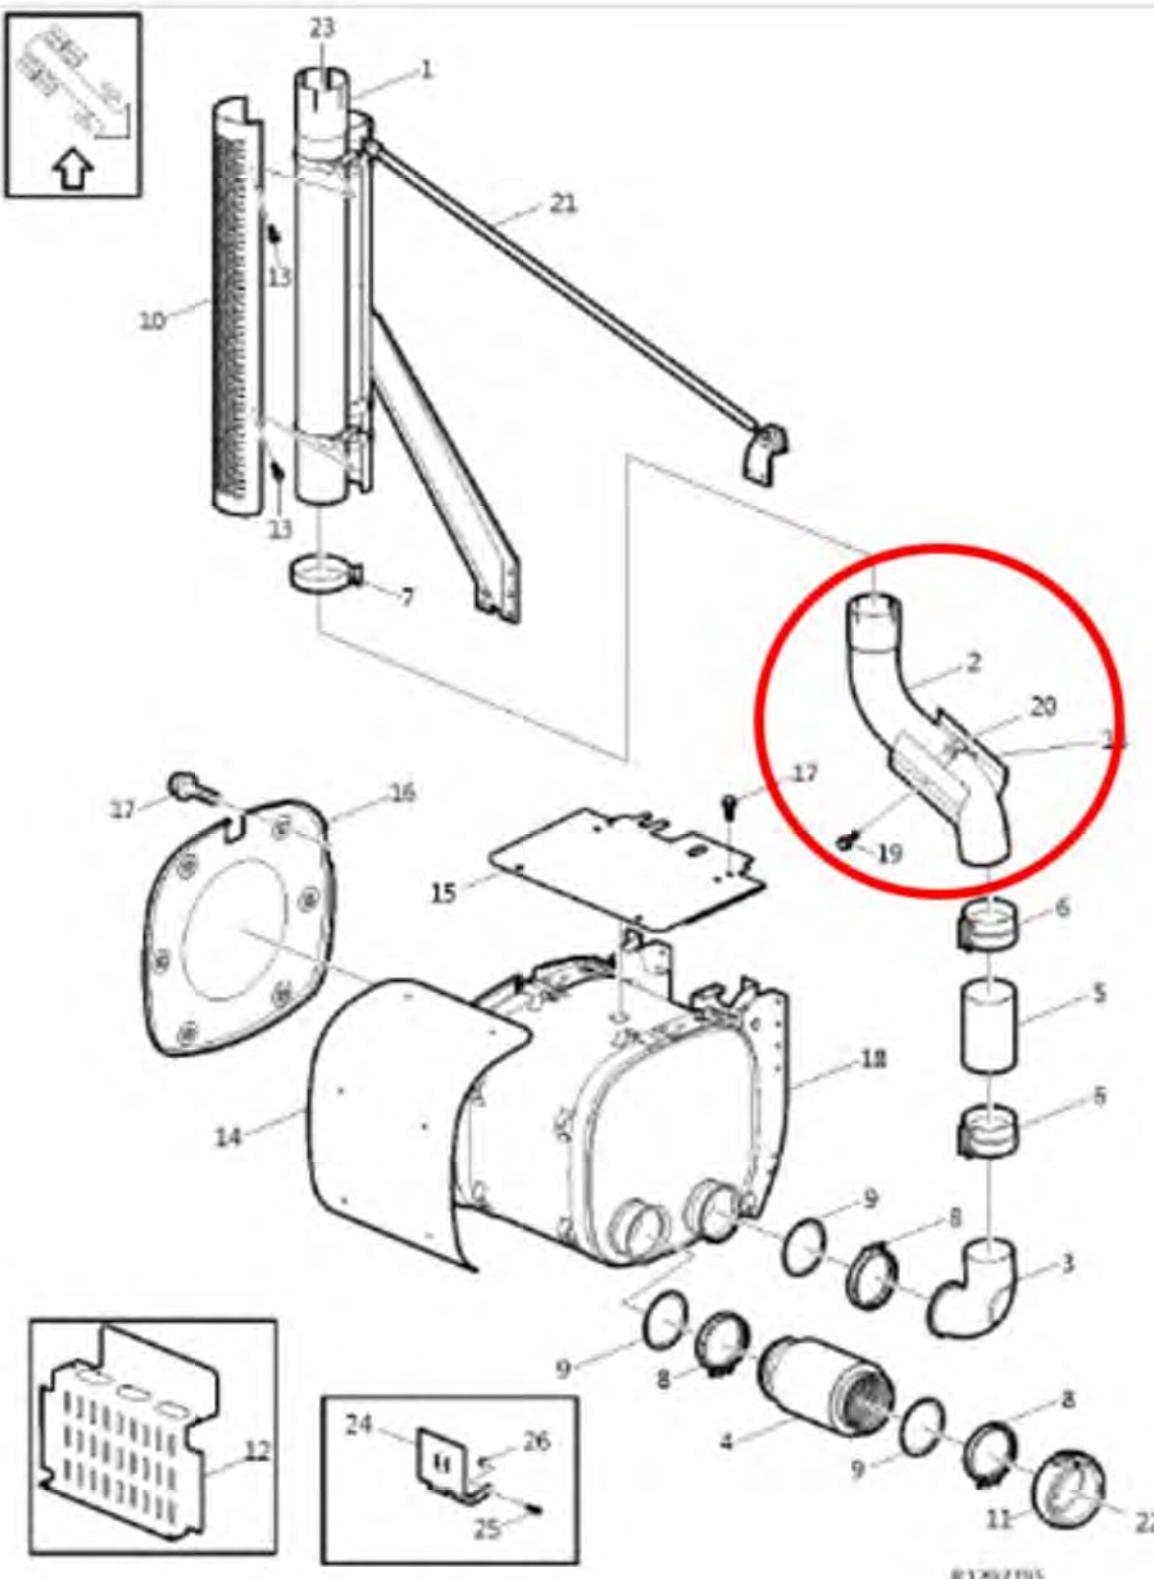
## Repair 2

Model	Cab Type	Exhaust Configuration	Pipe 1
VNM/VHD	Day Cab	Single Outlet Right Side Inboard	23630037

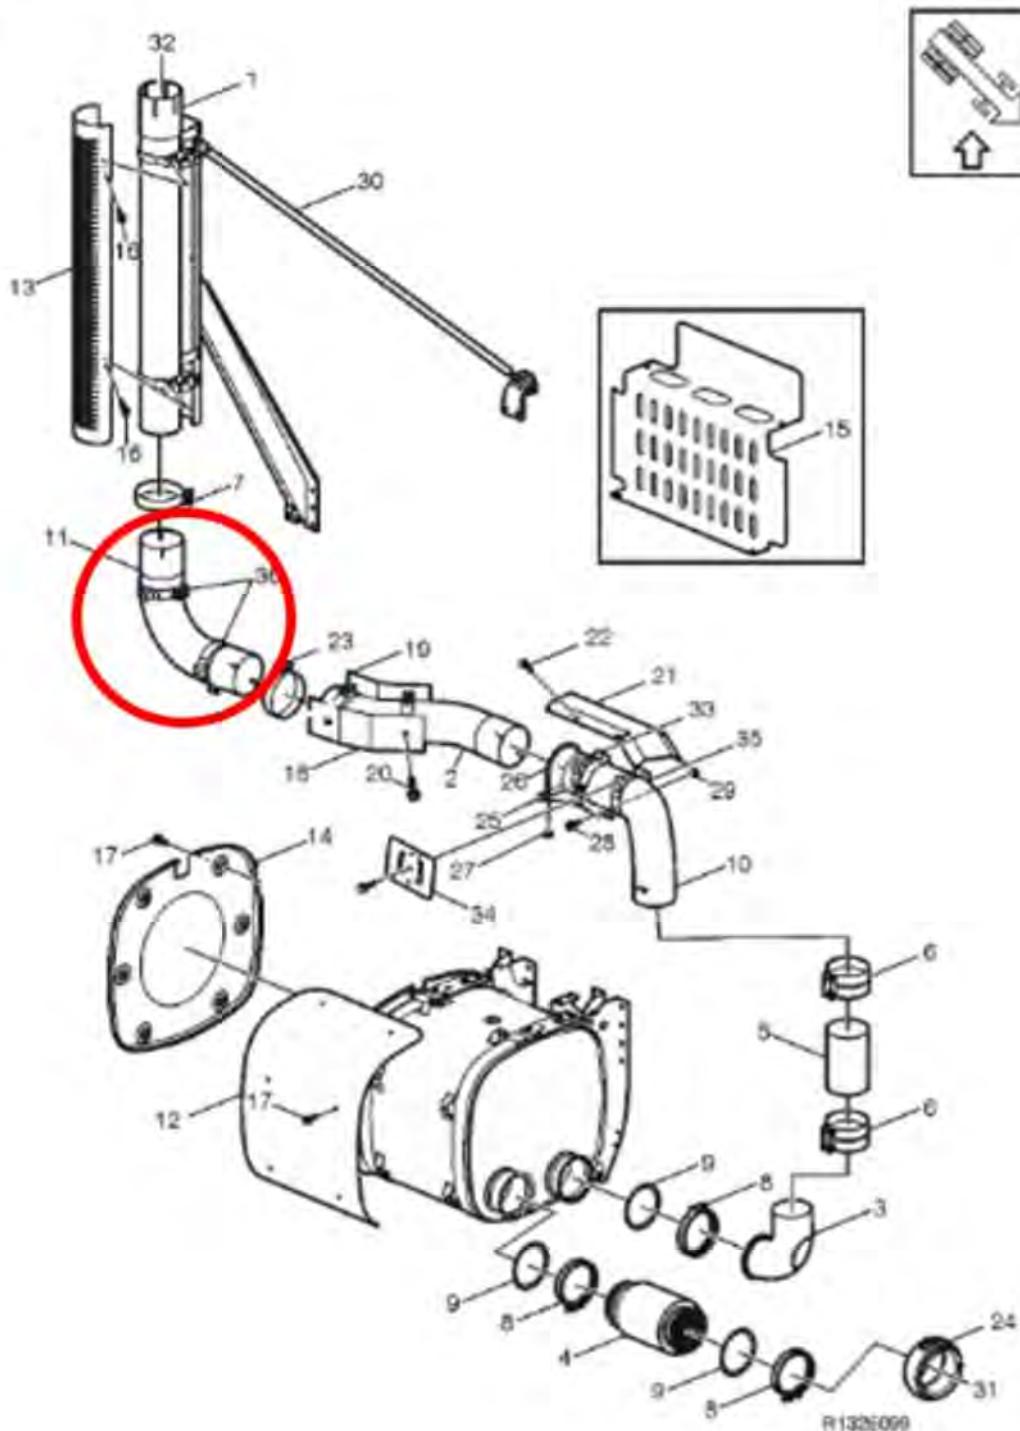
## Repair 3

Model	Cab Type	Exhaust Configuration	Pipe 1
VNL/VHD	430/630 Sleeper	Single Outlet Right Side Inboard	(Not Bright) 23154798

Note: If the original flex pipe has previously been replaced, you will need a new elbow in addition to the new flex pipe.

Model	Cab Type	Exhaust Configuration	Elbow
VNL/VHD	430/630 Sleeper	Single Outlet Right Side Inboard	21687278

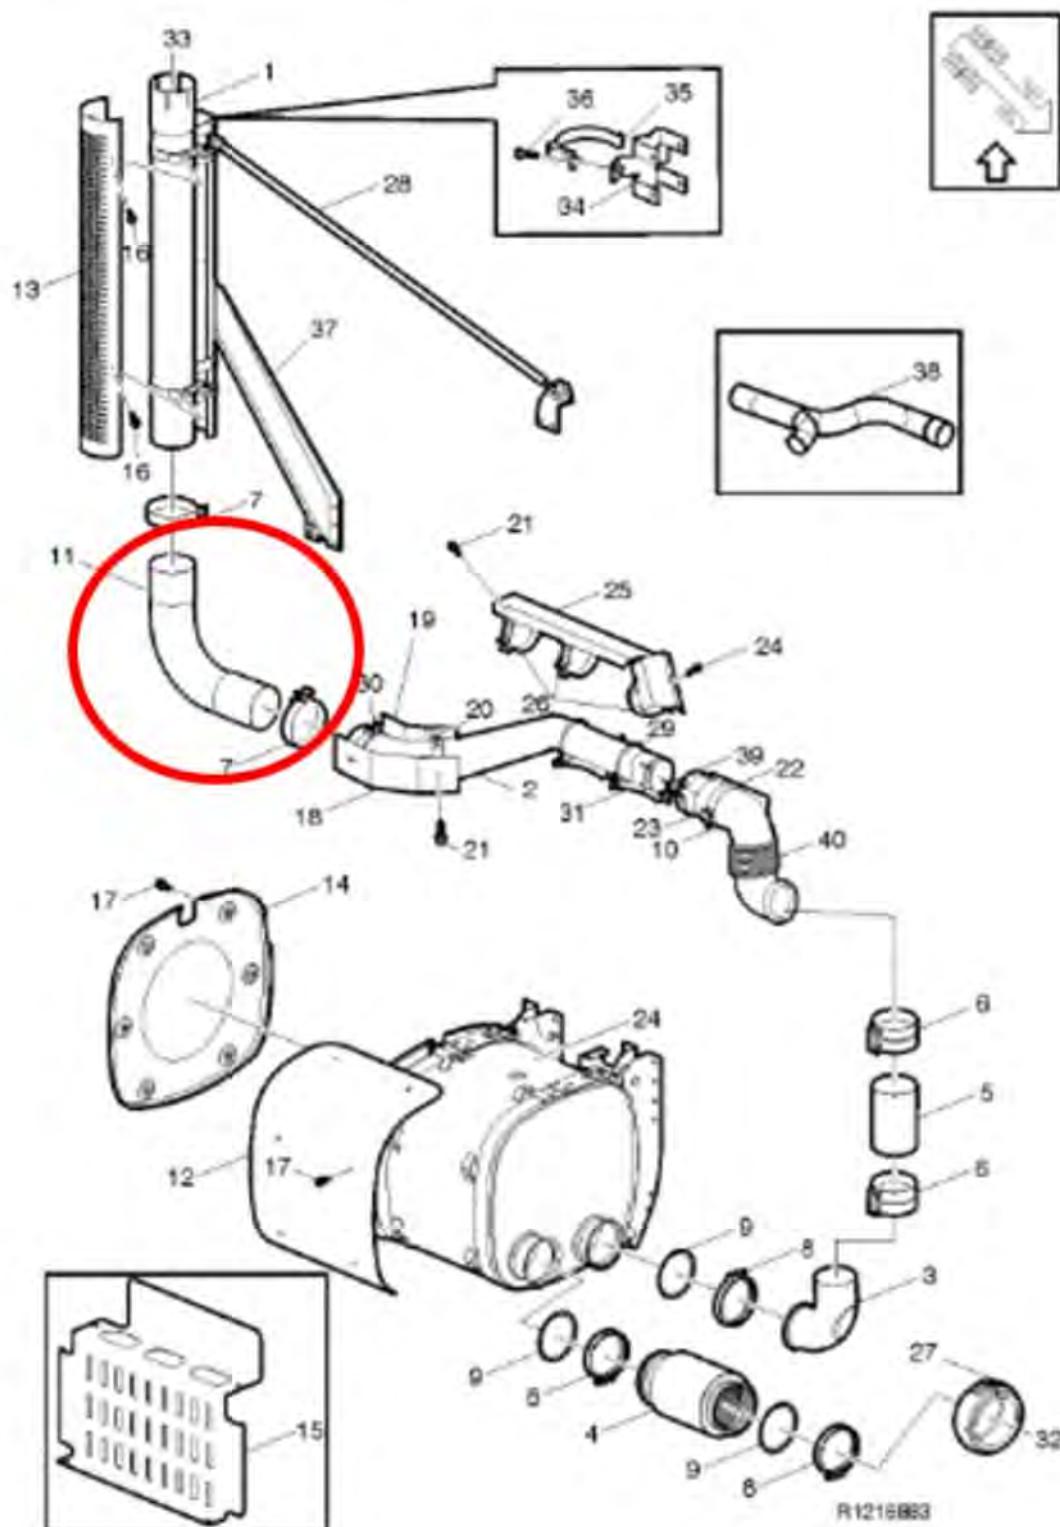
Repair 4

Model	Cab Type	Exhaust Configuration	Elbow
VNL	430 Sleeper	Single Outlet Right Side Inboard	21625282

Model	Cab Type	Exhaust Configuration	Elbow
VNL	670/780 Sleeper	Single Outlet Right Side Inboard	21625281

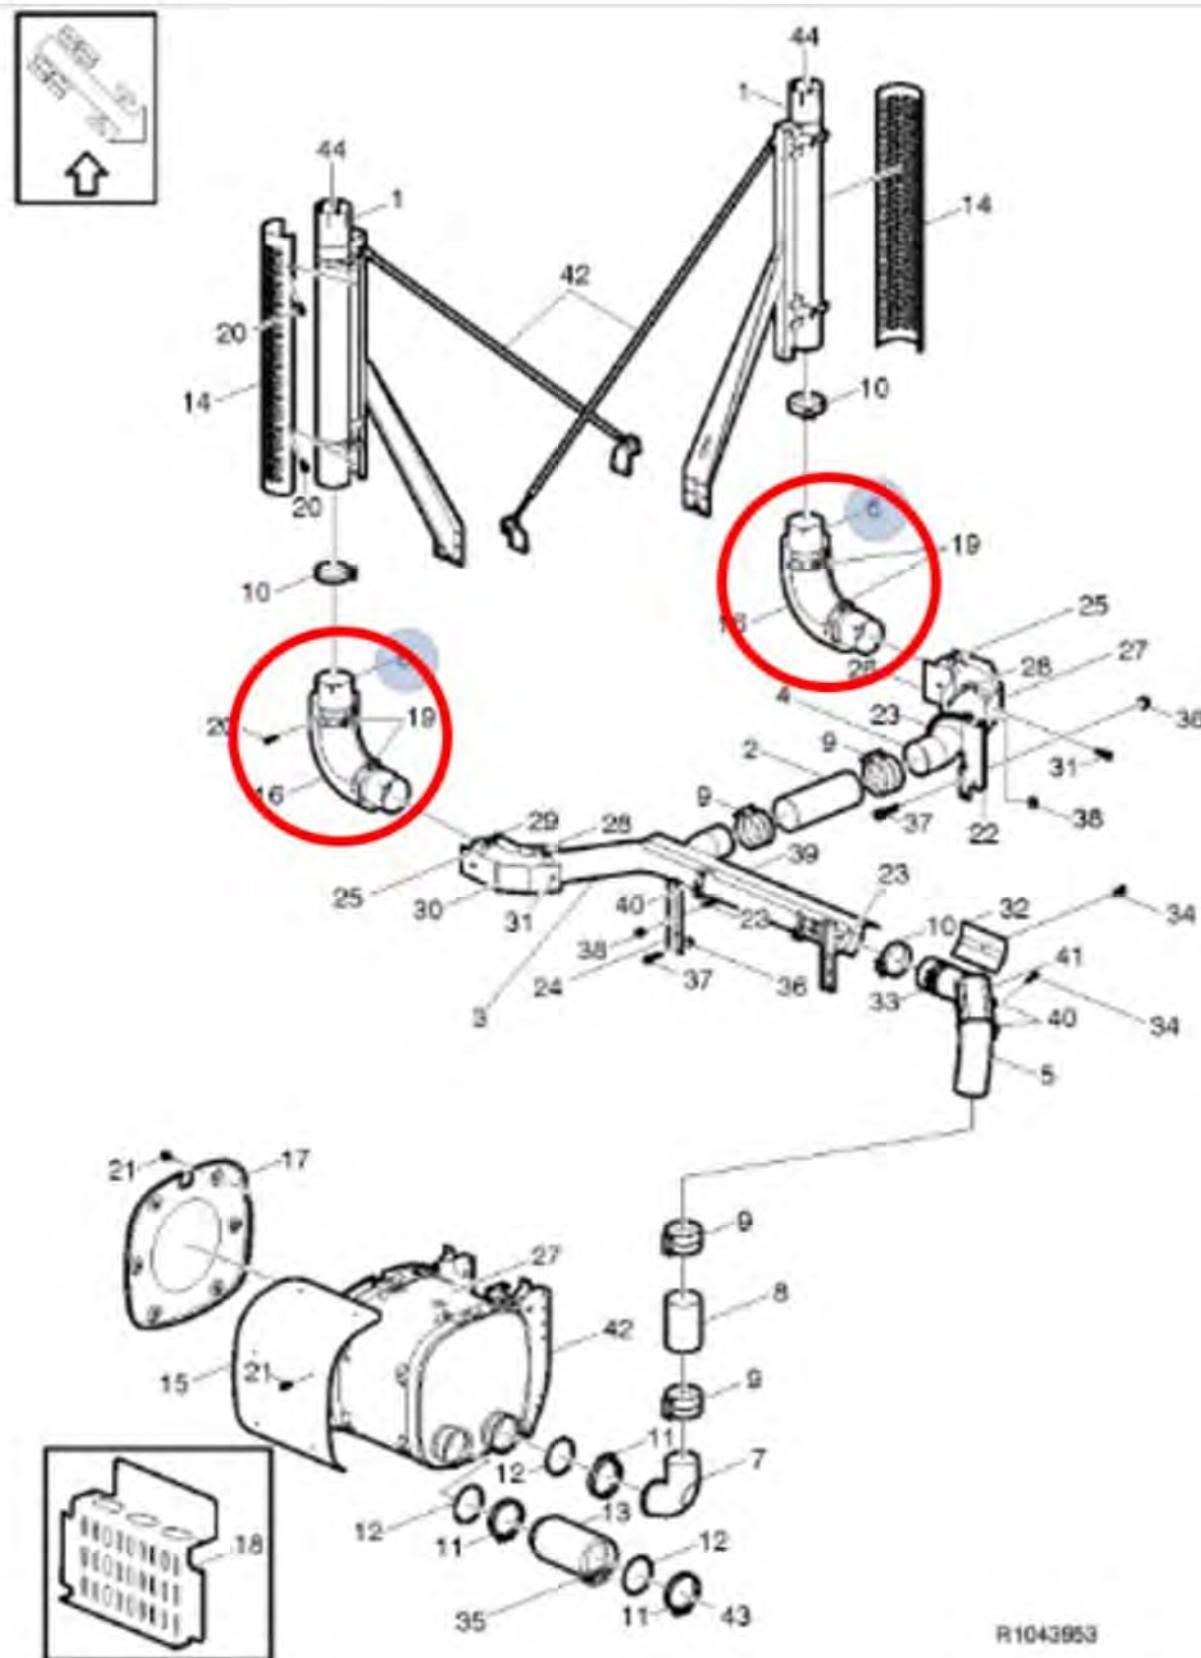
## Repair 5

Model	Cab Type	Exhaust Configuration	Pipe 1
VNL	430/670/780 Sleeper	Single Outlet Right Side Inboard	(Not Bright) 23154798 (Bright) 23154799

Note: If the original flex pipe has previously been replaced, you will need a new elbow in addition to the new flex pipe

Model	Cab Type	Exhaust Configuration	Elbow
VNL	670/780 Sleeper	Single Outlet Right Side Inboard	21625281

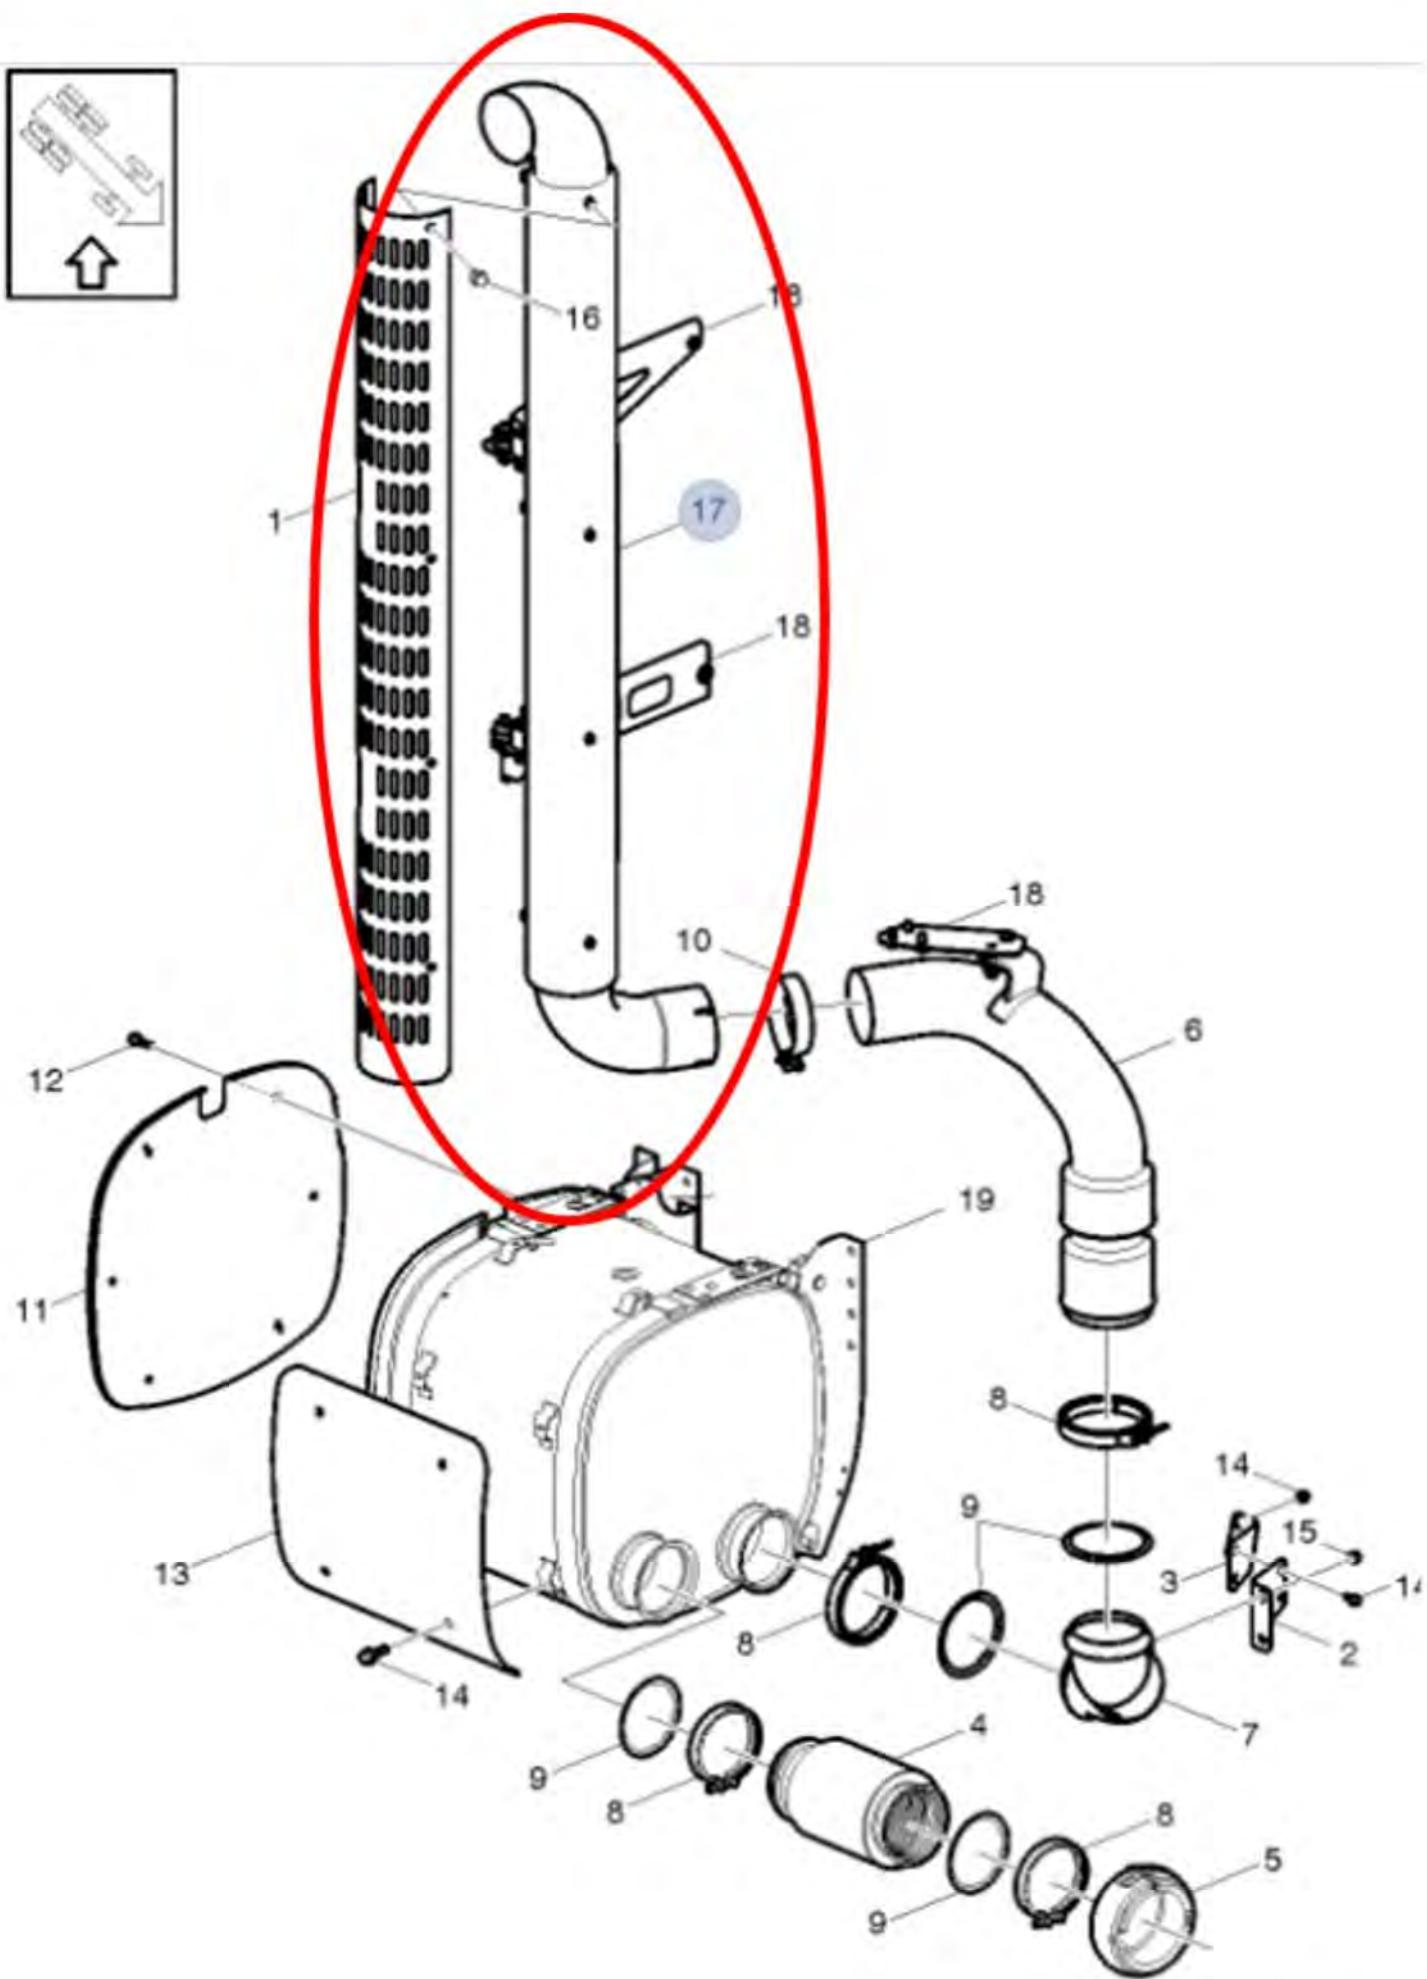
## Repair 6

Model	Cab Type	Exhaust Configuration	Pipe 1	Clamp (Qty will vary)
VHD/VNM	Cab Mounted	SCR RH Horizontal Forward Mount	23154823	20961913
VHD/VNM	Cab Mounted	SCR Horizontal	23154825	20961913
VNL 11/13	Cab Mounted	SCR Horizontal	23154827	20961913

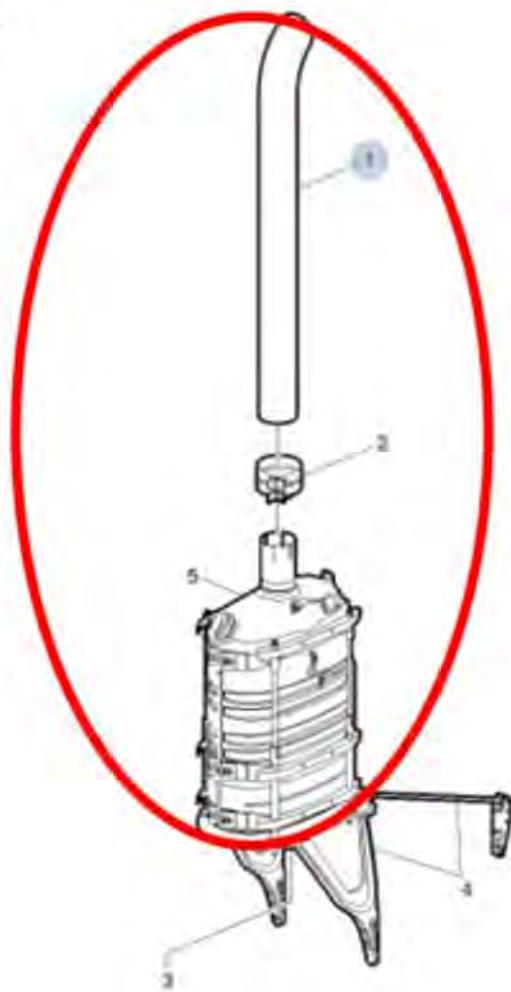
## Repair 7

Model	Cab Type	Exhaust Configuration	Pipe 1	Pipe Insert	Clamp (Qty will

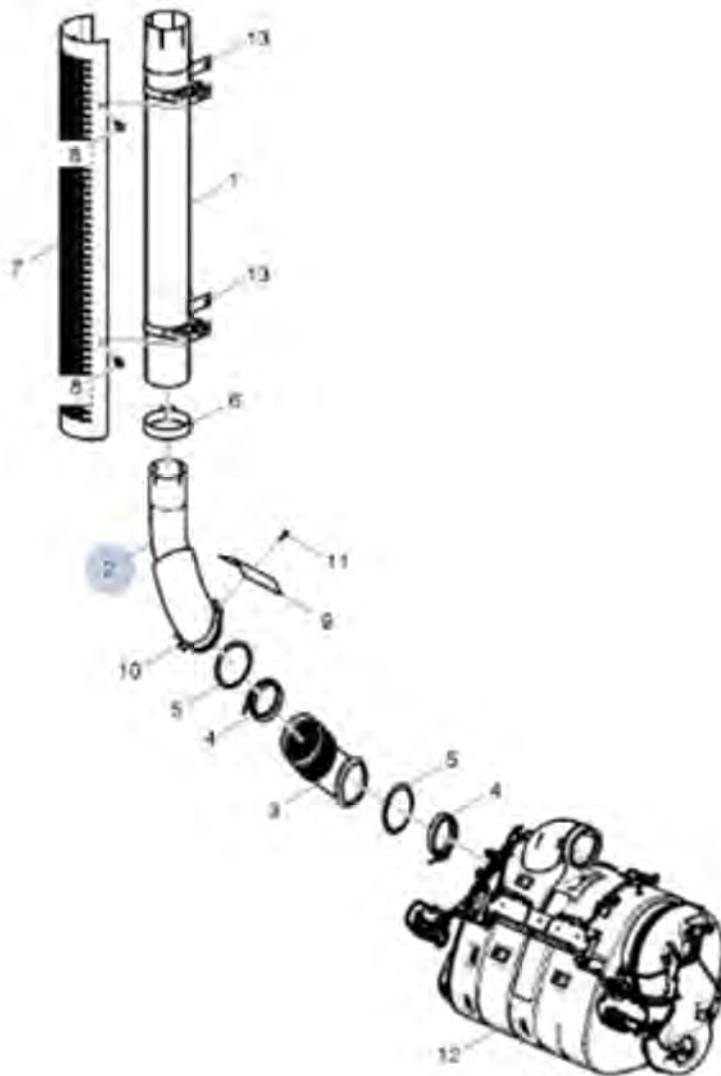
## Repair 1

Model	Cab Type	Exhaust Configuration	Pipe 1 (Stack with welded flex)	Pipe 2 (SCR Elbow)	Clamp
VNL	Day Cab	Single Outlet Right Side Outboard	23985907	22181981	25172497

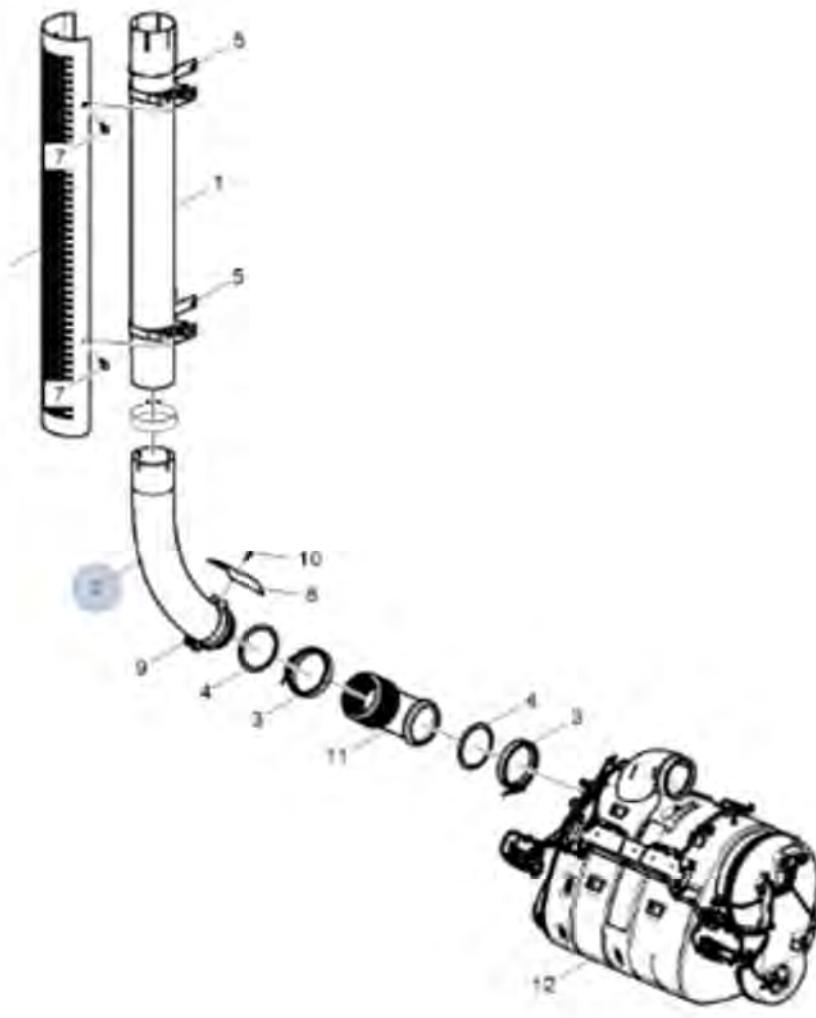
## Repair 2

Model	Cab Type	Exhaust Configuration	Pipe 1
VHD – Axe Forward	Day Cab	Single Outlet Right Side Inboard	23155762

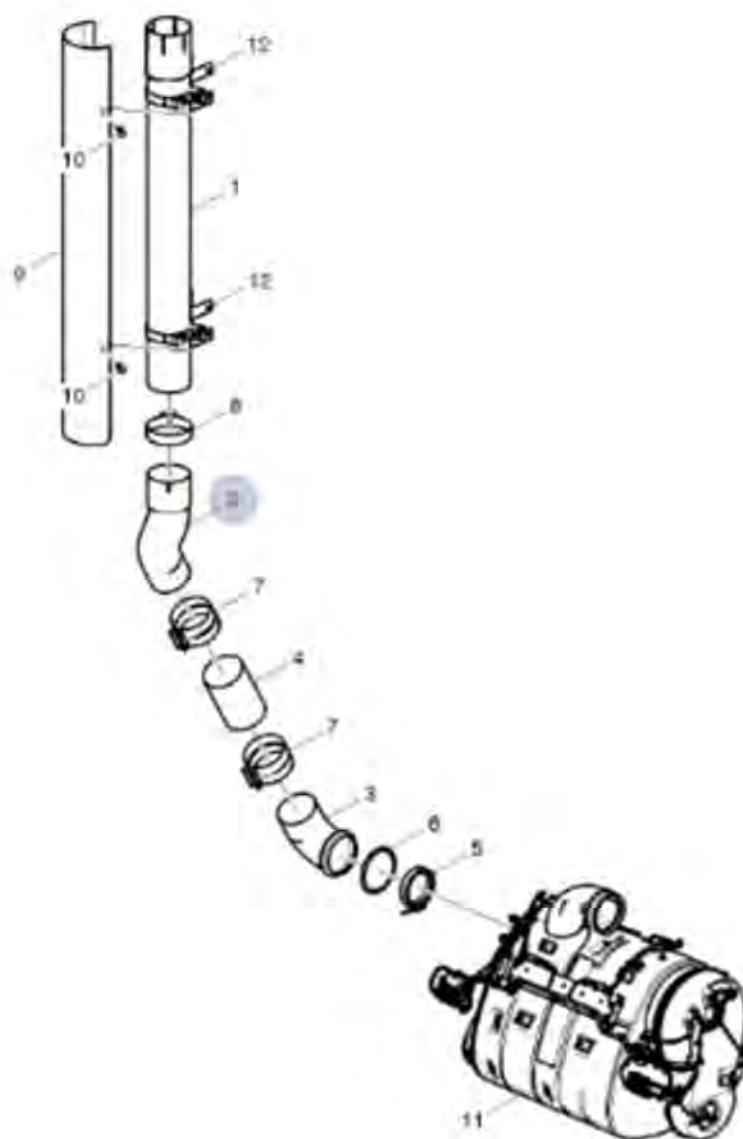
Repair 3

Model	Cab Type	Exhaust Configuration	Pipe 1
VNM/VHD	Day Cab	Single Outlet Right Side Inboard	23630048

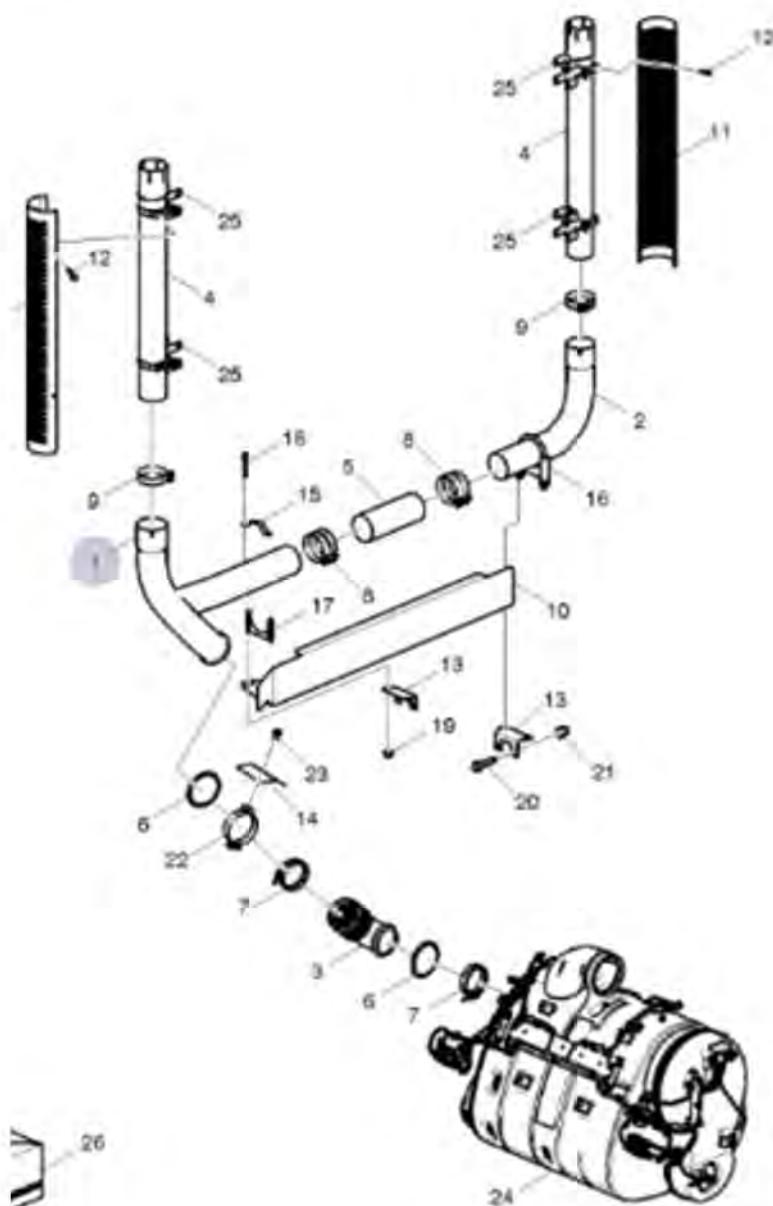
#### Repair 4

Model	Cab Type	Exhaust Configuration	Pipe 1
VHD Axle Bwd	Day Cab	Dual Outlet	23155774
VHD Axle Fd	Day Cab	Dual Outlet	23155785

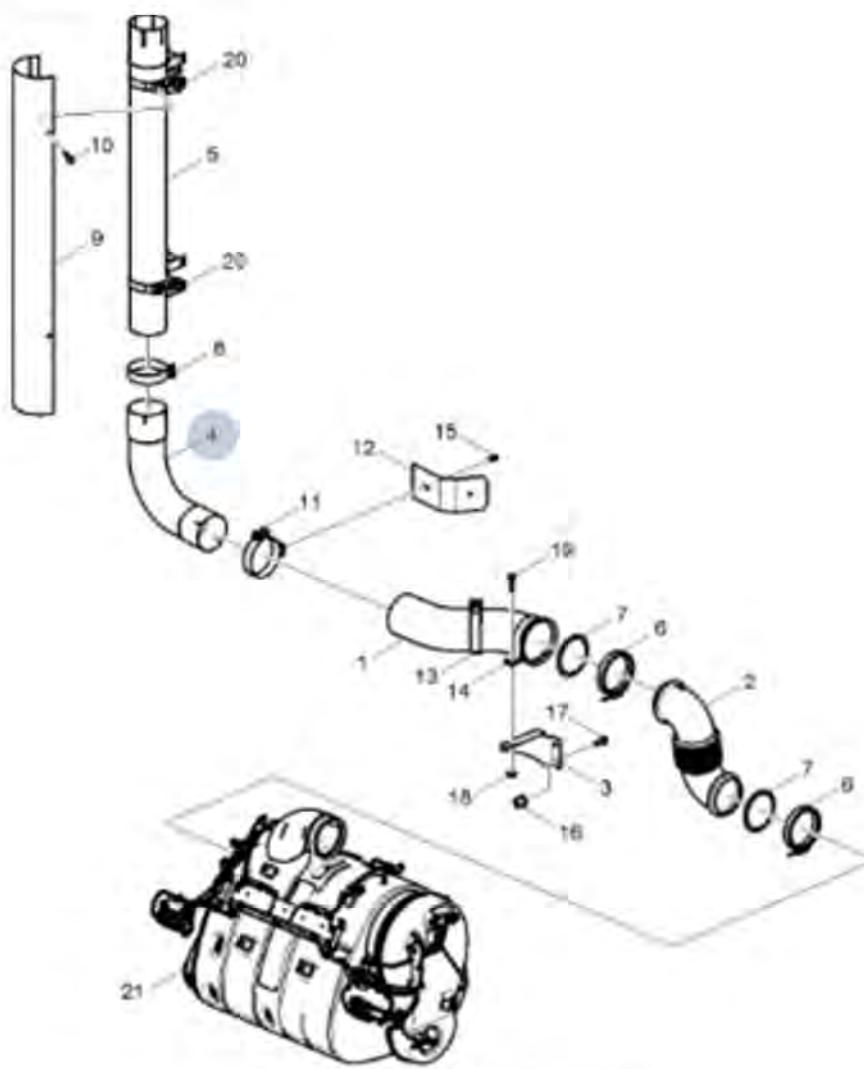
Repair 5

Model	Cab Type	Exhaust Configuration	Pipe 1
VNM			(Not Bright)
VHD			23154798
VNL	Sleeper Cabs	Single Outlet Right Side Outboard	(Bright) 23154799

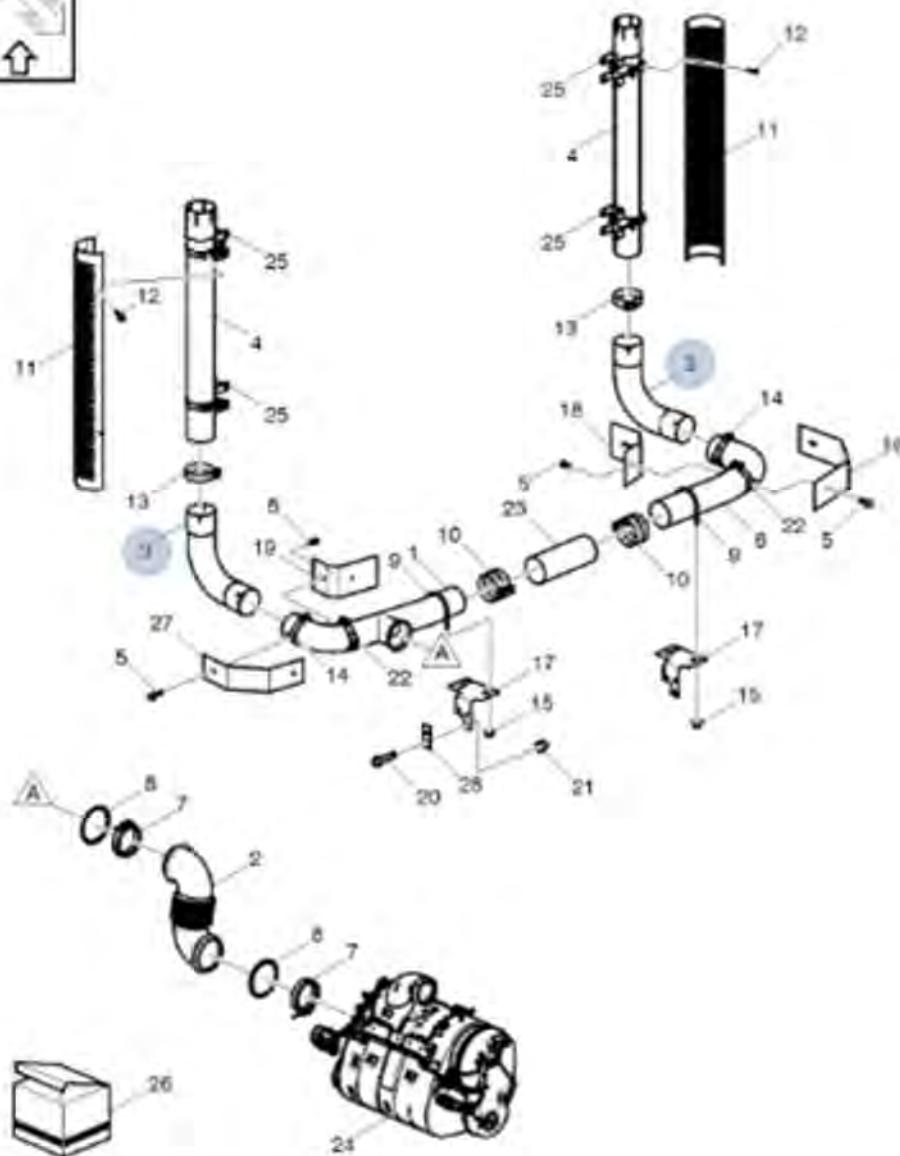
## Repair 6

Model	Cab Type	Exhaust Configuration	Pipe 1	Note
VNM	Sleeper	Dual Outlet	(Not Bright)	Requires 2 elbows per chassis
VHD	Cabs	Right Side Outboard	23154798	
VNL			(Bright) 23154799
