# RCA-78-22-010-1: Adjust and Repair Cowl Harness

<b>Document Type</b>	Customer Satisfaction Campaign Bulletin
<b>Date</b>	July 22, 2022
<b>Affected Region(s)</b>	USA
<b>Affected Model(s)</b>	R1T
<b>Model Year(s)</b>	2022
<b>Approximate Build Dates</b>	August 2021 - March 2022

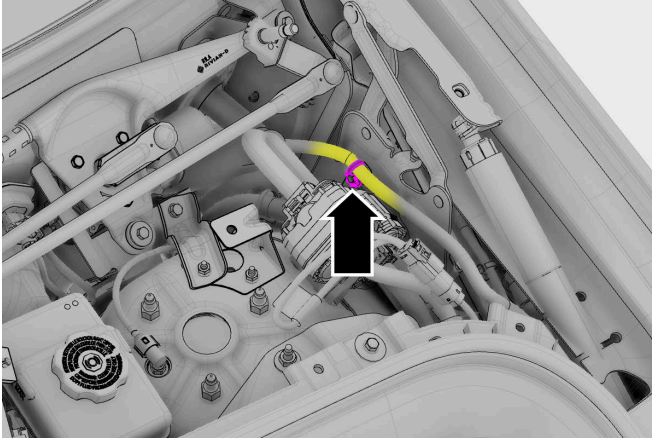
1.

2. Inspect the position of the grommet:

- If the small arrow next to the "L" points upward, skip to the [Secure Harnesses to Bracket](#) section.
- If the small arrow next to the "L" points in a different direction, continue to the next step.
