# Emissions Recall Code: 26N6

Catalyst

August 10, 2022

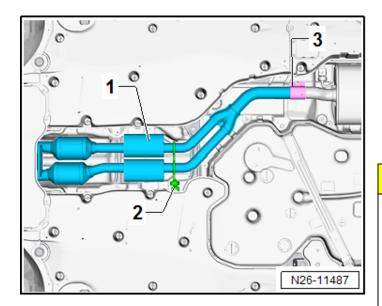
#### Section B - Replacing Catalyst

Over time and mileage, the factory-installed catalyst may not perform as required. If the effectiveness of the catalyst is reduced, this may result in increased tailpipe emissions and the vehicle could fail an emissions (IM) inspection.

- See ELSA Repair Manual: Repair Manual > Engine > 6-Cylinder Direct Injection (3.6L Engine, 4V) > 26 Exhaust System, Emission Controls > Emissions Control System > Catalytic Converter, Removing and Installing
- After replacing the catalyst:
  - Proceed to Section C to update the ECM software.

- All exhaust nuts must be soaked with penetrating oil prior to removal to avoid exhaust stud breakage.
- All exhaust nuts should be removed using hand tools and not impact tools.
- Any rusted fastener should also be soaked with penetrating oil to avoid breakage.

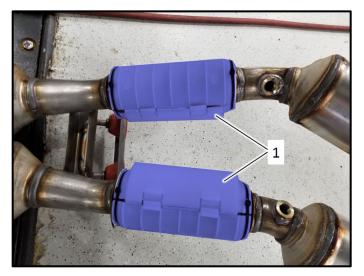
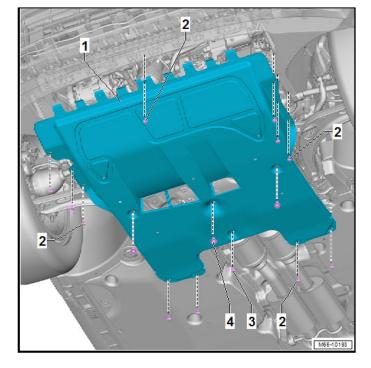
Do not bend the decoupling element more than 10°. Do not damage the wire mesh on the decoupling element.
