# Service Bulletin

Bulletin No.: 22-NA-155

**Subject:** Harsh Transmission Downshift 4-3

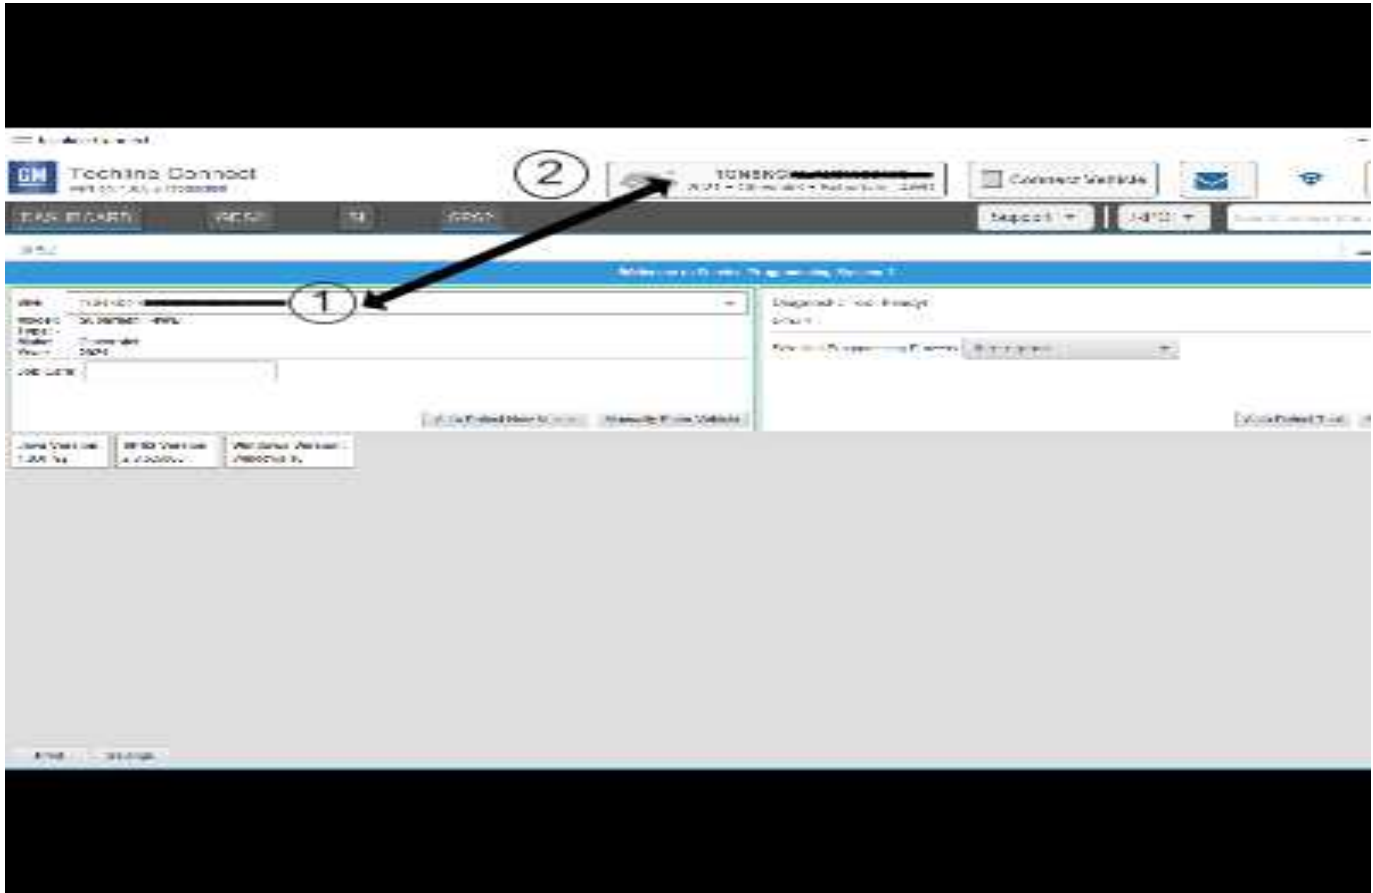
**Caution:** Be sure the VIN selected in the drop down menu (1) is the same as the vehicle connected (2) before beginning programming.
