Service Bulletin

Bulletin No.: 22-NA-157

Subject: Transmission Control Module Update

Brand:	Model:	Model Year:		VIN:		Engine:	Transmission:
		from	to	from	to		
Chevrolet	Corvette	2021	2021	—	—	—	—

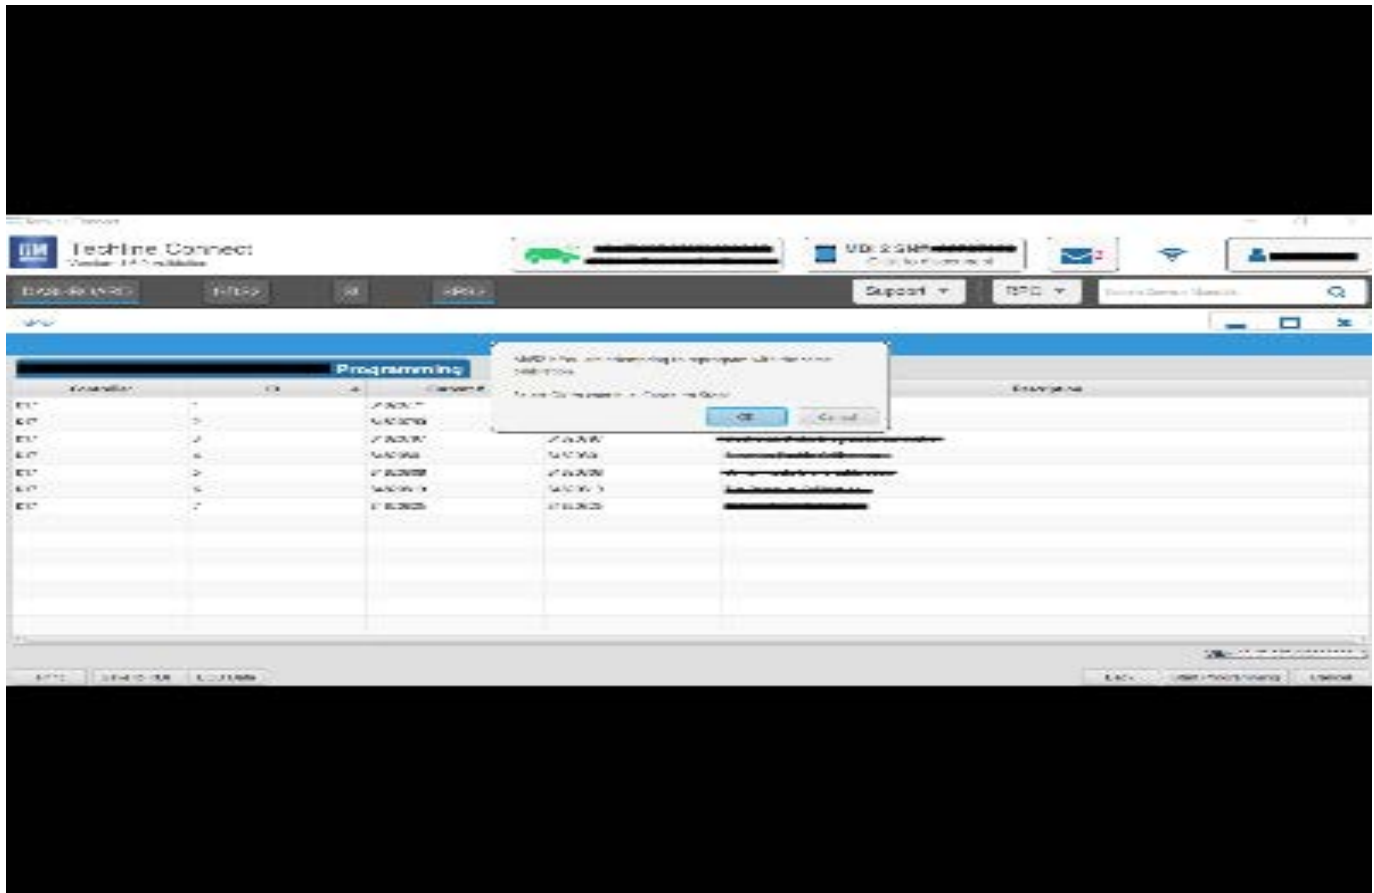
5644477

Important: Techline Connect screen shown above.
Important: If the same calibration/software warning is noted on the TLC or SPS Summary screen, select OK and follow screen instructions. After a successful programming event, the WCC is located in the Service
