# TECHNICAL SERVICE BULLETIN

Classification: AN22-016	Reference: NTB22-055	Date: July 7, 2022
-----------------------------	-------------------------	-----------------------

## SOFTWARE UPDATE FOR INFOTAINMENT ISSUES

**APPLIED VEHICLES:** 2021-2022 Maxima (A36)

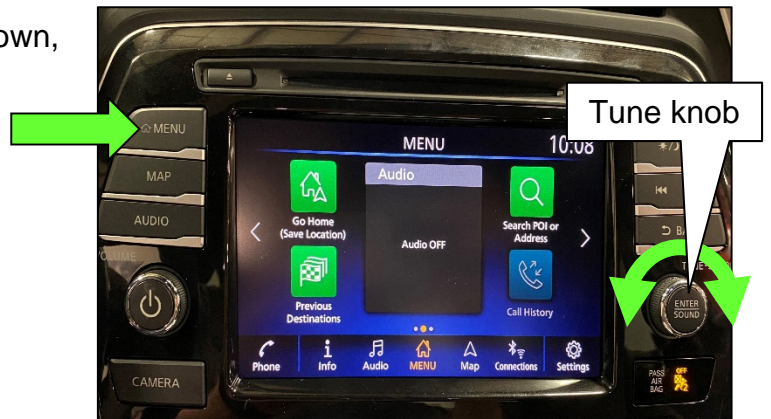
Figure 2

1. While holding the **MENU** button down, turn the tune knob left-right-left.

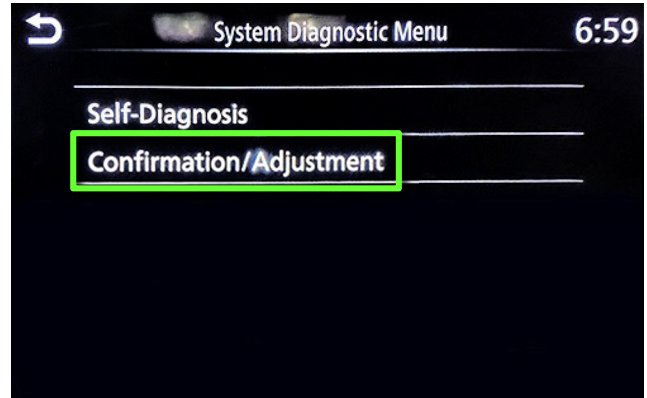
Figure 3

2. Select **Confirmation/Adjustment**.

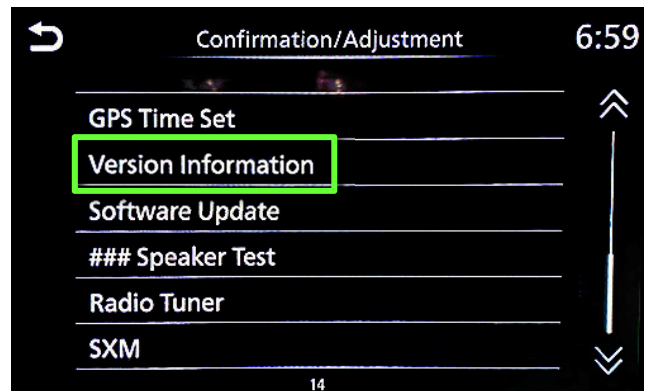
Figure 4

3. Select **Version Information**.

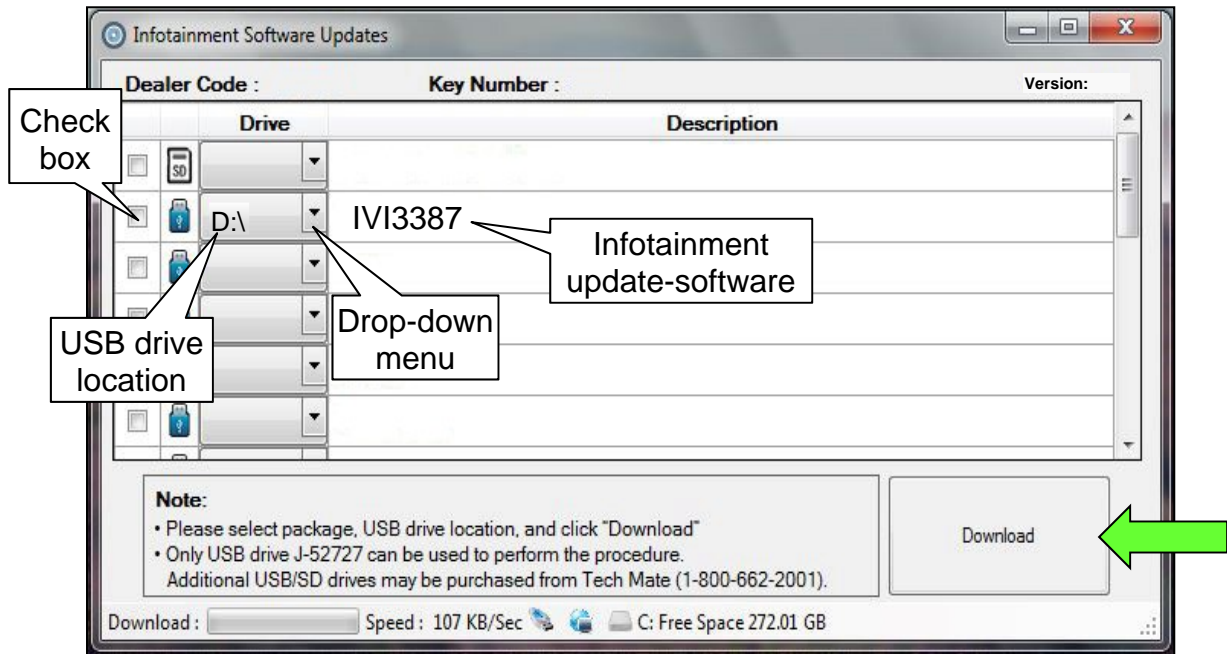
Figure 7

8. Select the check box next to infotainment update-software **IVI3387** (Figure 7).
9. Use the drop-down menu and select the location of the USB drive that was inserted in step 5 on page 5.

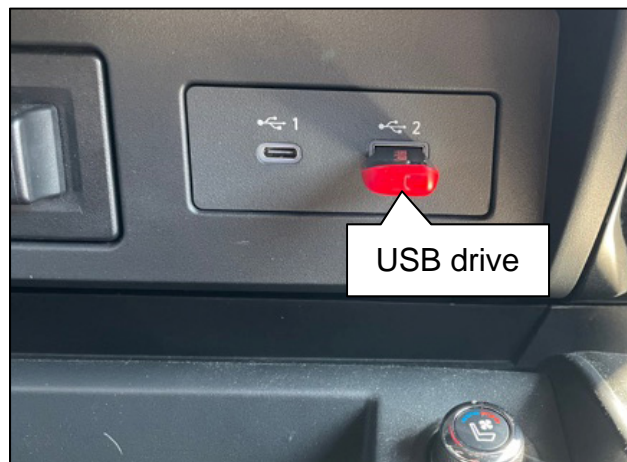
Figure 11

16. Insert the USB drive with the infotainment update-software into the vehicle's USB media port (Figure 11).

Do not insert the USB drive into a charging port. If used, the update-software and/or USB drive may become damaged. Only insert the USB drive in a USB media port.

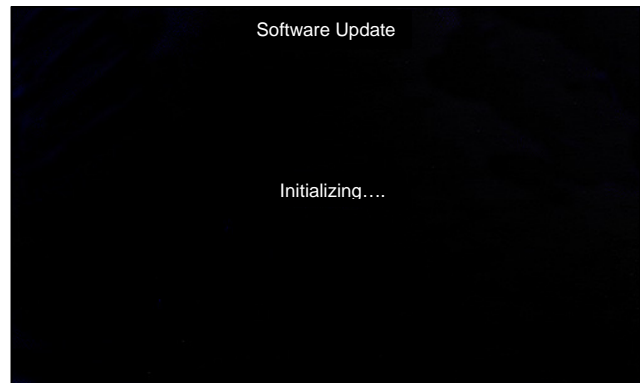
17. Wait approximately 10-30 seconds for the screen in Figure 12 to appear.
