# TECHNICAL SERVICE BULLETIN

Classification: EL22-011	Reference: NTB22-051	Date: June 17, 2022
-----------------------------	-------------------------	------------------------

## HORN INOPERATIVE

**APPLIED VEHICLES:**  
2019-2022 Altima (L34)  
2018-2022 Kicks (P15)  
2018-2022 LEAF (ZE1)  
2020-2022 Sentra (B18)  
2020-2022 Versa (N18)

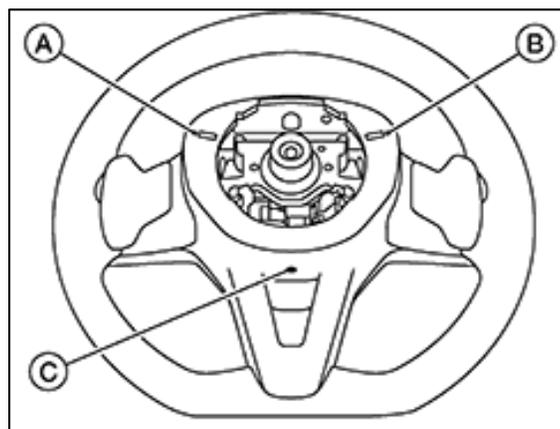
Figure 2

3. Locate the two (2) access holes on the back of the steering wheel and the one (1) access hole on the bottom of the steering wheel (Figure 2).
  - A. Right side access hole
  - B. Left side access hole
  - C. Bottom access hole

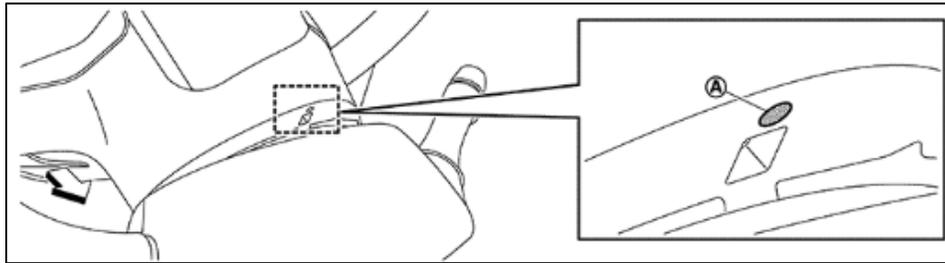
Figure 3

- Turn the steering wheel until the access hole (A) is visible from the top of the steering column (Figure 3).

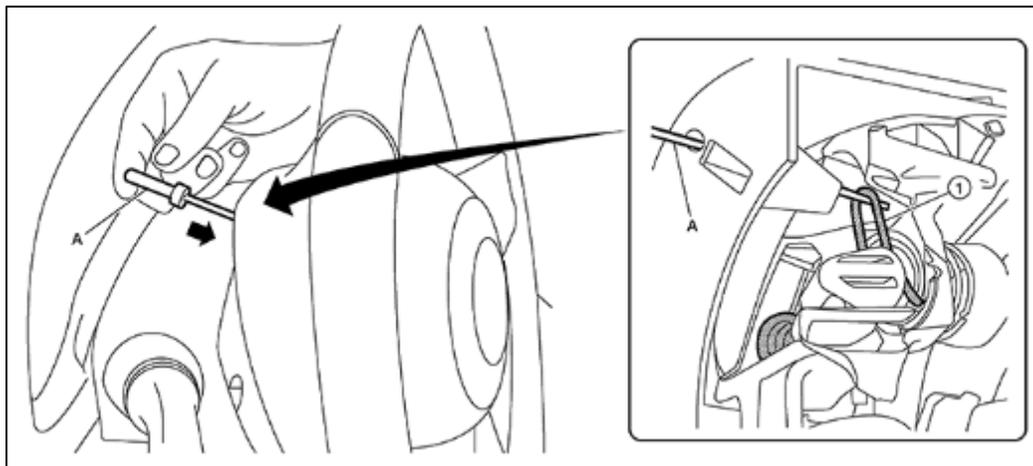
Figure 4

- Insert the Air Bag Release Tool, special tool J-52551 (A), into the access hole and under the spring (1), as shown in Figure 4.

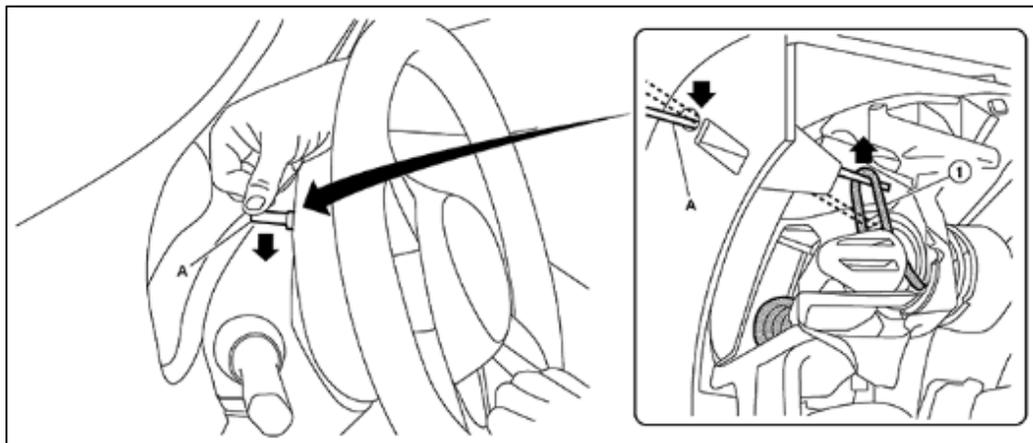
Figure 5

- Lift the spring (1) using the Air Bag Release Tool (A), to disengage the spring, as shown in Figure 5.

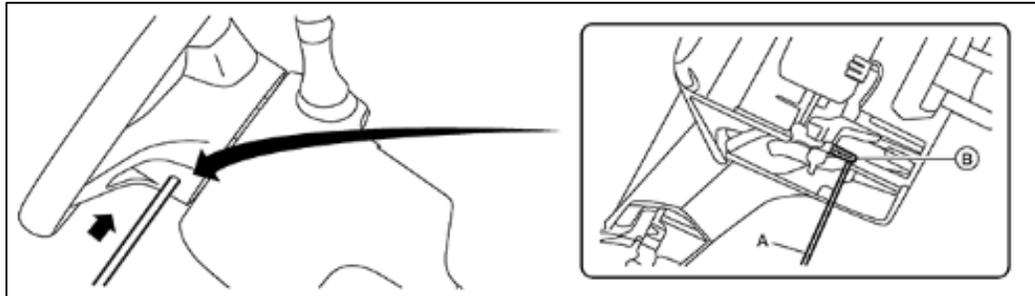
Figure 6

7. Turn the steering wheel in the opposite direction, and then repeat steps 4 - 6 to release spring B (Figure 2 on page 3).
8. Using the Air Bag Release Tool (A), gently push the bottom pawl (B) and gently tilt the bottom of the driver airbag module outward so that the pawl will not re-engage, and then pull out the driver airbag module.
