Subject: WHEN REPLACING BCM, SOME ECU MAY NEED REPROGRAMMING	Bulletin No.: 09-027/22
	Last Issued : 08/03/2022

DESCRIPTION

When replacing the body control module (BCM), some ECUs may need reprogramming. Without reprogramming the concerned ECUs, the power saving function may not work properly.

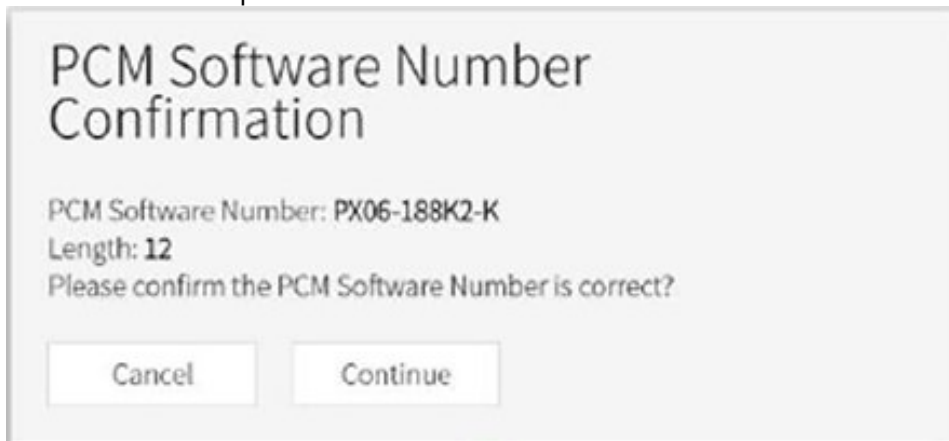
- Enter the software number adding “-” instead of a space.
Example: If “PX06 18 8K2H” is printed, enter “PX06-18-8K2H”.
- **NOTE:** Entering the wrong Software Number may lead to inappropriate software downloading and could result in abnormal operation of the vehicle.
