GROUP	MODEL
ELE	2022MY EV6 (CV)
NUMBER	DATE
257 (Rev 1, 08/18/2022)	June 2022

TECHNICAL SERVICE BULLETIN

SUBJECT: **SERVICE ACTION: AMP LOGIC UPDATE/REPLACEMENT
FOR NOISE/NO SOUND ISSUES (SA494A)**

This issue number is SA494A.

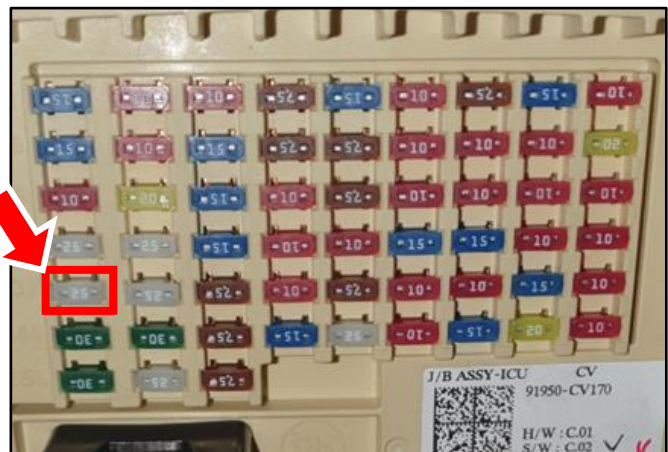
Refer to image at right for location of AMP fuse (5th down in first column).

If the Manual upgrade fails, disconnect then reconnect the AMP fuse in the fuse box. Then conduct the manual upgrade again.
