TECHNICAL SERVICE BULLETIN

Classification: AT21-003B	Reference: NTB21-023B	Date: August 30, 2022
------------------------------	--------------------------	--------------------------

DTC P0780 STORED IN THE TCM

APPLIED VEHICLES: 2021 Rogue (T33)

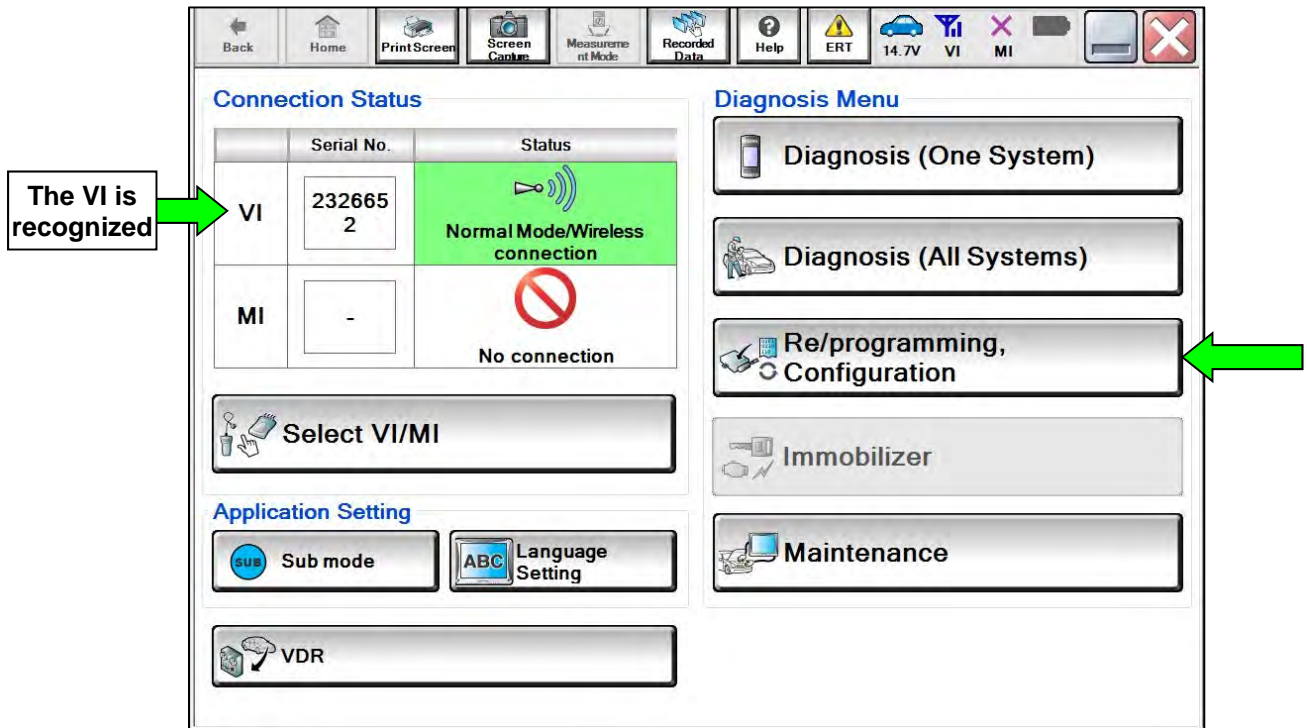
Figure 1

1. Connect a battery maintainer/smart charger to the vehicle.
2. Connect the VI to the vehicle.
3. Start C-III plus.
4. Wait for the VI to be recognized (Figure 1 on page 3).
 - The serial number will display when the VI is recognized.

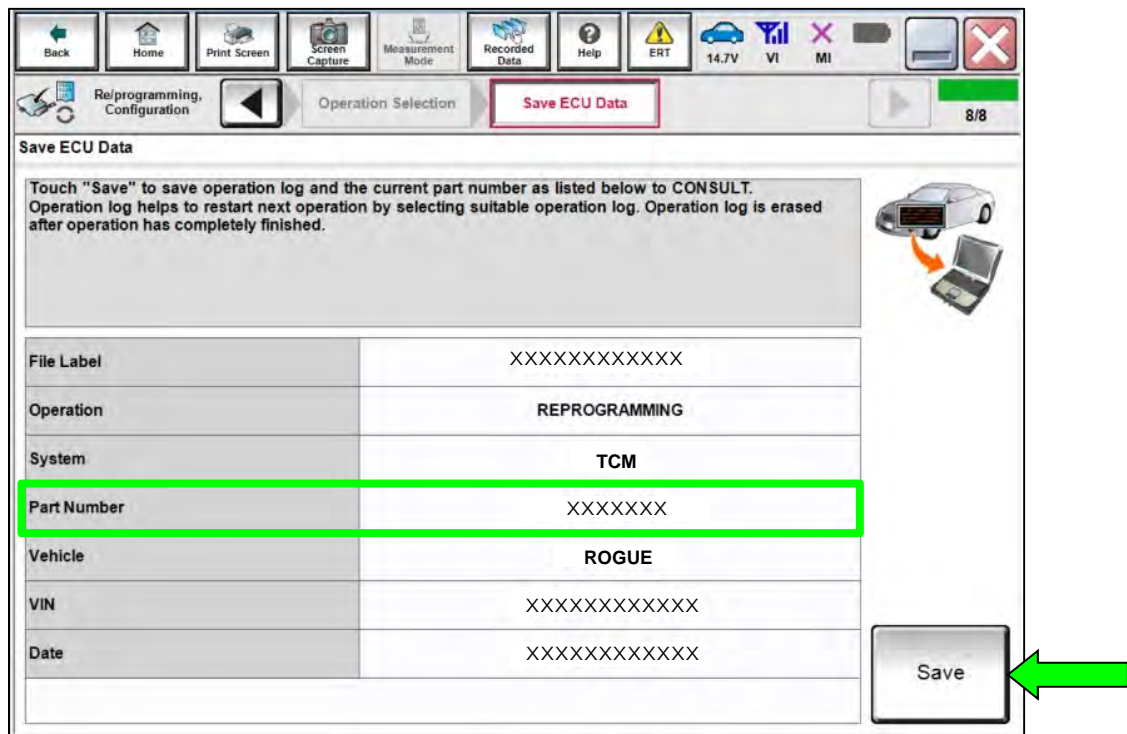
Figure 10

14. Find the TCM **Part Number** and write it on the repair order, and then select **Save**.
NOTE: This is the current Part Number (P/N).
