Service Alert

Mazda North American Operations
Irvine, CA 92618-2922

| Subject: CONNECTED VEHICLE SYMPTOM TROUBLESHOOTING | Service Alert No.: SA-017/22 |
| | Last Issued : 08/25/2022 |

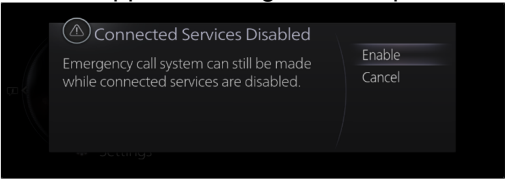
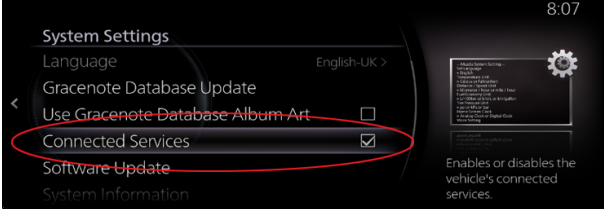
| <p>CX-5, CX-50, CX-9, MX-30 Mazda3, CX-30 built July 1, 2021 and later</p> <p>Connected Services Disabled message appears at engine start up</p> | <p>Connected Services disabled (box unchecked)</p> <p>Enable Connected Services (box checked) to prevent message appearing at engine start up.</p> <p>Note: If customer Opted-Out (CSP04), advise customer to keep Connected Services box checked. The vehicle will not transmit data.</p> |

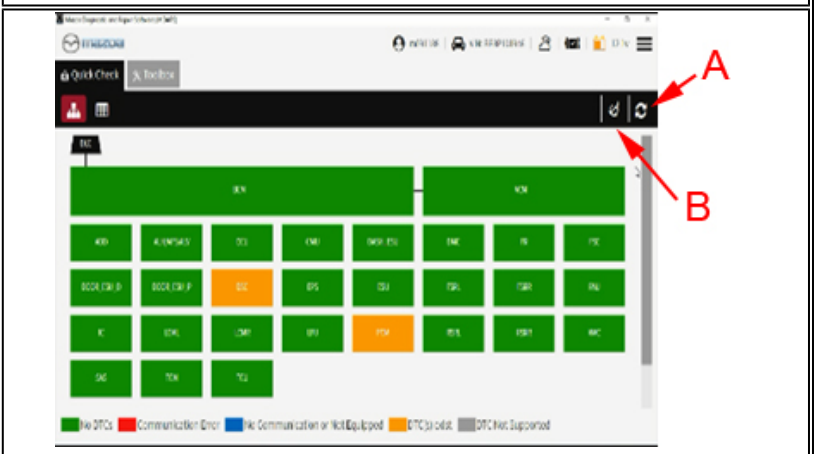
CAUTION: If the engine is not started, DTC P2610 is stored and cannot be erased.

5. Select Quick Check (A), then start the engine and select the DTC Clear icon (B).

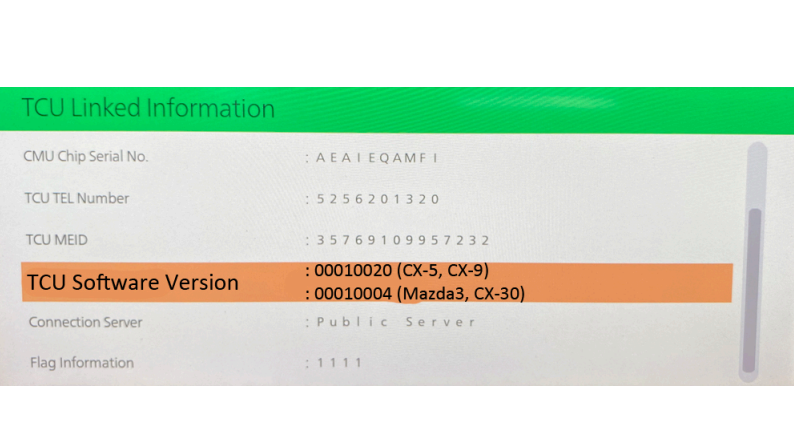
| | CX-5 and CX-9 | CX-30, CX-50, Mazda3 and MX-30 |
|--|--|---|
| <p>4. Scroll down to TCU Software Version and confirm the software version is at:</p> <ul style="list-style-type: none"> • Mazda3 - 10006 or later • CX-30 - 10006 or later • CX-5 - 10023 or later • CX-9 - 10023 or later • MX-30: 10019 or later • CX-50: N/A <p>Is the TCU software version correct?</p> <ul style="list-style-type: none"> • Yes: TCU Software Version Check is complete. | | |

- **No:** Go to [Telematics Communication Unit \(TCU\) Updates](#) to update the TCU software version.
