Service Bulletin

Bulletin No.: 22-NA-067

Subject: Poor Engine Performance in Extremely Cold Weather Conditions, PCV Bypass Hose and Charge Air Cooler Icing for LUV Engines, Malfunction Indicator Lamp (MIL) Illuminated - DTC P0299, P0234, P0236, P2261, P2227, P00C7 Set

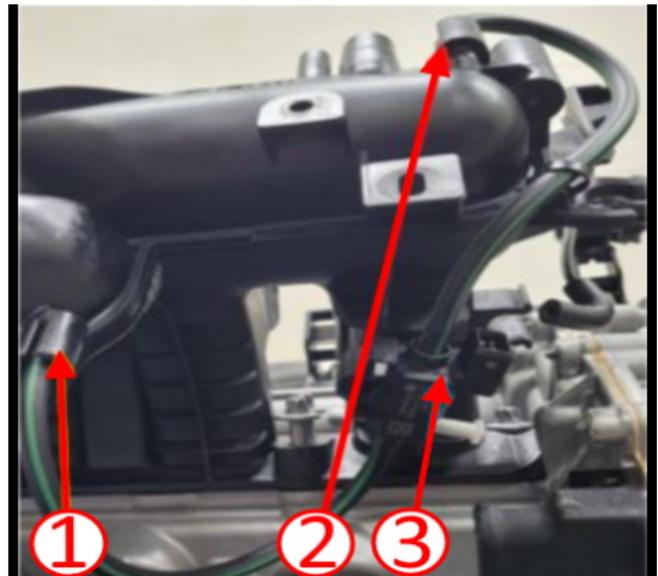
Old Design Intake Manifold

- Bypass Valve Vacuum (1)
- Intake Positive Pressure Port (2)
- Solenoid/Electrical Connector (3)

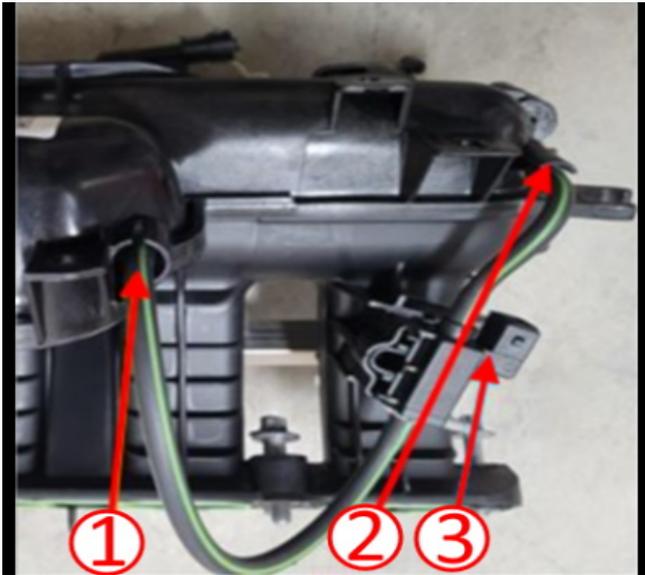
New Design Intake Manifold

New intake manifold with a re-designed intake positive pressure port location. Solenoid location is electrical connector forward. The vacuum feed is in the same location. If the solenoid is found to be loose, review the location of the electrical connector. If the connector is facing the head of the assembly, it is installed backwards and will need to be removed and installed correctly.

Note: The electrical receptacle location. Remove and re-install the lines and solenoid as they are retained to the intake if installed incorrectly. Tabs reversed, the solenoid is keyed and will not be seated in retainers.
