SERVICE PROGRAM BULLETIN

APPLICABILITY: 2022 MY WRX

NUMBER: WRA-22R

SUBJECT: WRX EyeSight® Reprogramming

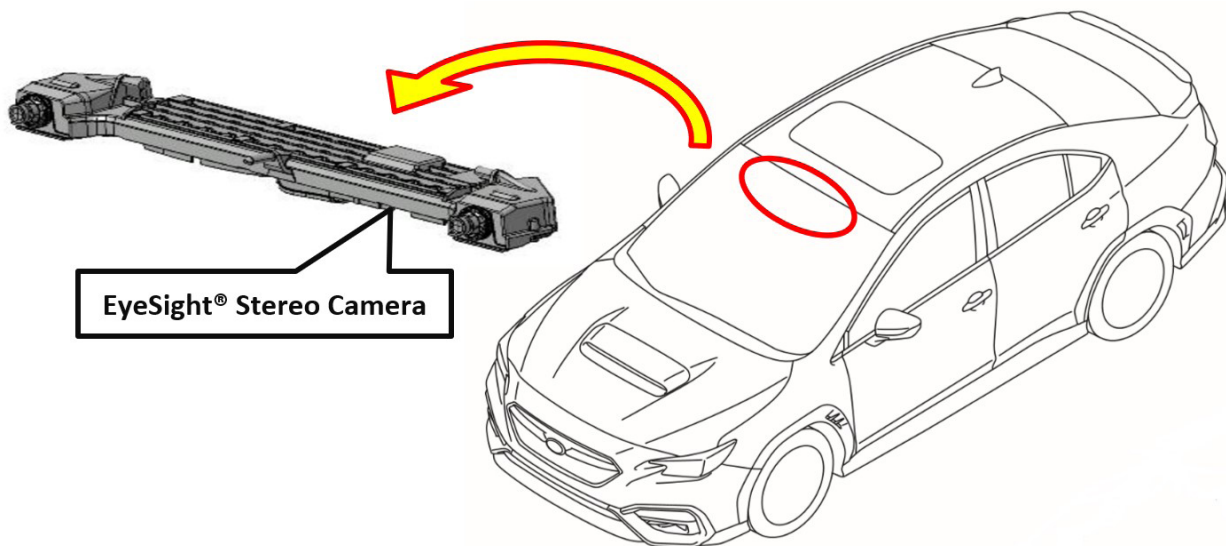
EyeSight® Stereo Camera Location:

The EyeSight® software in the vehicles included in this service program may erroneously cause the EyeSight® functions to temporarily stop working under certain operating conditions. EyeSight® functionality will be unavailable for the remainder of the drive cycle, the EyeSight® warning light will illuminate, and diagnostic trouble code (DTC) B28A6 will be stored. Following the next ignition cycle, the EyeSight® function returns to normal.

Subaru retailers will check and, if necessary, update the EyeSight® software as described in this bulletin at no cost to the customer.
