Odor Remediation After Water Intrusion

Service Category Vehicle Interior

Section Interior Panels/Trim

May 26, 2022 Rev1:

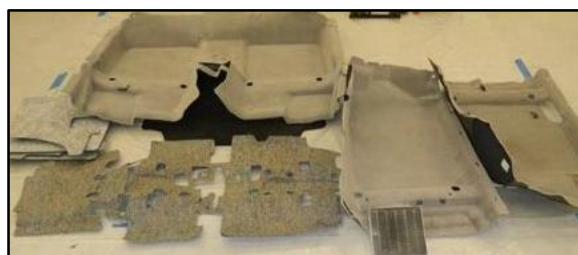
Figure 3. Example of Soft Parts

4. Inspect ALL soft parts for organic matter growth and/or staining that would indicate water contact.

- Soft parts include items that DO HAVE an absorbent quality that will require them to be removed and replaced with NEW parts if they have come into contact with moisture.
- Keep ALL soft parts that will be replaced away from the parts that will be reused.
Soft parts include:
 - Floor mats.
 - Carpet/Carpet padding/Jute padding.
 - Insulated pads/Styrofoam pads.
 - Dash panel insulator assembly (located behind instrument panel/dash pad).
- These parts should NOT be reused and require replacement with NEW parts once the remediation has been completed.

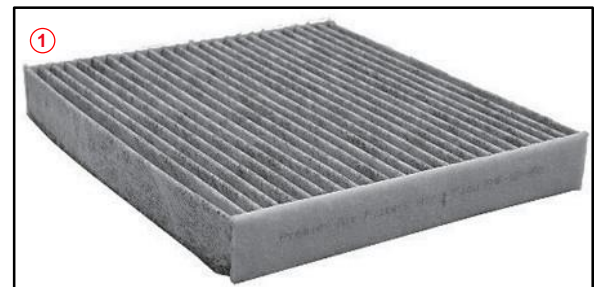
Figure 7. Cabin Air Filter

The Cabin Air Filter Should Not Be Installed in the HVAC During the Remediation Process

1. If equipped, remove the cabin air filter and discard.

- There should **NOT** be a cabin air filter installed in the HVAC during the remediation process.
- A **NEW** high-performance charcoal filter should be installed **AFTER** the entire remediation process has been completed.

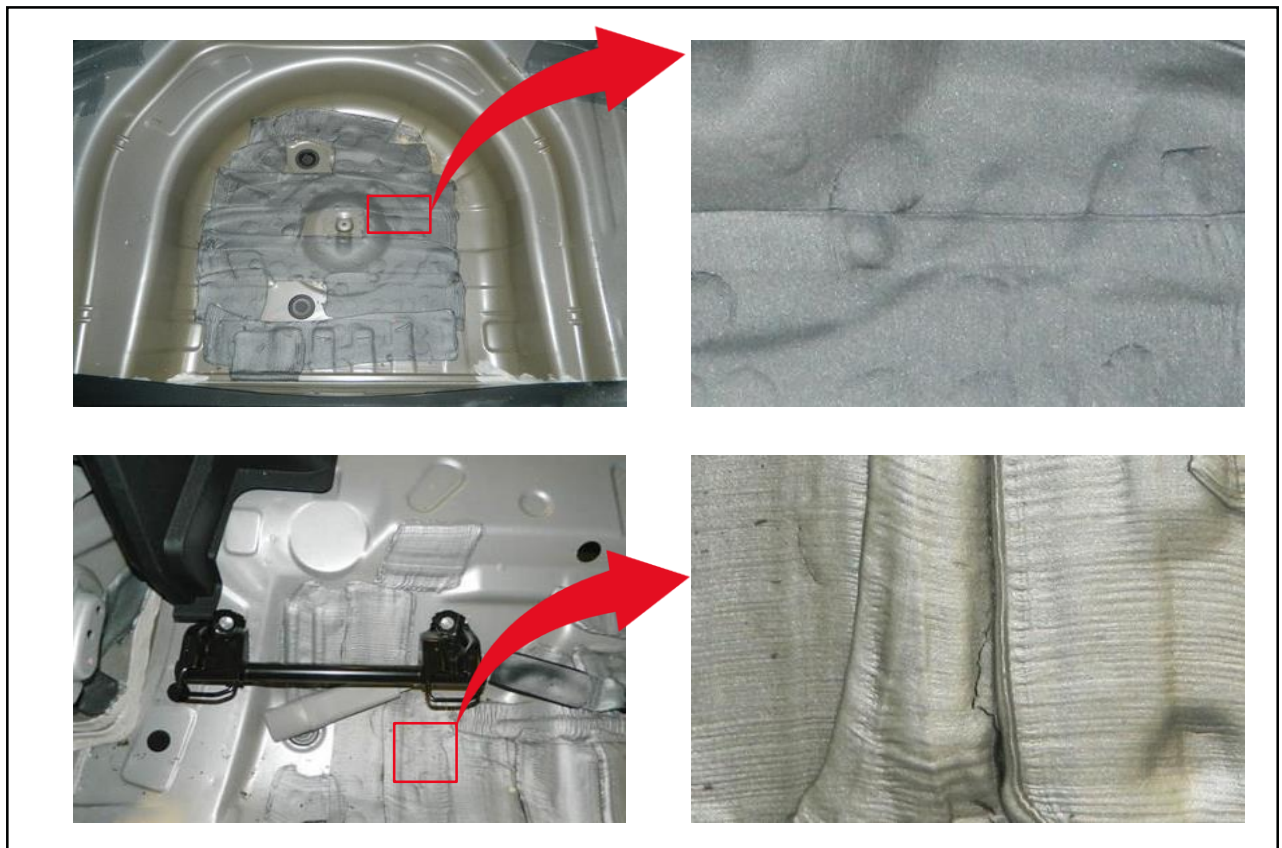
Figure 10. Examples of LASD

The appearance of LASD (color, texture) may vary (smooth vs. rippled) depending on the vehicle and application method.

LASD is a vibration damping coating that is used on the floor of vehicles to reduce road noise. To maximize the effectiveness of the remediation, LASD removal is required prior to the remediation process being performed.
