IMPORTANT SAFETY RECALL

COMPONENT/SUPPLIER RECALL CSR-3023-A

Steering Assembly U-Joint Pinch Bolts (Freightliner FL937A — NHTSA 22V394)

Subject: Freightliner Steering Assembly U-Joint Pinch Bolts

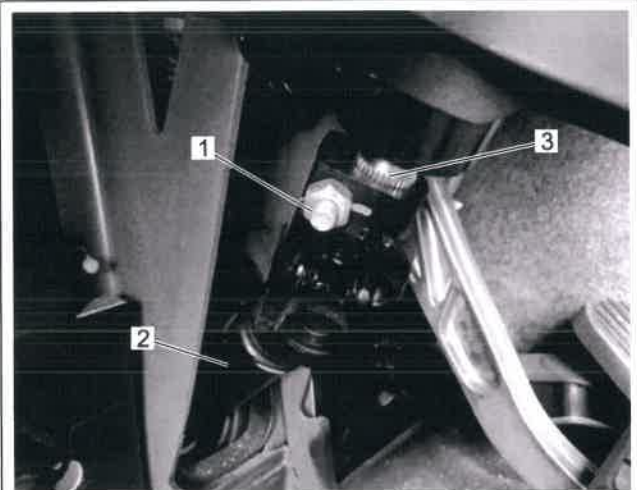
Fig. 4, Pinch Bolt and Front Firewall Location

1. Open the hood.
2. Locate the universal joint of the steering shaft at the front of the firewall. See [Fig. 3](#) and [Fig. 4](#).
3. Check the connections between the steering column and the steering shaft at the front of the firewall, and the nut to pinch bolt connection. See [Fig. 4](#).

1. Front Firewall
2. Pinch Bolt Location
3. Steering Shaft

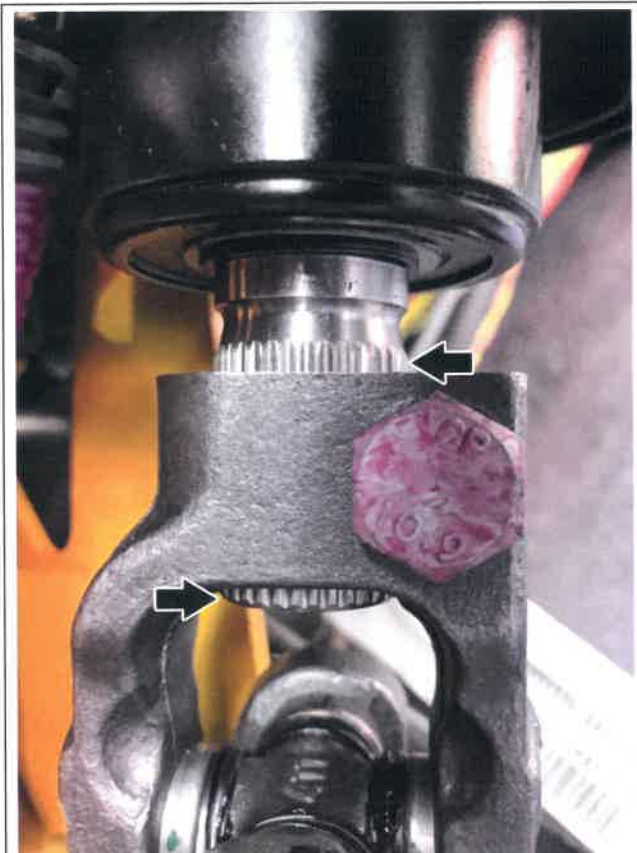
Fig. 1, Steering Pinch Bolt Location

Do not drive the vehicle if there are no bolt threads exposed beyond the nut, or there are no splines exposed on both sides of the bolted connection. Driving the vehicle without a fully secured steering assembly could result in disengagement of the steering column and a loss of steering control, which could result in personal injury and property damage.

1. Park the vehicle on a level surface, shut down the engine, and set the parking brake. Chock the rear tires.
2. Locate the steering shaft inside the cab, as shown in [Fig. 1](#).
3. Check the connections between the steering column and steering shaft, and the nut to pinch bolt connection, as shown in [Fig. 1](#). Remove the steering column cover to see the bolt.
4. Inspect the nut to pinch bolt connection. There must be bolt threads exposed beyond the nut as shown in [Fig. 1](#).

1. Steering Nut and Pinch Bolt
2. Steering Shaft
3. Steering Column

NO → **DO NOT** drive the vehicle. Have it immediately towed to the nearest DTNA dealership for repair.

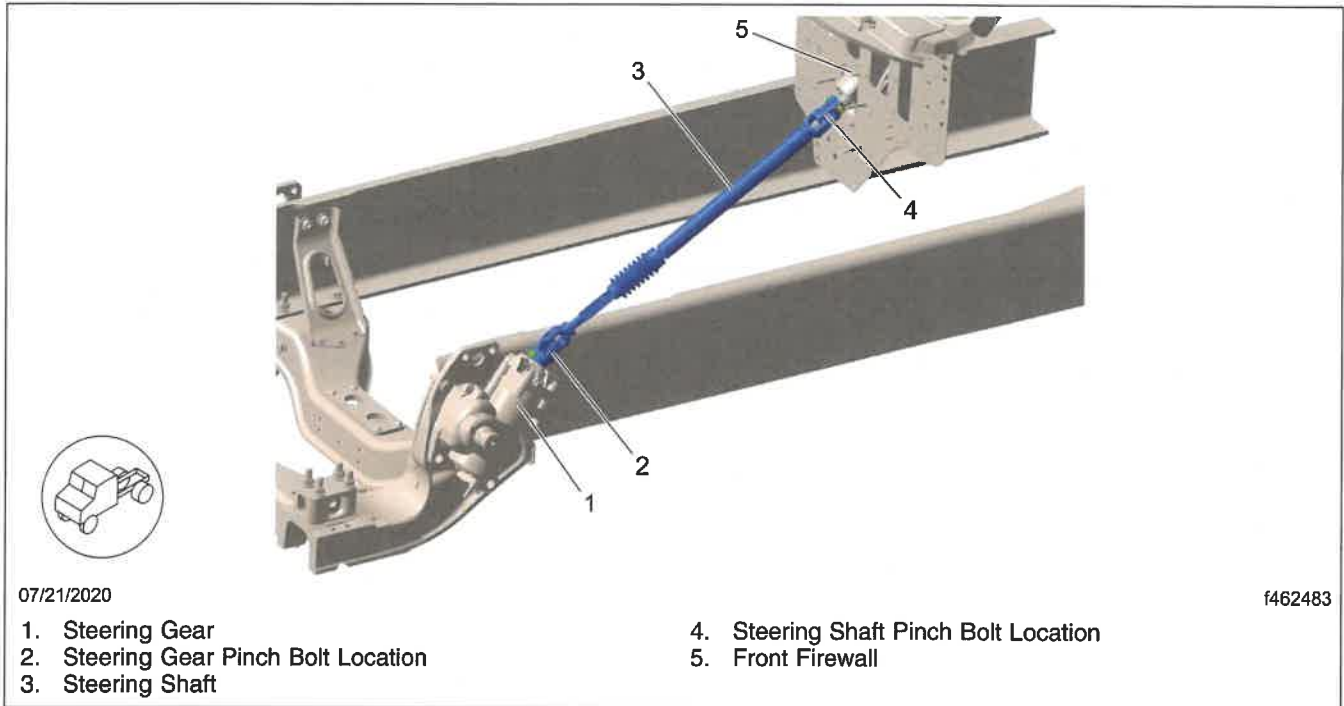
Fig. 3, Steering Assembly

1. Locate the universal joint at the steering gear. See **Fig. 3** and **Fig. 5**.
2. Check the connections between the steering shaft and the steering gear, and the nut to pinch bolt connection. See **Fig. 5**.

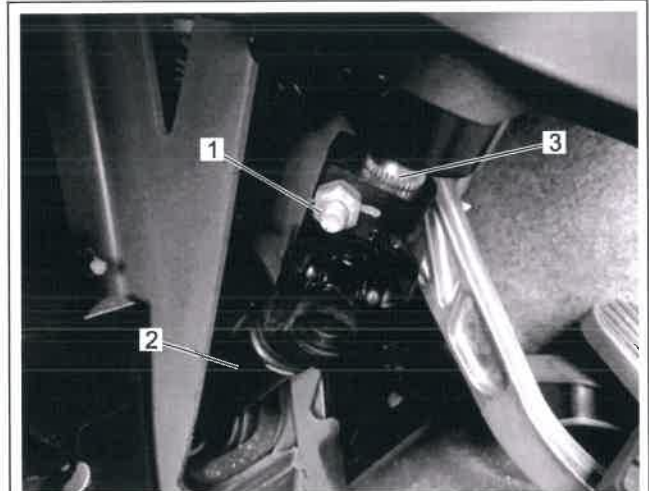
Fig. 5, Pinch Bolt and Steering Gear Location

1. Steering Shaft
2. Pinch Bolt Location
3. Steering Gear

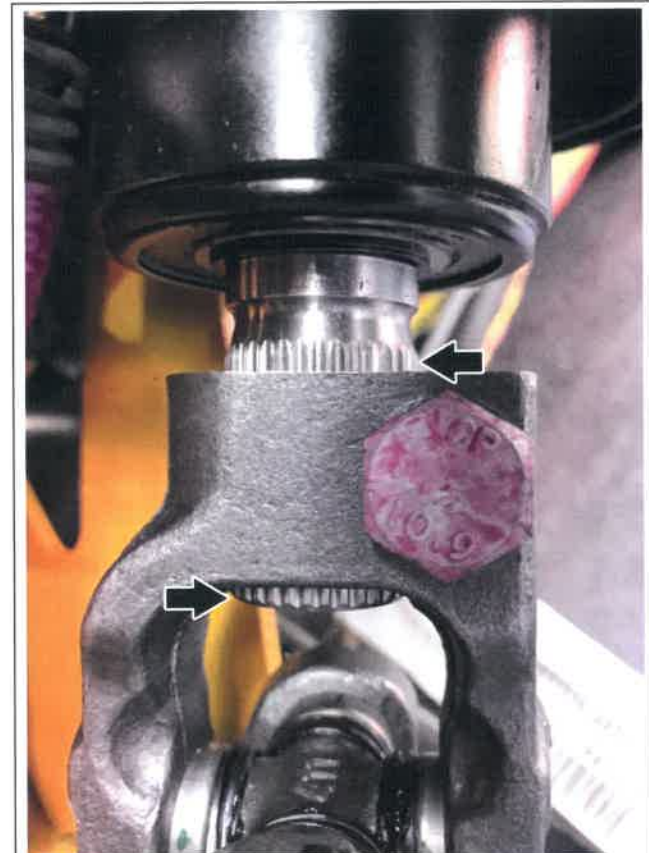
Fig. 1, Steering Pinch Bolt Location

3. Inspect the nut to pinch bolt connection. There must be bolt threads exposed beyond the nut as shown in **Fig. 1**.

1. Steering Nut and Pinch Bolt
2. Steering Shaft
3. Steering Column

NO → **DO NOT** drive the vehicle. Have it immediately towed to the nearest DTNA dealership for repair.
