# Customer Satisfaction Program

## N212354520 Heated Vented Seats Retrofit Due to Chip Shortage - Front Seats Only

**Release Date:** September 2022

**Revision:** 01

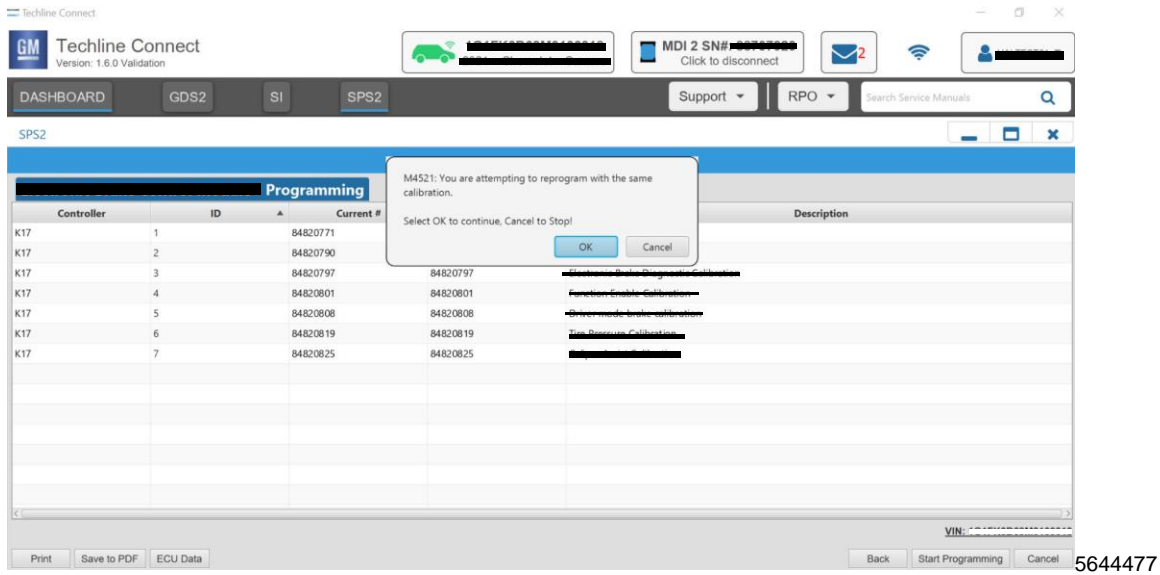
**Important:** Techline Connect screens shown above.

**Important:** If the same calibration/software warning is noted on the TLC Summary screen, select OK and follow screen instructions. After a successful programming event, the WCC is located in the Service Programming System dialogue box of the SPS Summary screen. No further action is required. Refer to the Warranty section of the bulletin.
