Technical product information

Topic	New Continental GT and GTC - Window drop glass concerns
Market area	Russische Föderation (5RU),Australia E04 Bentley rest Asia and Australia (6E04),China 796 VW Import Comp. Ltd (Vico), Beijing (6796),Germany E02 Bentley rest Europe (6E02),Japan E03 Bentley Japan (6E03),Korea, (South) E08 Bentley South Korea (6E08),United Arab Emirates E06 Bentley Middle East and Africa (6E06),United Kingdom E01 Bentley UK (6E01),United States E05 Bentley USA and rest America (6E05)
Brand	Bentley
Transaction No.	2067436/2
Level	EH
Status	Released for publishing
Release date	14-Sep-2022

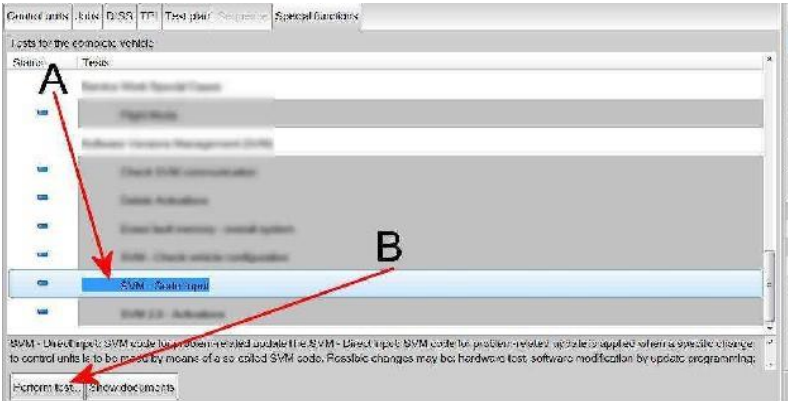
1)

- Referring to Figure 1 - Within the Special functions tab - Select SVM - Code Input (Point A)
- Select Perform test (Point B)

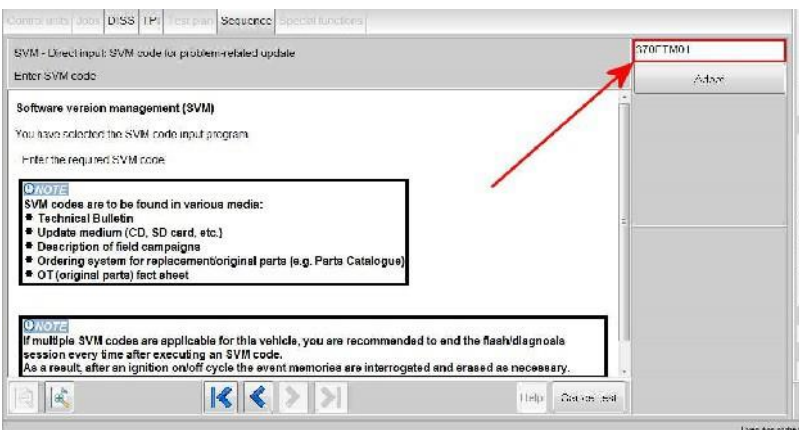
2) Referring to Figure 2 - Enter the SVM code 370FTM01

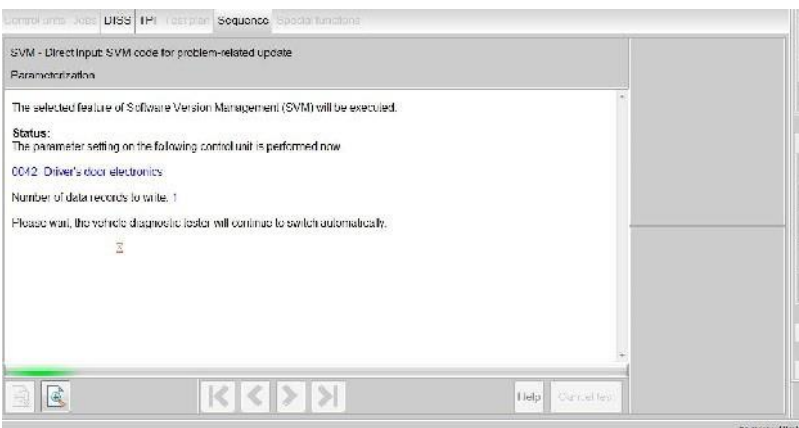
Figure 3

3) The Required control units will be automatically updated one by one, starting with 0042-Door electronics Drivers side

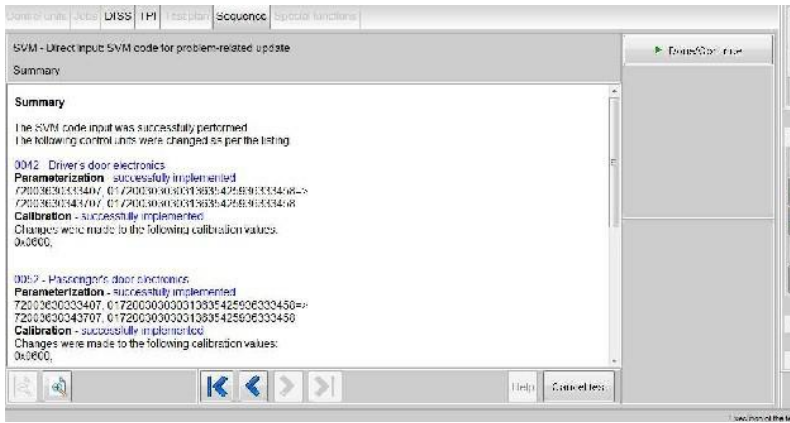
Figure 4

4) Once the update is complete the summary screen will be shown in Figure 4, this confirms completion of the required updates
