Articles Contained in this Issue

CODE	ARTICLE.....	PAGE
(00)	STIS New Releases	11-12
(01)	QMR of the Month	1-2
(01)	QMR of the Month Award Presentations	2
(12)	Diagnosing Repeat P2762 and P2757	3
(14)	Special Tools – Denso USB Cable & ECM/..... TCM Reprogramming	7
(05)	Ascent Noise from Rear Over Bumps or When Turning	9
(15)	Version 4 Eyesight and Immobilizer Registration, U1C00	10

01 TechShare QMR of the Month

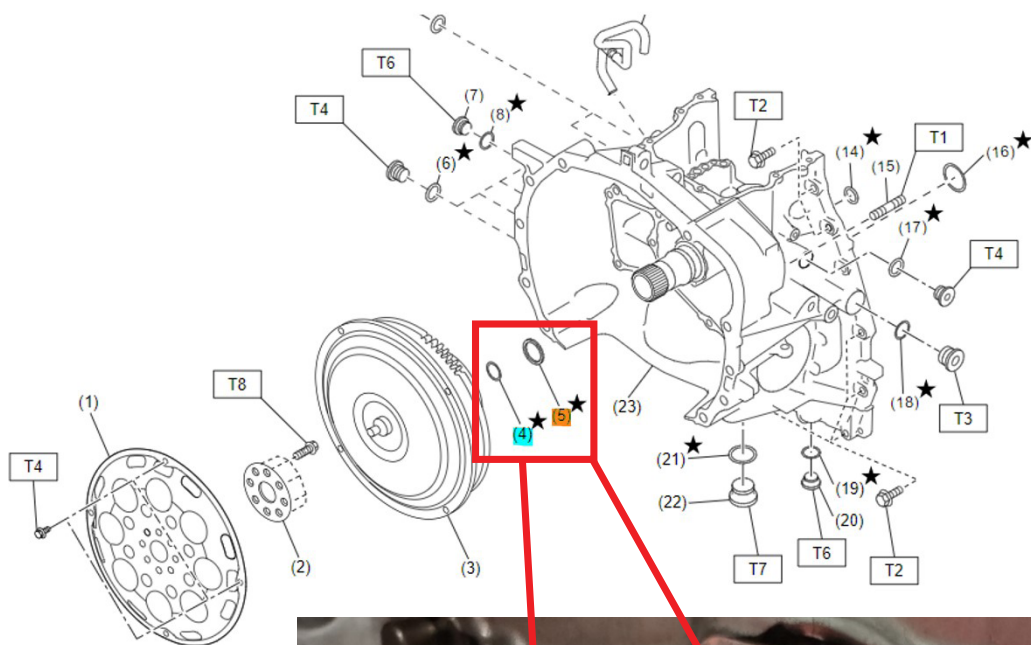
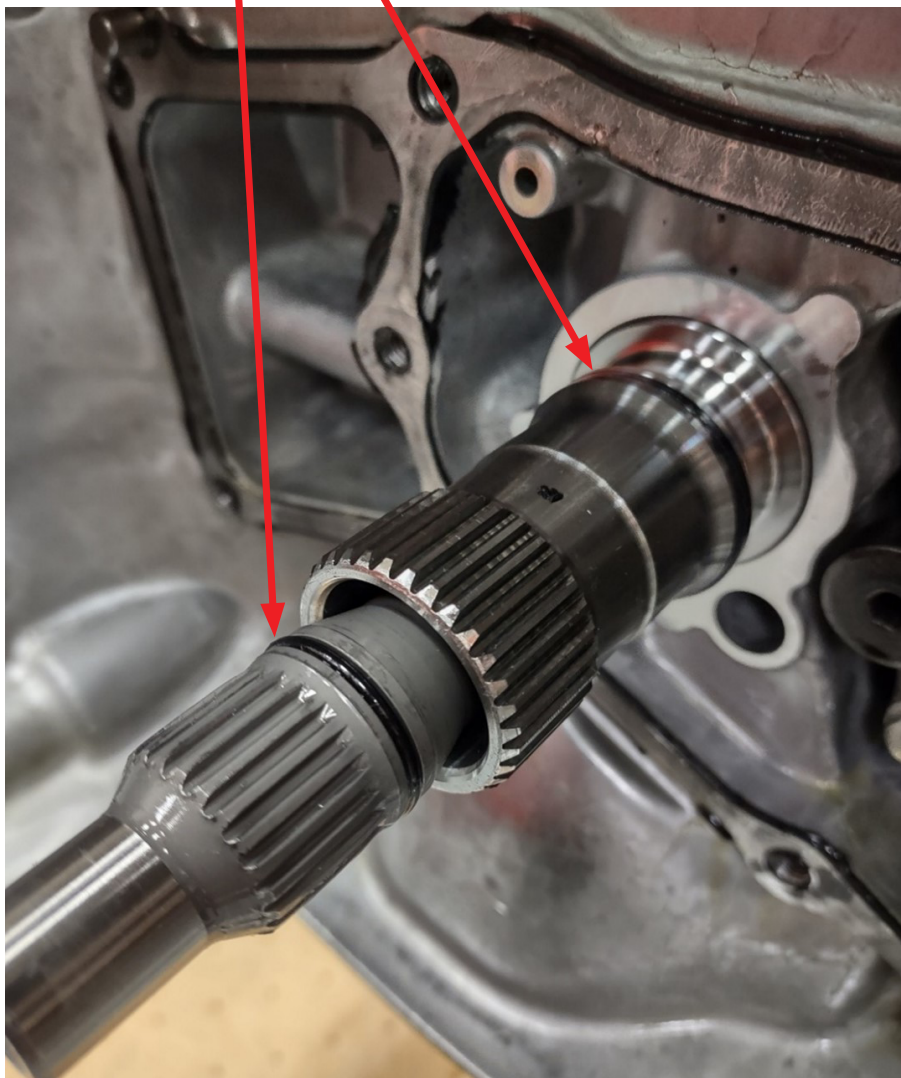
• When installing this new seal, it is **STRONGLY** recommended to use the proper installer tool ****OPTIONAL Special Tool 927890000** as shown in the illustration below. Otherwise, If the seal were to be installed too deep into the bore of the chain cover (beyond flush with the chain cover edge as shown below), the oil passage may become restricted or blocked.

Make sure to replace the oil seal (#1), O-ring (#4) and sealing ring (#5) as well as all other one-time use parts during R&R of the CVT assembly. The chain cover (#2) will need to be removed to replace the sealing ring.

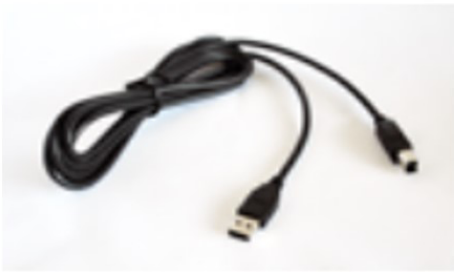
Nuspire Systems Integration DENSO USB CABLE 5135

Reports from the field of no communication with control modules, software updates crashing, and error messages being displayed, has resulted in unrecoverable control modules leading to unnecessary part replacement. These conditions have been identified and are directly related to the use of aftermarket USB cables. SOA would like to remind everyone to always use Originally Equipped Denso USB Cables when using the SSM4 and DST-i box.

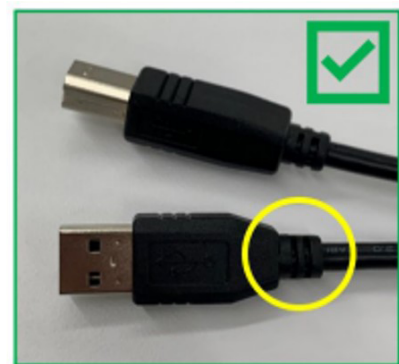
Correct Cable

Shown here are examples from the field of cable conditions that could cause problems.
