# Service Bulletin

Bulletin No.: 16-NA-405

**Subject:** Poor Engine Performance in Extremely Cold Weather Conditions, PCV Bypass Hose and Charge Air Cooler Icing for LUV Engines, Malfunction Indicator Lamp (MIL) Illuminated - DTC P0299, P0234, P2227, P00C7 Set

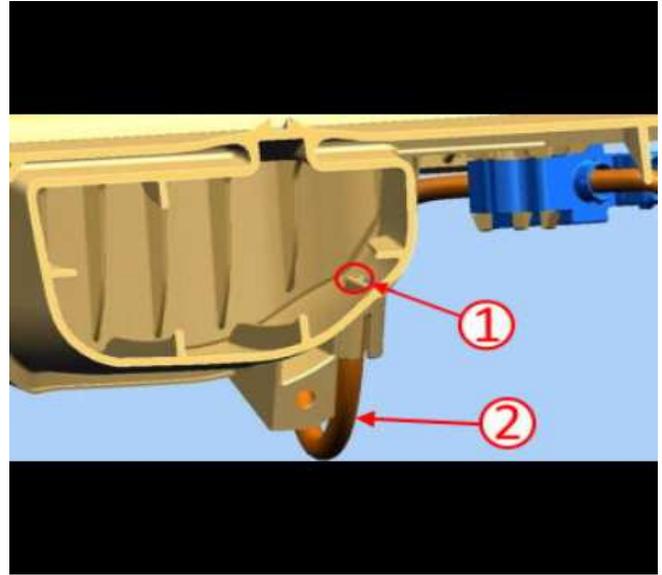
5587832

**Note:** The charge air bypass regulator solenoid valve can be affected if liquid has been found in the vacuum tank. Draining of the fluid can be done through the vacuum port (1).

5. Separate the charge air bypass regulator solenoid valve vacuum line (2) from the intake manifold.

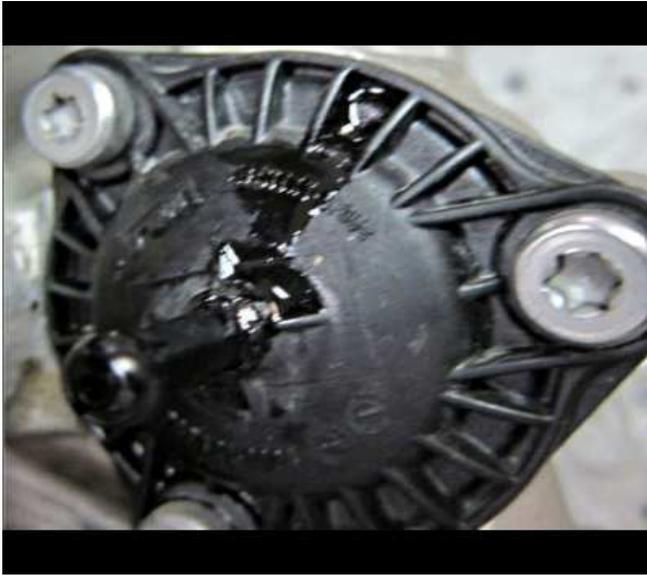
5590615

8. Inspect the charge air bypass valve for oil leaking from the vacuum side port.

- If oil is found leaking from the valve port, disassemble and clean the components. Refer to *Charge Air Bypass Valve Replacement* in SI.
  - Only if necessary, replace the components.
9. Install the valve.
  10. Install the intake manifold.
