Service Bulletin

Bulletin No.: 22-NA-191

Subject: Super Cruise Enhancement: Trailing and Active Lane Change

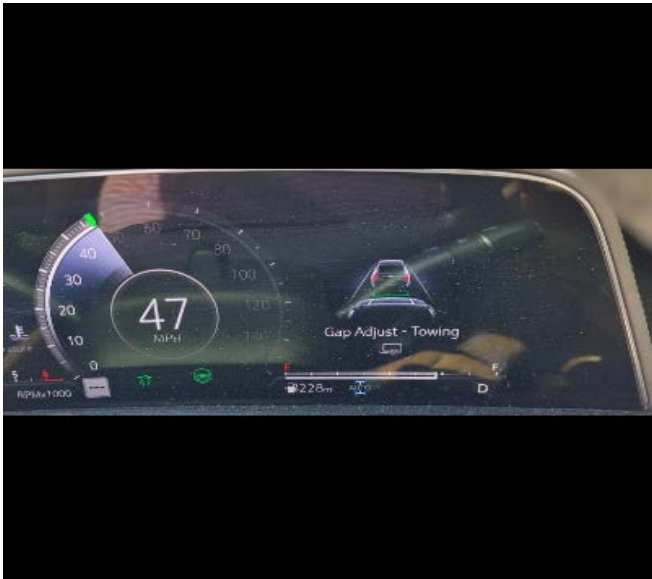
Involved Region or Country	United States, Canada
Condition	<p>Some customers may comment that the Super Cruise enhancement purchased through OnStar application has failed installation.</p> <ul style="list-style-type: none"> • Message on infotainment screen indicates “Installation Failed, See Dealer” • OnStar advisor referred customer to dealer to complete Super Cruise enhancement • The Super Cruise Enhancement is an Over the Air (OTA) one time purchase that enables additional Super Cruise features such as: <ul style="list-style-type: none"> • Automatic Lane Change: Enables vehicle to automatically pass slower vehicles in your lane without having to touch any controls. • Trailing Escalade: Allows Super Cruise to recognize when your vehicle is pulling a trailer, automatically adjusting safe stopping distance. ALC will be temporarily disabled while Trailing is activated. <p>Note: This is a customer pay enhancement through the OnStar application. Customers should first contact OnStar to resolve the OTA installation.</p>

Cause	The cause of the condition may be OTA update failures caused by a number of conditions such as vehicle not located in an area that can receive the update or correct vehicle battery state of charge.

<p>Correction</p>	<ul style="list-style-type: none"> • Confirm the customer has purchased the Super Cruise enhancement. <p>Note: The customer should have a confirmation number in their OnStar app.</p> <ul style="list-style-type: none"> • Confirm infotainment system displays a “Failed to Install” or ‘See dealer’ message. • The Super Cruise enhancement can be installed using Techline Connect and SPS (Service Programming System) with a special reconfiguration of the Active Safety Module. <ul style="list-style-type: none"> • To request a reconfiguration, contact Techline Customer Support Center (TCSC) with the following: <ul style="list-style-type: none"> – BAC – Customer purchase confirmation number – VIN – Error information indicated from the infotainment system • TCSC will request a reconfiguration of the Active Safety Module from the SPS team. Once the reconfiguration is completed, program the Image Processing Module using Techline Connect and SPS. <p>Note: The reconfiguration can take up to 24 hours to complete.</p> <p>This feature when installed will only be visible when in Super Cruise mode and towing.</p>
