## STAR ONLINE PUBLICATION

**Case Number:** S2223000004

**Symptom/Vehicle Issue:** Cruise Control SET + Button Sticking. DTC P1593 SPEED CONTROL SWITCH 1/2-STUCK and or P0585 SPEED CONTROL SWITCH 1/2 CORRELATION

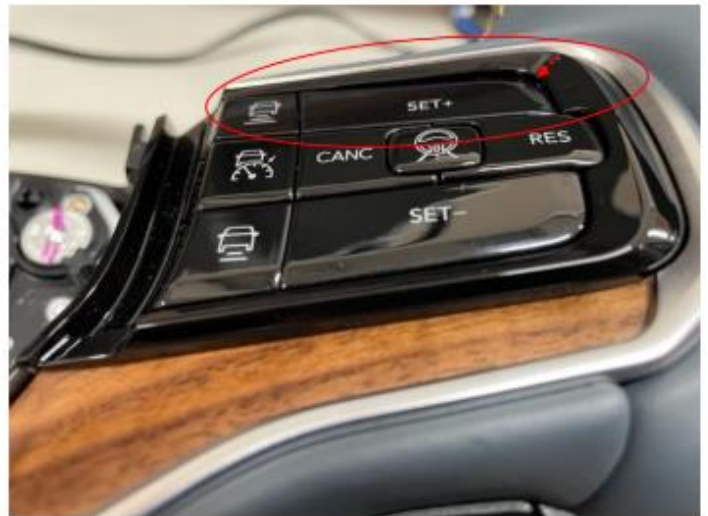
### UNACCEPTABLE SWITCH

"SET +" Switch is stuck and under flush with surrounding trim piece.

To allow the "SET+" switch to spring back to design position, press down on the trim piece at the top right corner of the switch. You will hear a "click" noise when the trim piece becomes fully engaged.
