NUMBER: 08-003-22

GROUP: 08 - Electrical

DATE: January 8, 2022

UAQ and UCQ Radio Enhancements

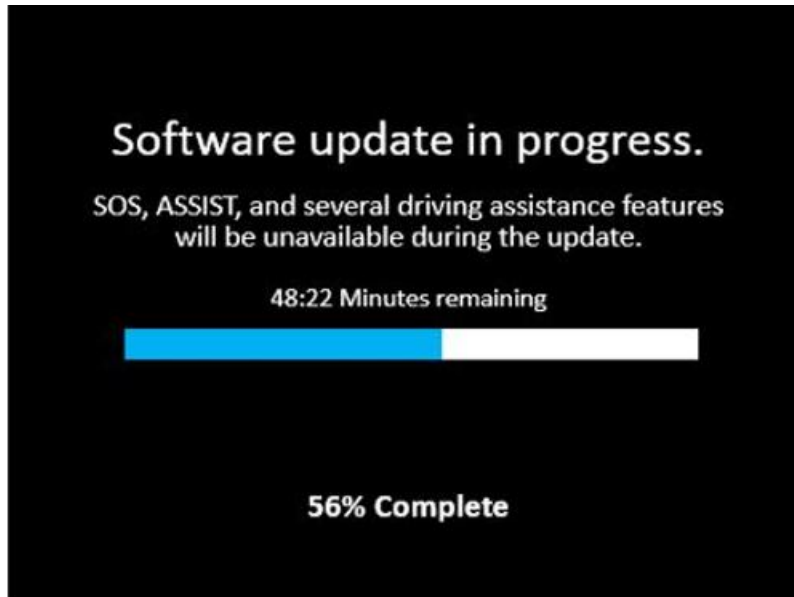
Fig. 9
Software Update In Progress

NOTE: The completion indicator may not reach 100%, even though the software update has been completed. Once the software update has finished, the radio and display screen will turn off.

15. The radio will reboot and the update will begin. The update should only take 25 minutes, the timer on the screen may display the incorrect time remaining, (Fig. 9) .
