TECHNICAL INSTRUCTIONS

LIMITED SERVICE CAMPAIGN 22TD04

ACCESSORY DASH CAMERA FIRMWARE UPDATE

CERTAIN 2021 MODEL YEAR SIENNA VEHICLES
CERTAIN 2021 MODEL YEAR VENZA VEHICLES

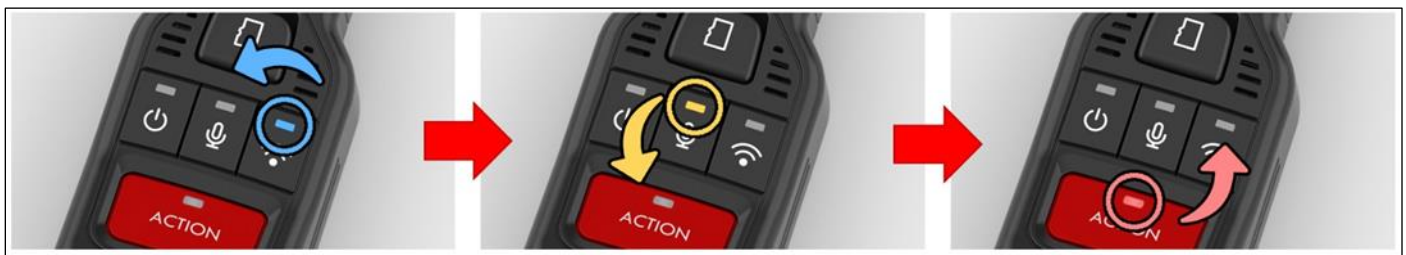
7. FIRMWARE UPDATE:

- a. Press and hold the Microphone and Wi-Fi buttons together
- b. While holding the buttons, start the engine
- c. Hold buttons until the camera starts the update process. You should observe the Microphone, Action and Wi-Fi buttons flashing in a counter-clockwise sequence (see picture below).

Note: Process will take around 2 minutes to complete,
Don't leave from the vehicle during firmware update to ensure a completion. This is a necessary step to not miss step 8a.
