## Aftersales Bulletin

### 00 51 48 05 00 – Service Action Comfort Entry Access Check and Rework

This Service Action affects Rolls-Royce Ghost (RR21/22) and Cullinan (RR31) models produced from January 28<sup>th</sup>, 2022, up to March 11<sup>th</sup>, 2022. These vehicles are equipped with Comfort Entry Access feature (option code 322) which has been identified as having a potential issue with this system functionality. Due to an issue relating to a semi-conductor shortage, the Comfort Entry System would not operate as intended.

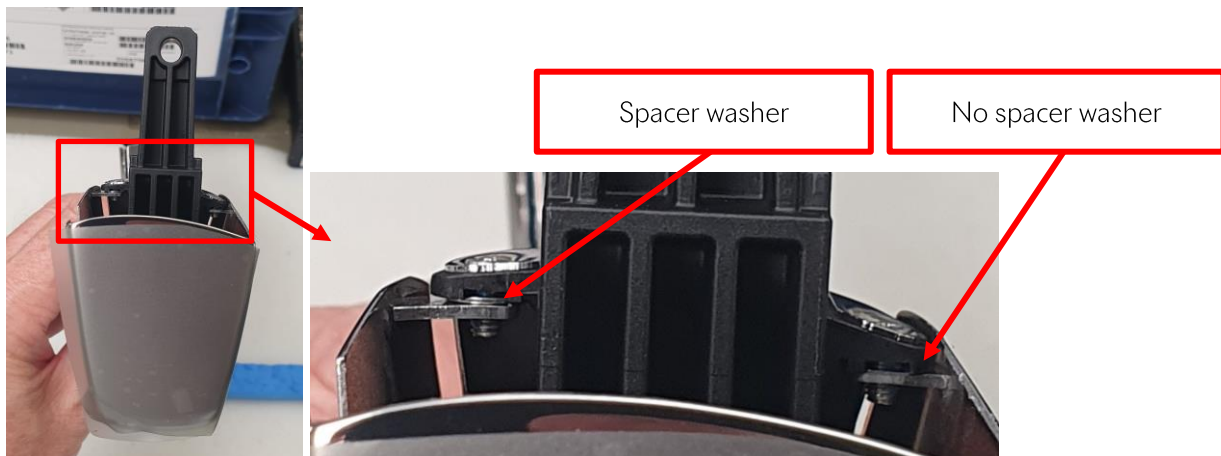
4. Check the supplier build day code on the white label to see if it is between range 0192 and 0982 (from 19th to 98th day of 2022).

Batch Identification Number	Status
xxxx 0190 0191	If number is lower than 0192, Part is OK – Do not replace insert
0192 xxxx xxxx xxxx 0982	If number is in this range part is <b>Not OK</b> and will require insert replacement work to be performed
0983 0984 xxxx	If number is higher than 0983 Part is OK – Do not replace insert

- If the number on label is outside (lower than 0192 or higher than 0982) of this range (OK part), go to Step 29 of this instruction.
  - If the number on label is within the day range above (**not OK** part), the insert will need to be replaced. Continue with repair from steps 7 onwards.
5. Place the door handle to be repaired on a clean padded surface.
  6. Observe the original position and quantity of previously installed spacer washers that may be already fitted to the part, as this will need to be replicated after replacement of plastic handlebar electronics.

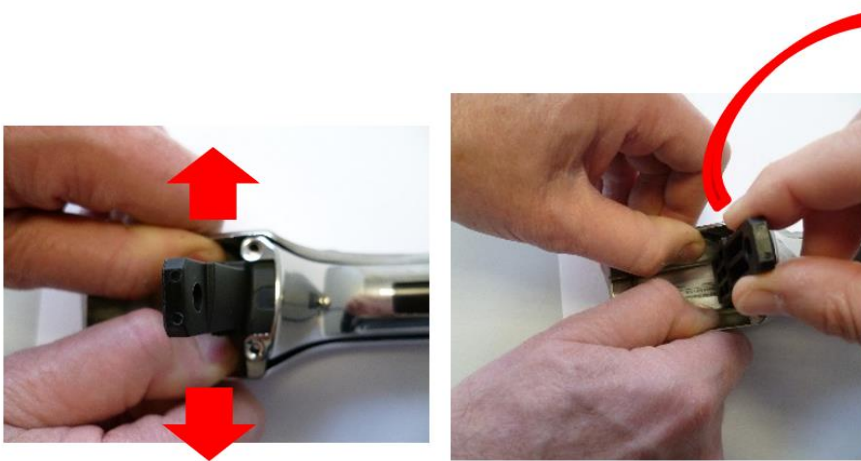
**Risk of Damage!** Do not open the sides of the outer metal shell more than necessary as it will deform the outer surface and create permanent damage to the part.

- With the aid of a second person, gently spread open the outer metal shell apart and pull out the plastic handlebar electronics, with metal inner shell still fitted.

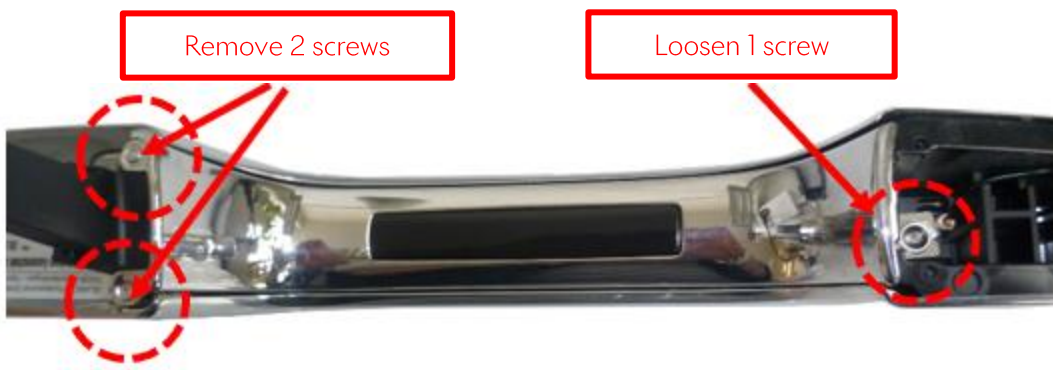
- If the button sensor alignment gap is within the required range ( $1.2 \pm 0.2$  mm) – adjustment is not needed. Please go to Step 28 of this repair instruction.
- If the button sensor alignment gap is outside the required range ( $1.2 \pm 0.2$  mm) – further adjustment is needed. Follow Steps 22 – 27 for the additional work.

22. Steps 22 – 27 are **only required if button sensor alignment it not OK.**  
Remove the 2 x countersunk screws and loosen round head screw (do not fully remove).

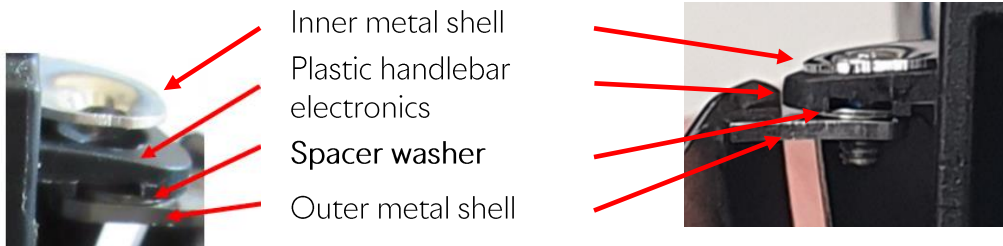
A spacer washer reduces the gap between the button sensor and the outer shell on the same side where it is inserted.

23. Remove or place a single spacer washer between the outer metal shell and door plastic handlebar electronics to adjust the gaping.
