Service Bulletin

Bulletin No.: 22-NA-081

Subject: Paint Peeling or Chipping on Front Fascia at Headlamp or Fender Seam

Brand:	Model:	Model Year:		VIN:		Engine:	Transmission:
		from	to	from	to		
Chevrolet	Corvette	2020	2023	—	—	All	All

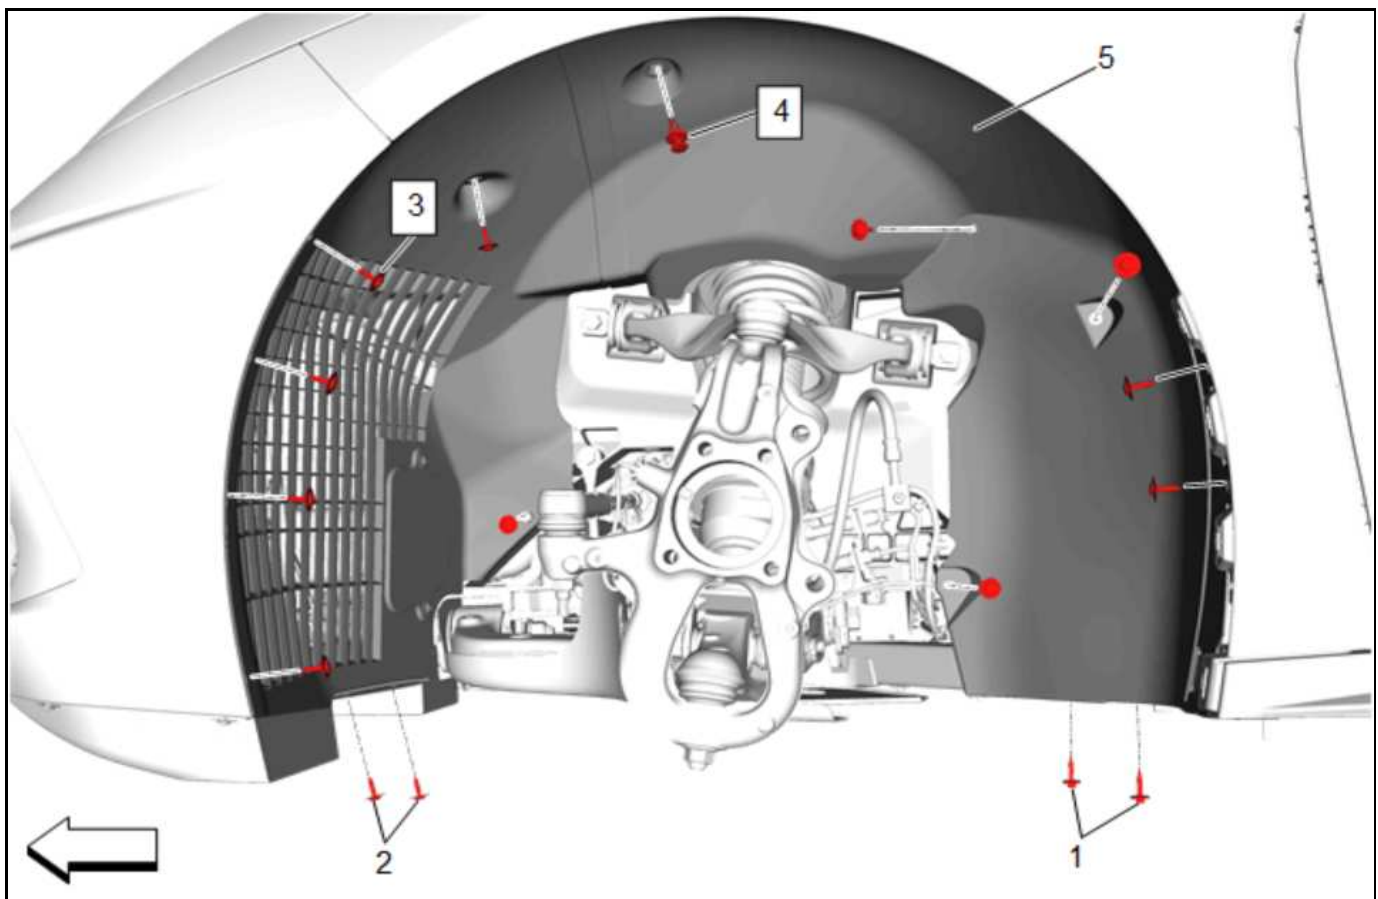
2. Check for a tight gap at area # 2.

3. Remove both front tire/wheel assemblies and wheelhouse liners. Refer to the appropriate *Front Wheelhouse Liner Replacement* procedure in SI.

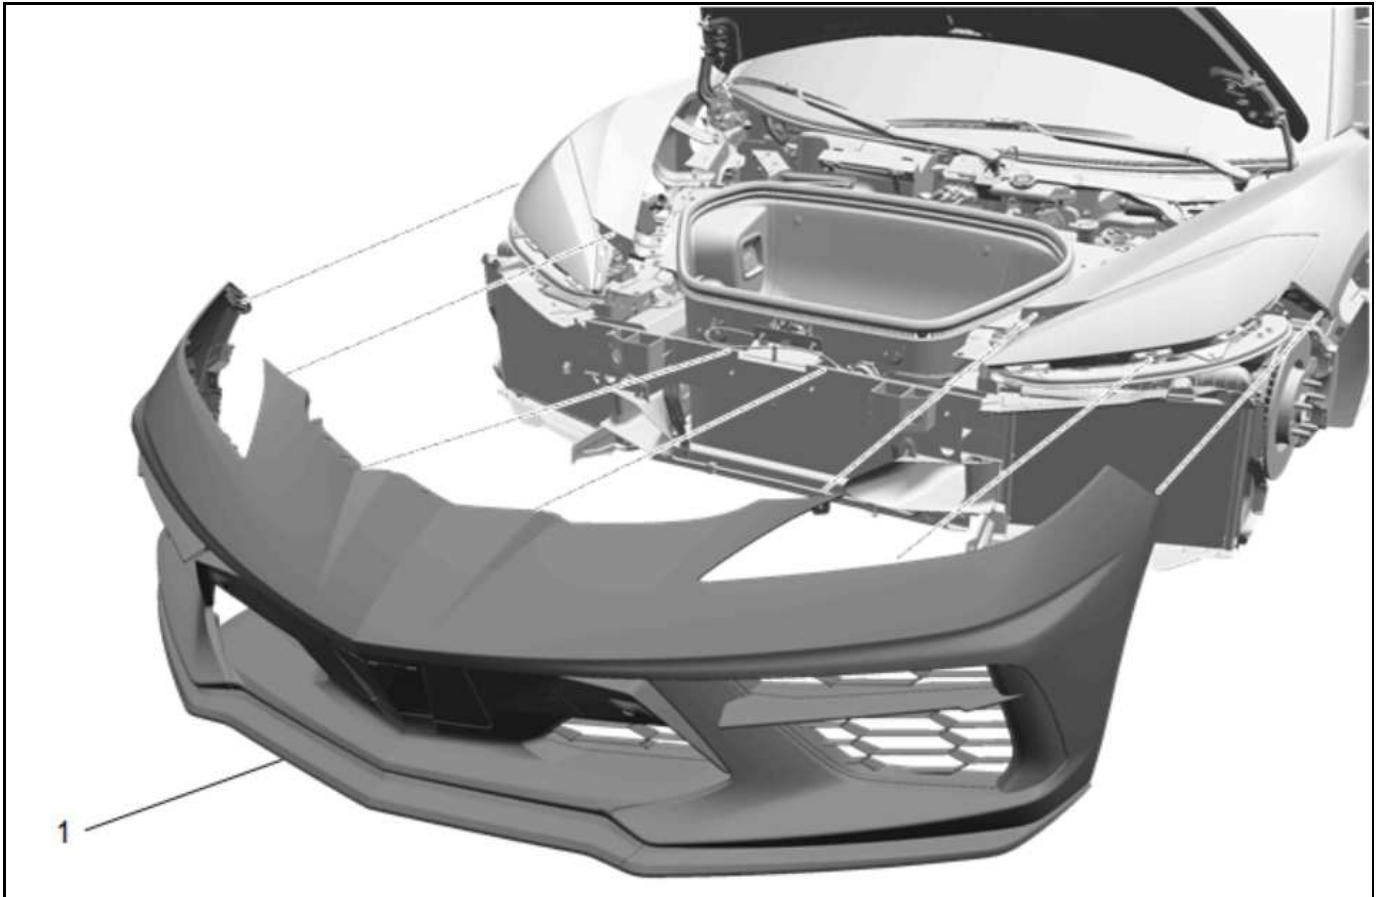
5354777

Note: The gap may not be completely uniform all around the headlamp, however ensure the gap is at least 0.5 mm wide in all areas.

7. Reinstall the front fascia (1). Refer to *Front Bumper Fascia Removal and Installation* in the Service Manual.
