Service Bulletin

Bulletin No.: 21-NA-149

Subject: Engine Wire Harness Chafing / IPC Gauges Sweep / IPC Warning Message / SES/Check Engine/MIL / No Start / No Crank / Runs Rough / Stalls / Reduced Engine Power / Various DTCs

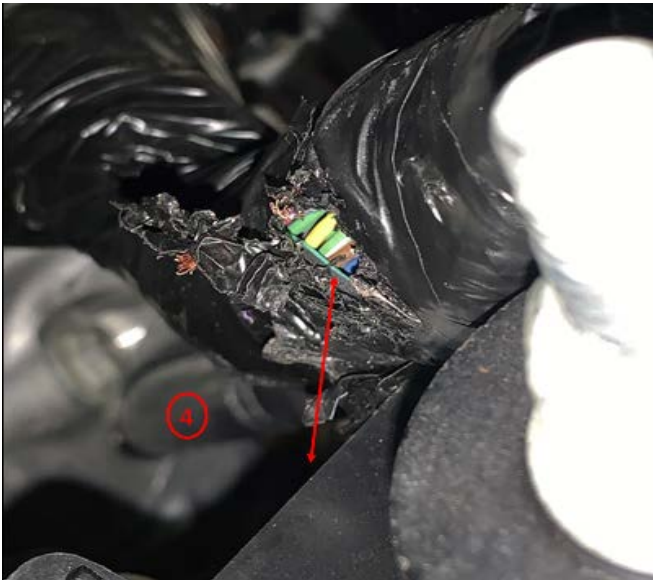
</div> <p>5583331</p>
----------------	---

<p>Cause 4</p>	<p>This Cause pertains to vehicles equipped with engines 5.3L L82, 5.3L L84, 6.2L L87, 4.3L LV3, 2.7L L3B, or 3.0L LM2.</p> <div data-bbox="615 220 1263 795">

The cause of the condition may be an engine wire harness clip was removed during production due to ergonomic issues (hand clearance and branch stiffness). This led to an uncontrolled branch that came into contact with a sharp edge (1) & (2) on the ECM/TCM bracket, driver side upper control arm, and/or shock tower and caused chaffing during engine vibration and roll.

If engine wiring harness contact is isolated during inspection, use a seam ripper type tool to carefully inspect for internal wiring damage.

If found, repair the damaged wiring following the SI wire to wire repair procedures.

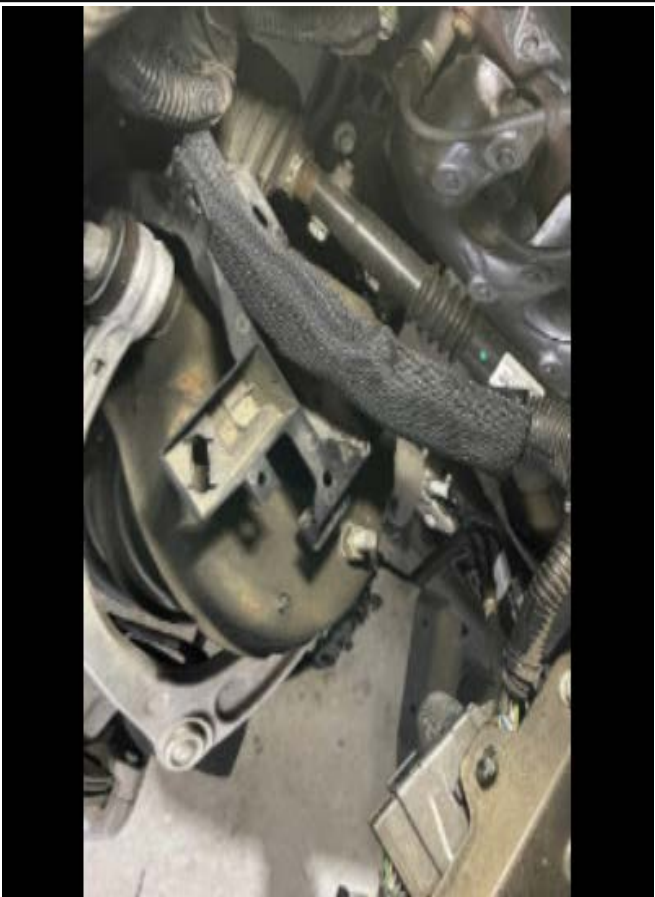
5868358

9. At the shock tower point there is a wire harness canal (1).

11. Verify the wire harness is wrapped and secured at all three points, the ECM/TCM Bracket (1), Upper Control Arm (2), and the Shock Tower (3). Then reassemble the vehicle.
12. Reinstall the front wheelhouse liner and tire and wheel. Refer to *Front Wheelhouse Liner Replacement* and *Tire and Wheel Removal and Installation* in SI.
13. Remove the support and lower the vehicle.
