SIB 52 06 22

2ND ROW PASSENGERS SEAT INTERMITTENTLY WON'T LATCH

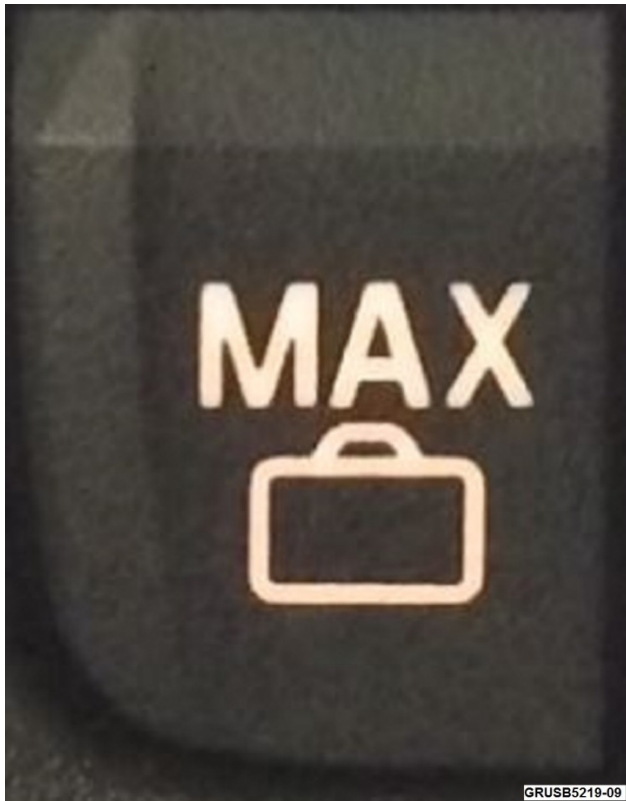
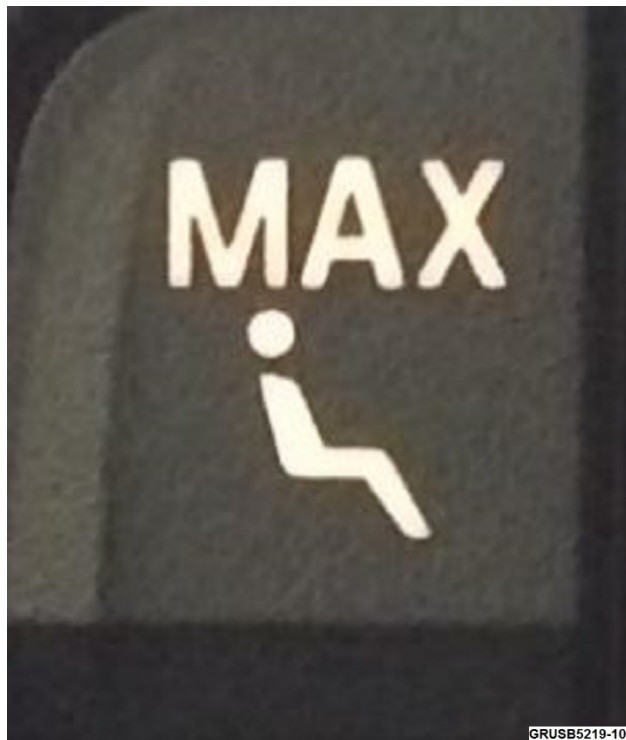
<p>A quick test to see if they are initialized (if equipped with third row power seats) is-</p> <ul style="list-style-type: none"> • Access the rear switches in the D pillar area • Push the button for maximum cargo space
--	--

- Alternatively, push this button for maximum seating.
- Intended result:
- All 2nd and 3rd row seats should move
