## Aftersales Bulletin

### 00 51 49 05 00 – Service Action Comfort Entry Access Reactivation, Check and Rework

This Service Action affects Rolls-Royce Phantom (RR11/12), Ghost (RR21/22) and Cullinan (RR31) models produced from January 28<sup>th</sup>, 2022, to April 12, 2022, which are fitted with Comfort Entry Access feature (option code 322).

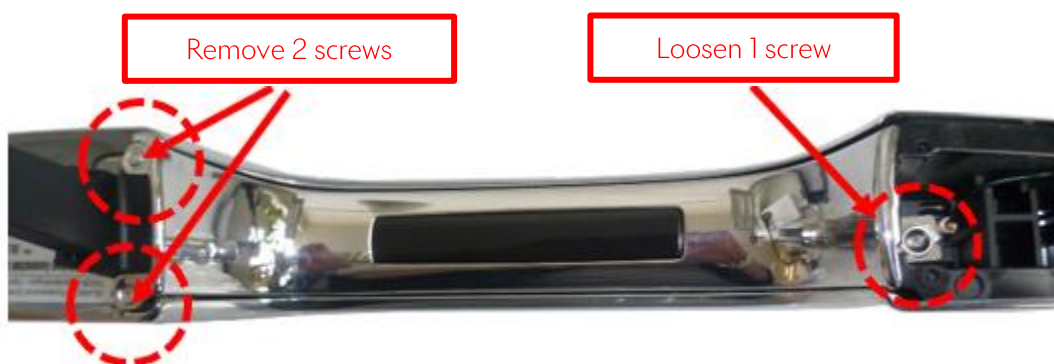
- If the button sensor alignment gap is within the required range ( $1.2 \pm 0.2$  mm) – adjustment is not needed. Please go to Step 28 of this repair instruction.
  - If the button sensor alignment gap is outside the required range ( $1.2 \pm 0.2$  mm) – further adjustment is needed. Follow Steps 22 – 27 for the additional work.
22. Steps 22 – 27 are **only required if button sensor alignment it not OK.**  
Remove the 2 x countersunk screws and loosen round head screw (do not fully remove).
