Service Bulletin

Bulletin No.: 22-NA-085

Subject: Radio Software Version 135120 (IOR) – Multiple Updates

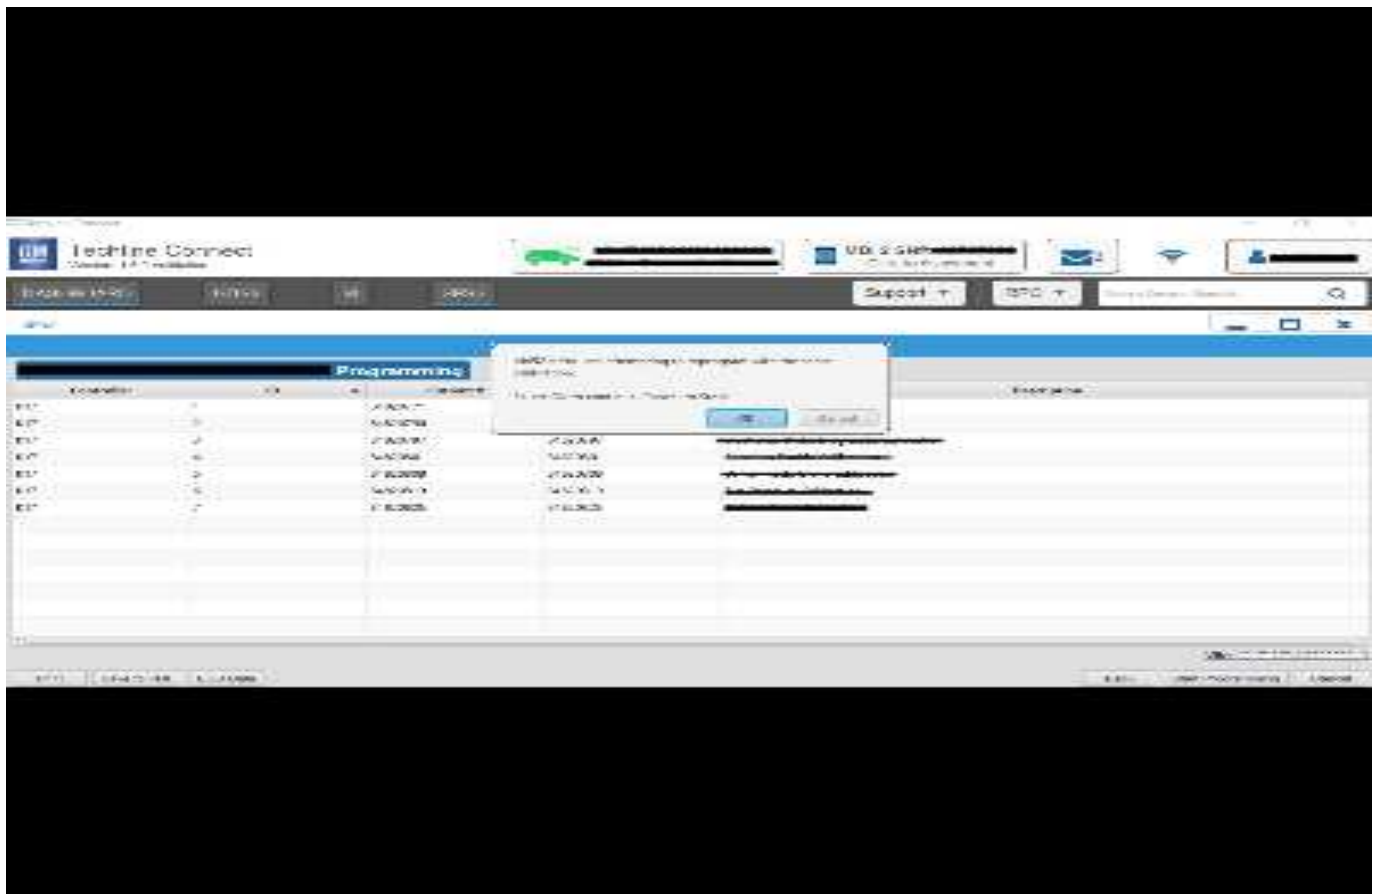
5644477

Important: Techline Connect screen shown above.

Important: If the same calibration/software warning is noted on the TLC or SPS Summary screen, select OK and follow screen instructions. After a successful programming event, the WCC is located in the Service Programming System dialogue box of the SPS
