Service Bulletin

Bulletin No.: 22-NA-206

Subject: Service Engine Soon (SES) Light/Message with DTCs P16F3 and/or P060C in Engine Control Module (ECM)

Brand:	Model:	Model Year:		VIN:		Engine:	Transmission:
		from	to	from	to		
Chevrolet	Corvette	2020	2023	—	—	6.2L (RPO LT2)	—

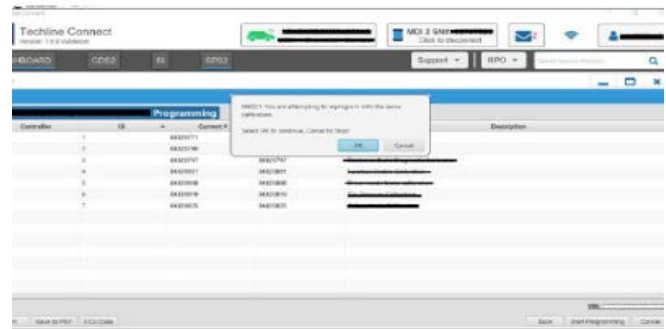
6175818

Important: Techline Connect screen shown above.

Important: If the same calibration/software warning is noted on the TLC or SPS Summary screen, select OK and follow screen instructions. After a successful programming event, the WCC is located in the Service Programming System dialogue box of the SPS
