**Campaign 549**

# Service Campaign 549 Levante V8 Engine Harness Position Check

DATE: OCTOBER 26 2022

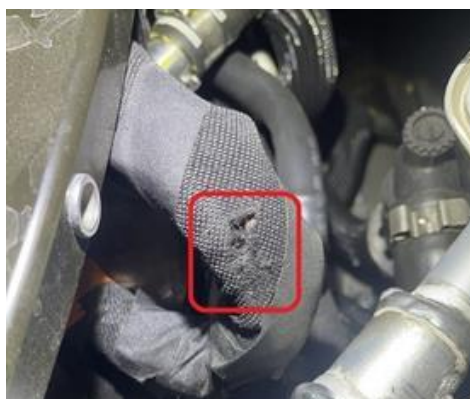
4. During the rework, check the integrity of the harness.
  - If the harness does not present any type of damage proceed to **Step 5**.
  - If there is a sign of abrasion or damage to the sheath, Open a BOL for "SUPPORT REQUEST" attach pictures, and await further instructions

5. Unscrew the screws (1) and release the indicated clips.
