**SERVICE BULLETIN**

**APPLICABILITY:** 2019-**23**MY Impreza  
 2019-**23**MY Crosstrek (Including Hybrid Model)  
 2019-**23**MY Forester  
 2019MY Legacy/ Outback  
 2019-21MY WRX  
 2019-21MY WRX STI  
 2019-21MY BRZ- Navigation -equipped ONLY  
 2019-22MY Ascent

**NUMBER:** 15-236-18R

**SUBJECT:** Reprogramming File Availability for Optimization of Harman Gen 3.1 and Gen 3.1α Audio and Navigation Head Units

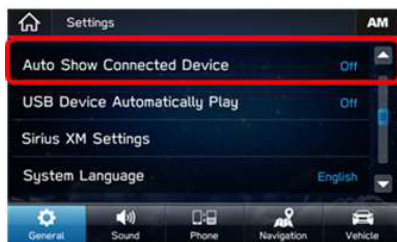
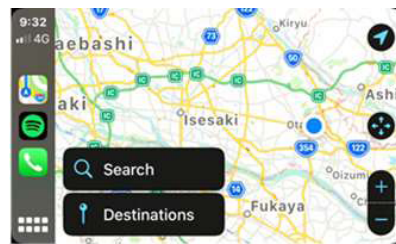
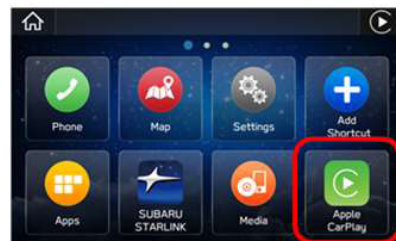
In a case where the iPhone was disconnected while playing music then reconnected while it is playing music, the system moves to CarPlay screen no matter what is set in <Auto Show Connected Device> in Setting (depending on iOS version of the iPhone.)

On

Move to CarPlay.

Off

Move to HOME and CarPlay icon is displayed.
