## Technical product information

<b>Topic</b>	Convertible hood cannot close - Header trim flap eyelet broken
<b>Market area</b>	Bentley: worldwide (2WBE)
<b>Brand</b>	Bentley
<b>Transaction No.</b>	2060120/6
<b>Level</b>	EH
<b>Status</b>	Released for publishing
<b>Release date</b>	07-Nov-2022

### New Continental GTC

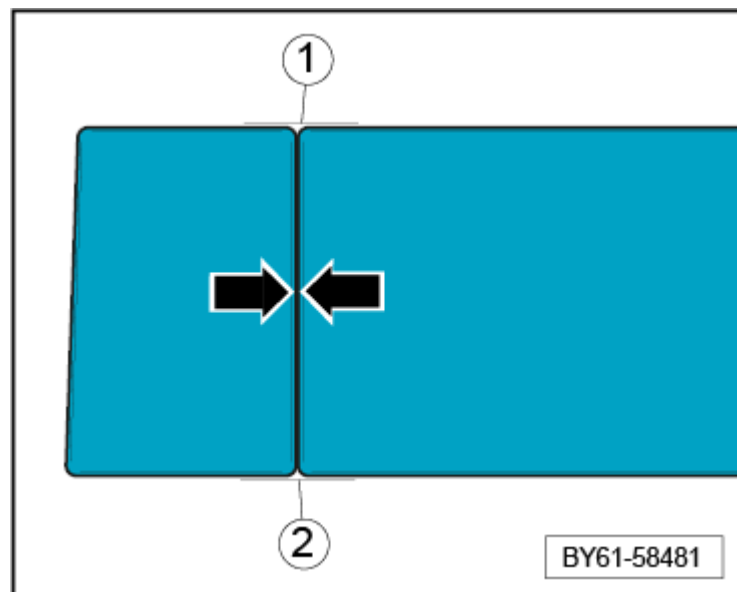
***Misalignment of the panels can cause damage to both the header trim panel and the header trim panel flap assembly.***

- Align the flap assembly to the header trim panel, ensuring that the edges **-1-** of the two panels align, and that the gap **-arrowed-** between the two panels is 2.5mm (+0.5/-1.5) and consistent along the whole length .
