**ANB4 - Retrofitting Locking Caps on the Front Left and Right Headlights (Stop Delivery / Recall Campaign)**

Model Line: **Carrera GT (980)**

Concerns: **Caps on headlight**

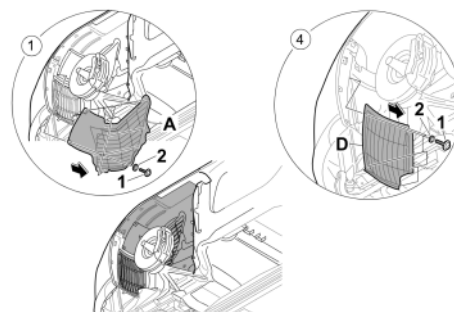
*Overview of front wheel housing liner*

- 3 Remove ⇒ *Overview of front wheel housing liner -A-* section of front wheel housing liners.  
For instructions, see Workshop Manual: **505619 Removing and installing wheel housing liner front**
