Service Bulletin

Bulletin No.: 21-NA-149

Subject: Engine Wire Harness Chafing / IPC Gauges Sweep / IPC Warning Message / SES/Check Engine/MIL / No Start / No Crank / Runs Rough / Stalls / Reduced Engine Power / Various DTCs

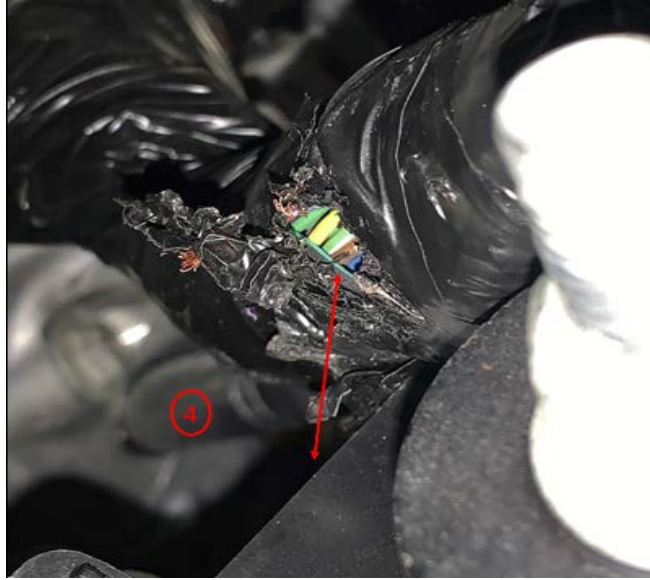
5583331

This Cause pertains to vehicles equipped with engines 5.3L L82, 5.3L L84, 6.2L L87, 4.3L LV3, 2.7L L3B, or 3.0L LM2.

The cause of the condition may be an engine wire harness clip was removed during production due to ergonomic issues (hand clearance and branch stiffness). This led to an uncontrolled branch that came into contact with a sharp edge (1) & (2) on the ECM/TCM bracket, driver side upper control arm, and/or shock tower and caused chaffing during engine vibration and roll.

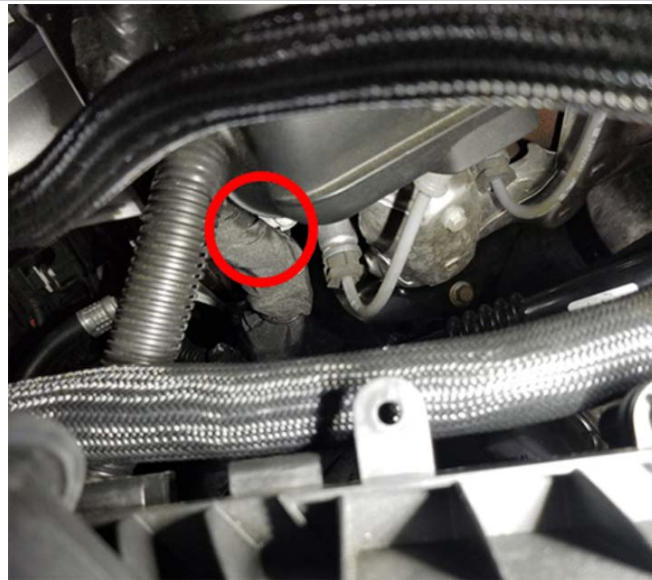
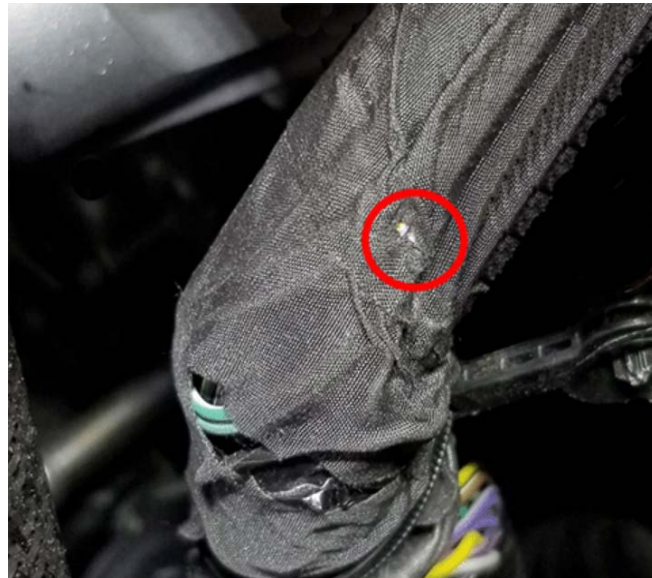
This Correction pertains to vehicles equipped with engine 4.3L, LV3 only.
Note: The first graphic below is a before, and after (2), repair example of harness chaffing at the Oil Dipstick bracket.

To correct this concern, repair the damaged wiring following the SI wire-to-wire repair procedures. Once repaired, protect and reposition the engine wiring harness to prevent future harness damage.

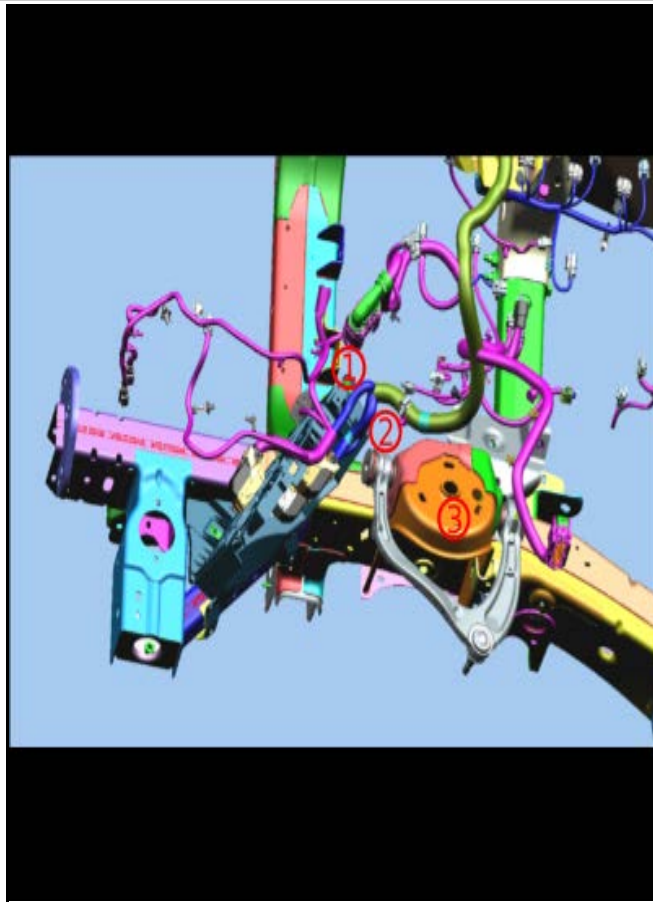
5868341

3. Locate the three contact points where the wire harness is chaffing, the ECM/TCM black bracket (1), the upper control arm (2), and the shock tower bolt (3).
