Odor Remediation After Water Intrusion

Service Category Vehicle Interior

Section Interior Panels/Trim

Market USA

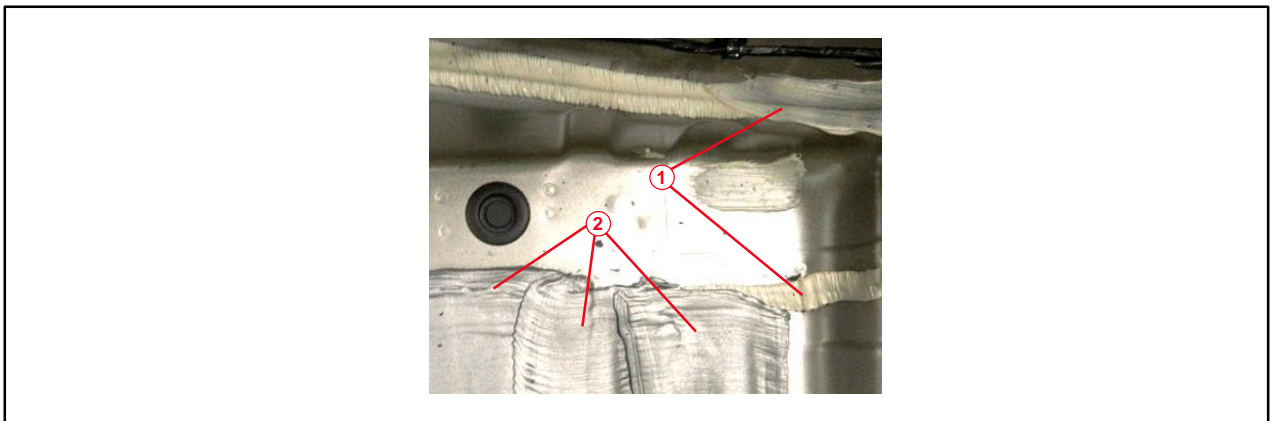
Figure 9.

1	Urethane Seam Sealer
2	LASD

- Avoid removal of the urethane seam sealer where sheet metal panels join. If the urethane seam sealer has been removed during the LASD removal process, it will be necessary to reapply as needed AFTER the remediation process is complete.

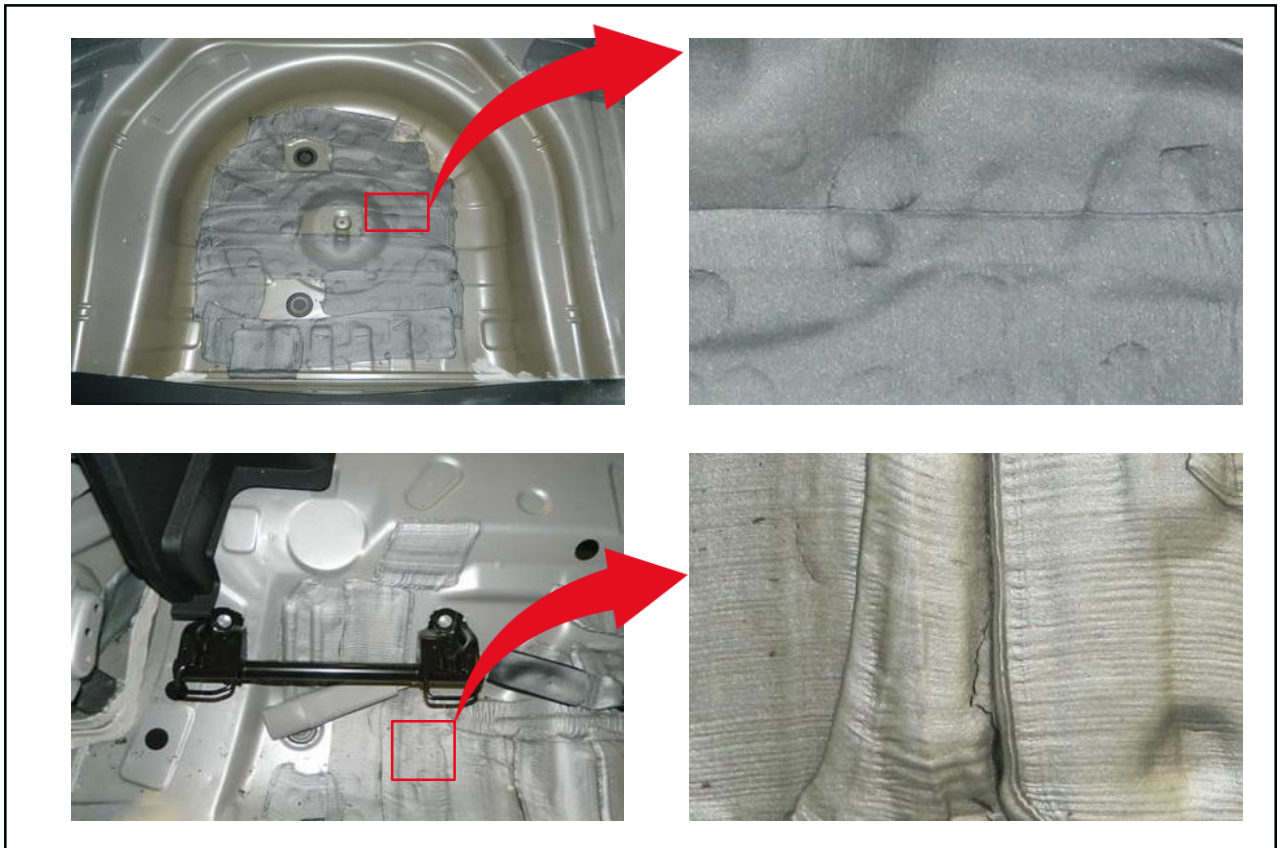
Figure 10. Examples of LASD

The appearance of LASD (color, texture) may vary (smooth vs. rippled) depending on the vehicle and application method.

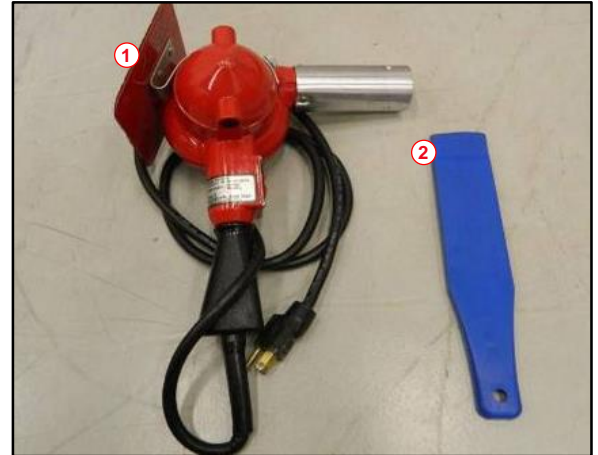
Figure 11.

1	Heat Gun
2	Plastic Scraper

- Using a flat-bladed plastic scraper and a heat gun is the **ONLY** approved method for removing LASD.
- Ensure ALL LASD is removed.

- A. Select a square area approximately 6 in. by 6 in. and begin heating the LASD with the heat gun for approximately 30 seconds.
- B. Check the heated sound deadening material with the plastic scraper to determine if it is pliable enough to remove.
 - (1) If the material is soft enough to remove, use the plastic scraper and remove the selected area.
 - (2) If the material is still too hard to remove, use the heat gun for an additional 30 seconds to see if the LASD is ready for removal. Keep track of the length of time necessary for effective sound deadening removal and adjust as needed.
