# TECHNICAL SERVICE BULLETIN

Technical Service Bulletin: 51-1576

Forest River is alerting you to an issue involving certain 2022-2023 Georgetown, FR3, Coachmen Encore, Mirada, pursuit and Coachmen Class A Motorhome recreational vehicles. Please see the information below which describes the issue and provides you with details on the steps you should take to have your vehicle repaired.

# JACK INSPECTION, REMOVAL AND REPLACEMENT (IF NEEDED) FOR 8K JACKS ON MOTORIZED UNITS

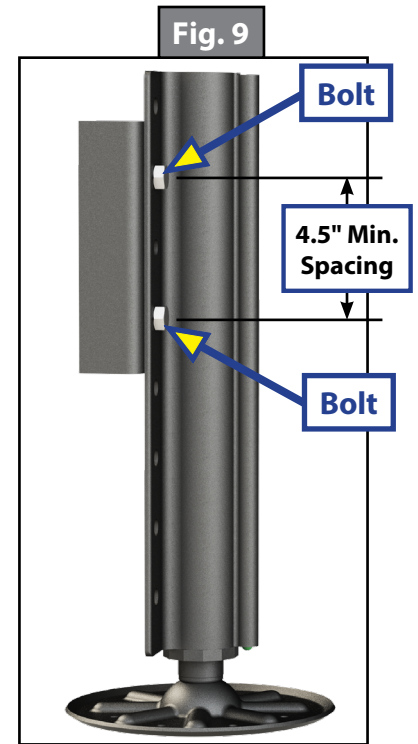
Fig. 10

- A. If the Gen I jack has two orange extend hoses and two black retract hoses (Fig. 10A), an O-ring face tee fitting (Fig.11) must be used to connect the hoses to the single extend and retract hoses on the Gen II jack (Fig. 11).
- B. If the Gen I jack has only one orange extend hose and one black retract hose (Fig. 10B), a 90-degree O-ring face elbow fitting (Fig. 11) will be needed to connect the single black and orange hoses to the Gen II jack (Fig. 11).

1. Remove hoses from the 8K jacks on the unit.
2. Follow procedures outlined in the Replacement Jack Location section, and then unbolt and remove existing leveling jacks (Fig. 7).
3. Match the number of mounting holes from the first bolt to the bottom of the jack and then bolt the new Gen II jacks (Fig. 8) to the mounting brackets.
  - A. Upper and lowermost bolts are vertically spaced with a minimum of two-hole patterns spaced 4.5" apart (Fig. 9) and tightened. Torque to 90 ft-lbs for a lubricated bolt or torque to 120 ft-lbs for dry bolt. A spacing of three-hole patterns (6.75") is recommended where possible.
4. Measure the distance from the footpad to the ground to verify installation is correct.
5. Connect the hoses to the new 8K Gen II jacks.
