Subject: REVISION: N212350630-02 - Service Update
Overhead Console Sets DTC Incorrectly
Revised Parts Table

Models: 2022 Buick Envision

N212350630 Overhead Console Sets DTC Incorrectly

Revision: 02

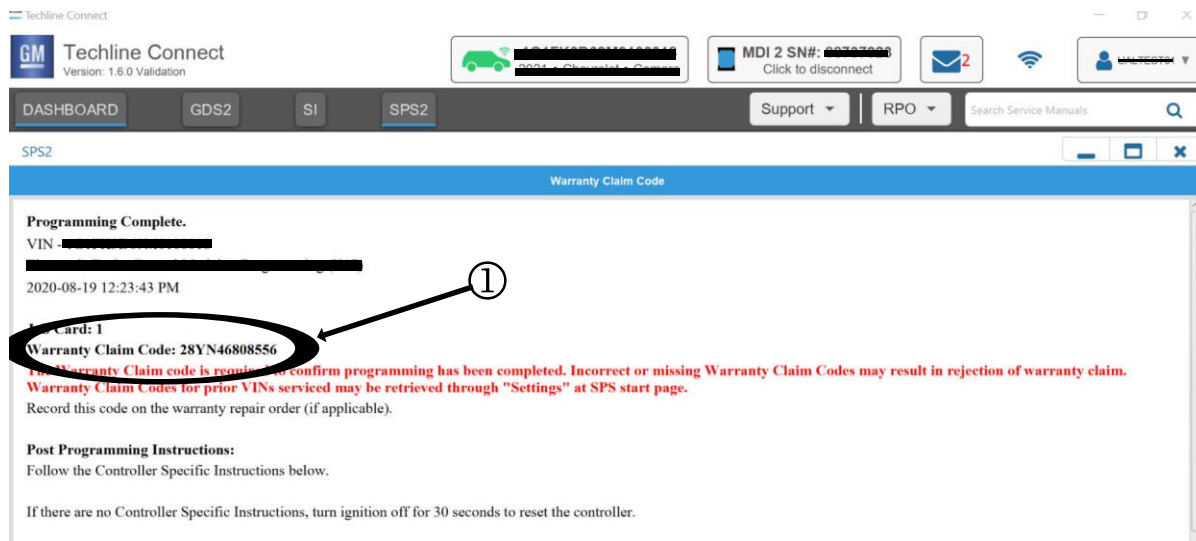
5644478

Note: The screenshot above is an example of module programming and may not be indicative of the specific module that is being programmed. Module selection and VIN information have been blacked out.

5. Reprogram the body control module. Refer to *K9 Body Control Module: Programming and Setup* in SI.
