Service Alert

MAZDA CONNECT SYMPTOM TROUBLESHOOTING (7TH
GENERATION VEHICLES)

Last Issued: 12/14/2022

2019-2023 Mazda3 2020-2023 CX-30 2021-2023 CX-5 2021-2023 CX-9 2022-2023 MX-30 2023 CX-50

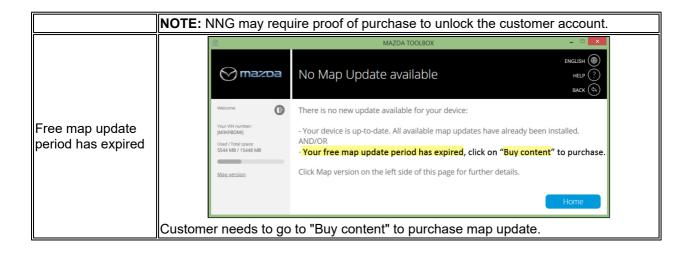
- 1. Purchase a Genuine Mazda Navigation SD card.
- Customer or dealer must contact NNG helpdesk by email at piracy@nng.com and request customer account unlock.
