# Service Alert

<b>Subject:</b>  CONNECTED VEHICLE SYMPTOM TROUBLESHOOTING	<b>Service Alert No.:</b> SA-017/22
	<b>Last Issued :</b> 12/13/2022

2019-2023 Mazda3  
2020-2023 CX-30  
2021-2023 CX-5  
2021-2023 CX-9  
2022-2023 MX-30  
2023 CX-50

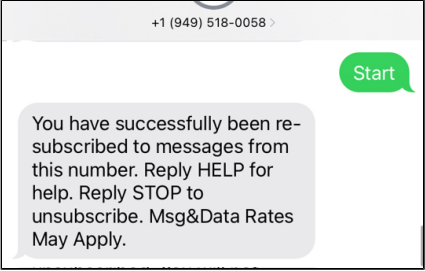
<p>1</p> <p><b>MyMazda Website - ERROR! Unable to send one-time password.</b></p>

<p>Customer inadvertently texted <b>“Stop”</b> to 1-949 518-0058 (Twilio SMS for Mazda)</p>

<ol style="list-style-type: none"> <li>Text <b>“Start”</b> to 1-949 518-0058 (Twilio SMS for Mazda)</li> <li>Retry to create a MyMazda account.</li> </ol> <p><b>NOTE: USA and Canada only</b></p>

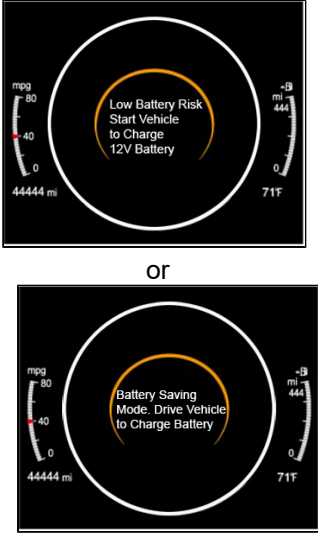
8	<p>2021 Mazda3, CX-30, CX-50, and MX-30 functions inoperative</p> <ul style="list-style-type: none"> <li>• Vehicle Status Alert</li> <li>• Remote Engine Start / Stop</li> <li>• Remote Door Lock / Unlock</li> <li>• Remote Hazard Lights ON / OFF</li> <li>• Vehicle Finder (vehicle location mapping function is available)</li> </ul>	<p>Vehicle's electrical control area network (CAN) is in "Sleep Mode"</p>

<p>or</p> <p>No dealer visit is required. Sleep Mode can be reset by starting the engine and idling or driving for 5 minutes or longer.</p> <p>Go to <a href="#">09-010/22</a>.</p>
9	<p>First remote control attempt fails, second attempt works fine.</p> <ul style="list-style-type: none"> <li>• Engine Start / Stop</li> <li>• Door Lock / Unlock</li> <li>• Lights ON / OFF</li> </ul>	<p>Improper telematics communication unit (TCU) software.</p>	<p>Go to TSB <a href="#">16-002/20</a>.</p>
