## SERVICE BULLETIN

**APPLICABILITY:** 2022MY Forester with Gen 2 Telematics  
 2022MY WRX with Gen 2 Telematics  
 2022-**23**MY BRZ with Gen 2 Telematics

**NUMBER:** 15-306-22R

**SUBJECT:** Intermittent Request Failure of Remote STARLINK® Services

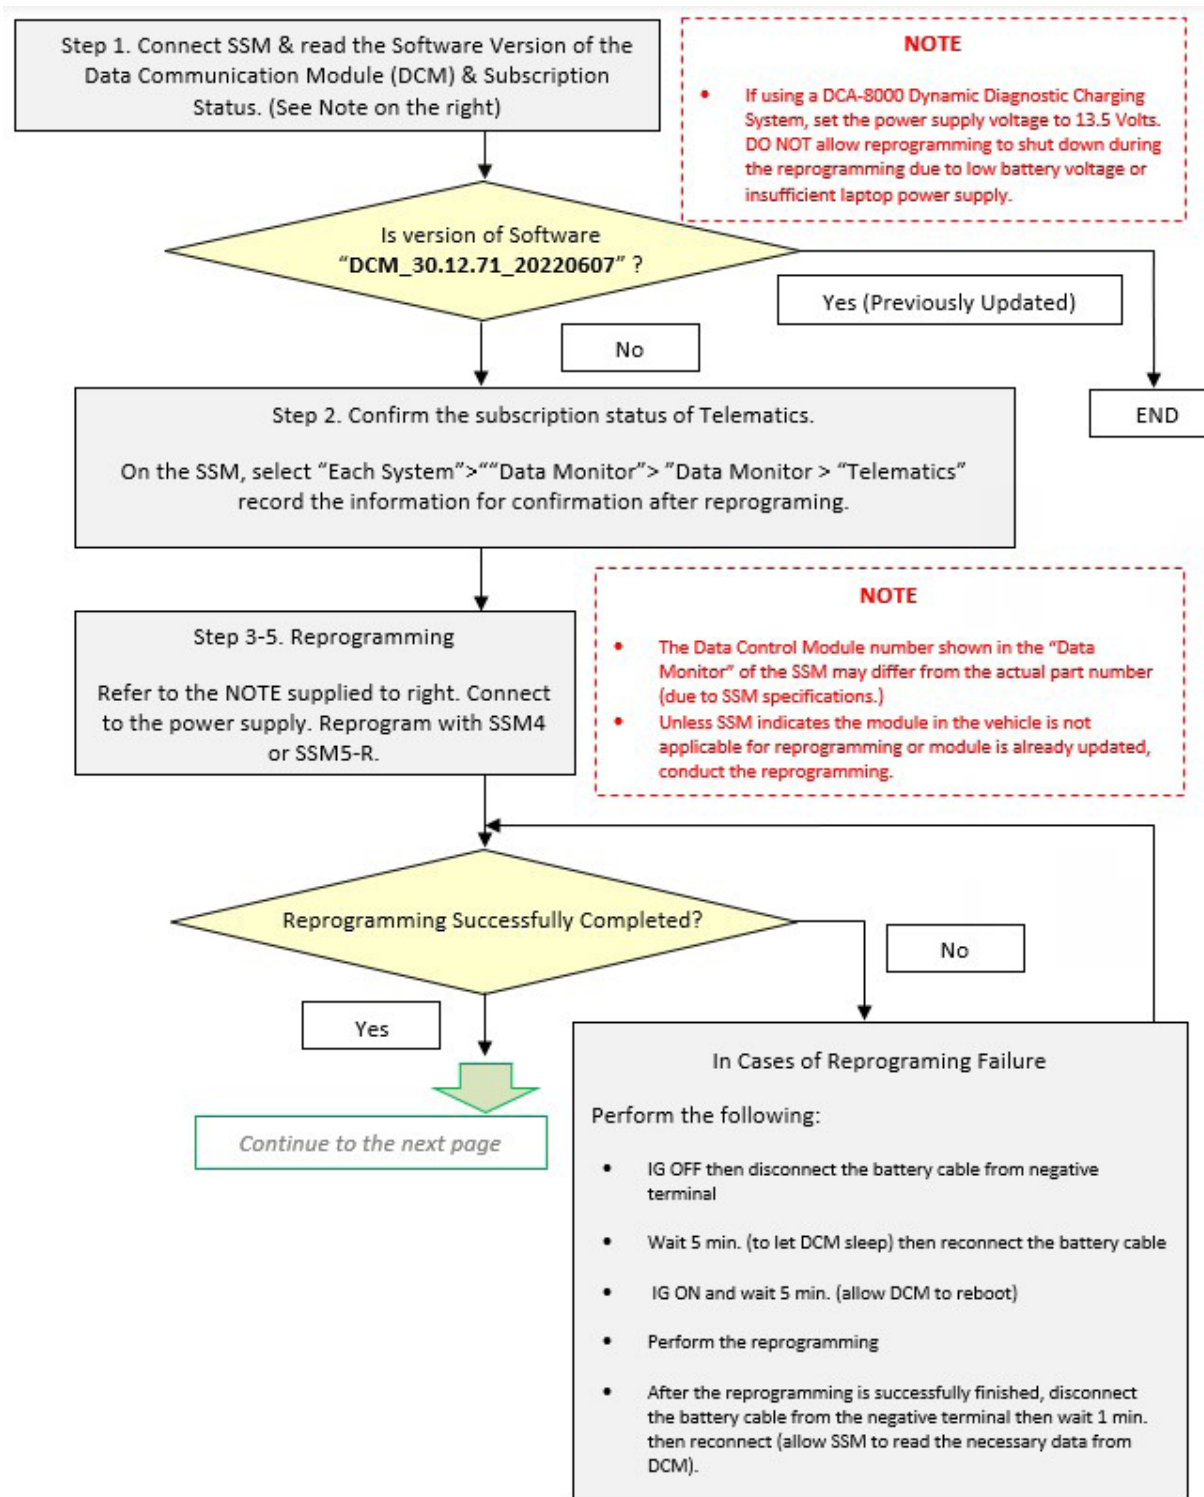
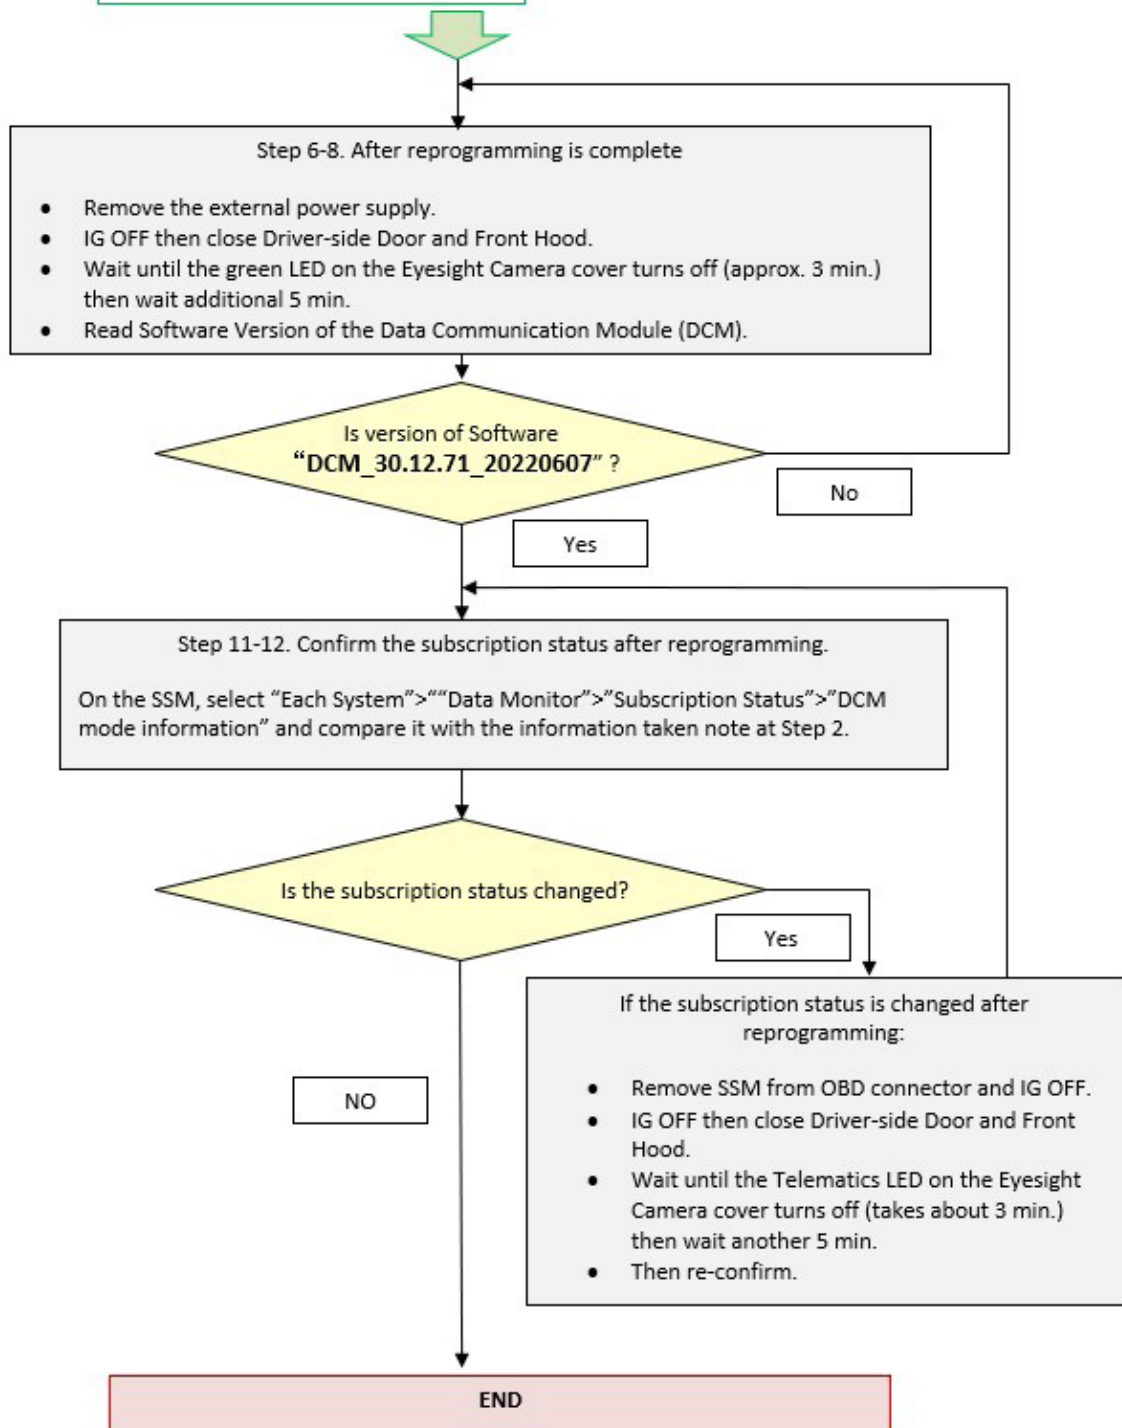
## SERVICE PROCEDURE FLOWCHART:

This bulletin announces the availability of new reprogramming files to address cases of remote services from the STARLINK® app or website including remote engine start (RES), remote door lock request, remote actuation of the horn/lights, and vehicle locator. This is caused by an inaccurate internal timer within the Data Communication Module (DCM). The new files contain enhanced logic to optimize the internal timer program within the DCM. If this concern is reported, reprogram the DCM using the procedure outlined in this bulletin.

- For **Forester** and **WRX** models, reprogram the DCM using the normal FlashWrite procedure.
- For **BRZ** models, reprogram DCM following the normal SSM5-R procedure. Additional information regarding the SSM5-R reprogramming procedures can be found in TSB **14-28-21**.
