Technical Service Bulletin (TSB)
UAQ and UCQ Radio Enhancements

REFERENCE:	TSB: 08-003-22 REV. A GROUP 08 - Electrical	Date:	December 16, 2022	REVISION:	08-003-22 and 08-133-21
VEHICLES AFFECTED:	<p>2019 - 2023 (KL) Jeep Cherokee 2018 - 2020 (WD) Dodge Durango 2018 - 2021 (MP) Jeep Compass 2019 - 2021 (BV) Jeep Renegade 2018 - 2022 (LA) Dodge Challenger 2018 - 2022 (LD) Dodge Charger 2018 - 2022 (LX) Chrysler 300 2018 - 2023 (JL) Jeep Wrangler 2020 - 2023 (JT) Jeep Gladiator 2018 - 2021 (DS) RAM 1500 Pickup 2018 (WK) Jeep Grand Cherokee 2018 (BU) Jeep Renegade 2018 (DJ) RAM 2500 Pickup 2018 (D2) RAM 3500 Pickup 2018 (DD) RAM 3500 Cab Chassis 2018 (DF) RAM 3500 <10K Cab Chassis 2018 (DP) RAM 4500/5500 Cab Chassis</p> <p>NOTE:This bulletin applies to vehicles equipped with a Uconnect 4C Nav With 8.4" Display radio (Sales Codes UAQ or UCQ).</p> <ul style="list-style-type: none"> This bulletin applies to JL and JT vehicles built on or before November 23, 2022 (MDH 1123XX). This bulletin applies to KL vehicles built on or before November 21, 2022 (MDH 1121XX). 				<p>MARKET APPLICABILITY:</p> <p><input checked="" type="checkbox"/> NA <input type="checkbox"/> IAP <input type="checkbox"/

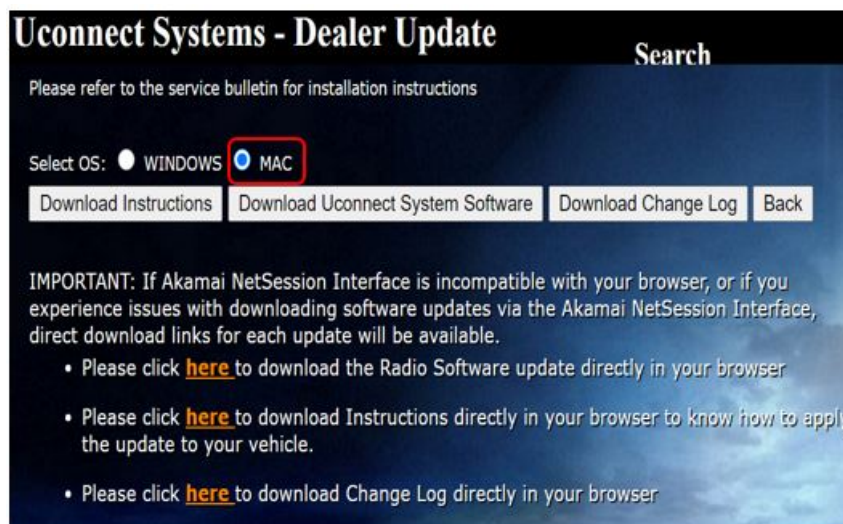
Fig. 2
MAC Download Steps

4. Use one blank USB flash drive with at least 4GB of space for each software update. Follow the on-screen instructions to download the software files.
5. Download the software update file to your local PC's desktop. Make sure to select the "MAC" radial button for all downloads ([Fig. 2](#)) .

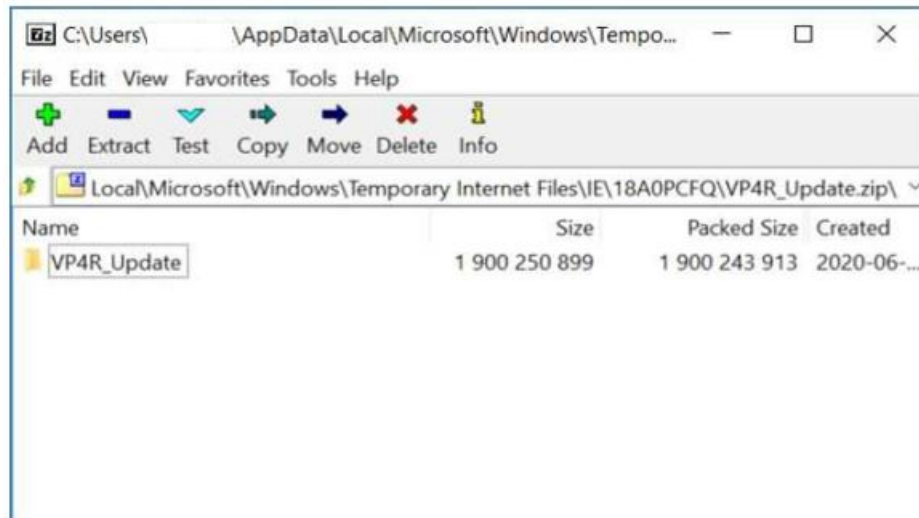
Fig. 3
Files/Folders In The USB Flash Drive

7. Unzip the file to the root folder of USB flash drive. File should not be within a zip folder. Your USB file should look like (Fig. 3) when you open it.

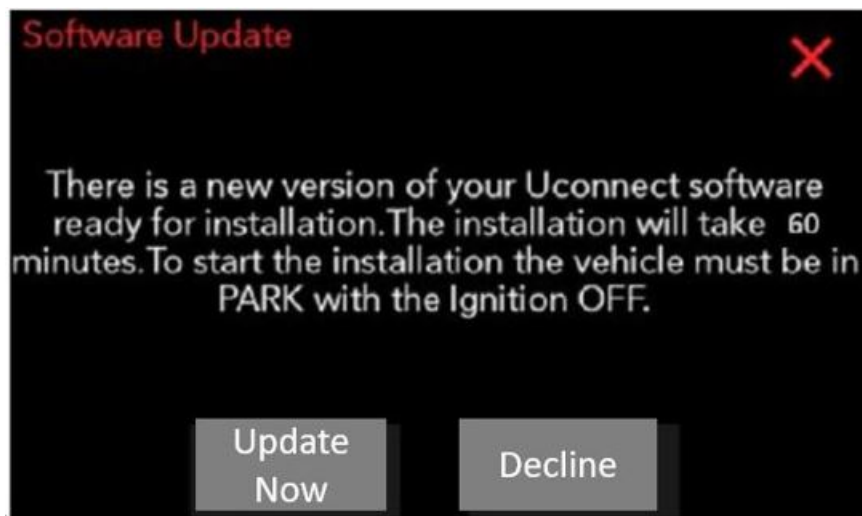
Fig. 6

12. Once the system has verified there is an available update, press the “Update Now” button. Make sure the vehicle is in park, **DO NOT** turn off the ignition (Fig. 6) .

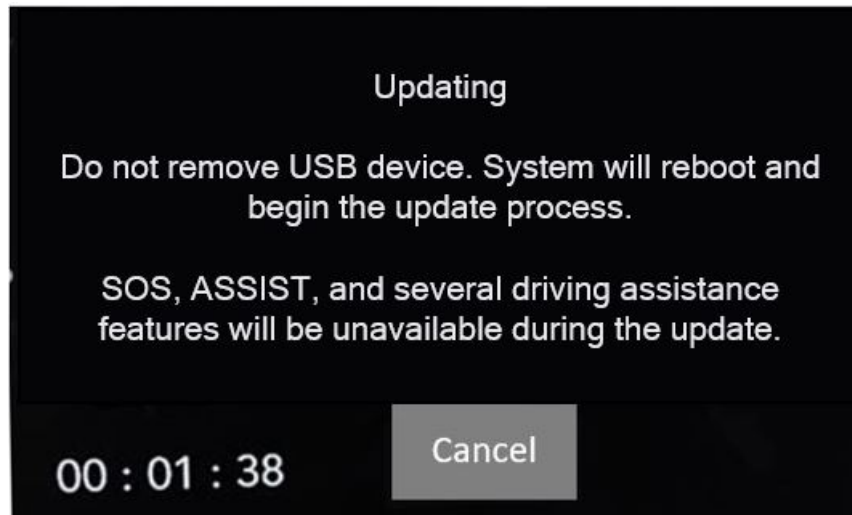
Fig. 7
Updating Screen

13. When the radio starts updating, the screen in (Fig. 7) will be displayed.

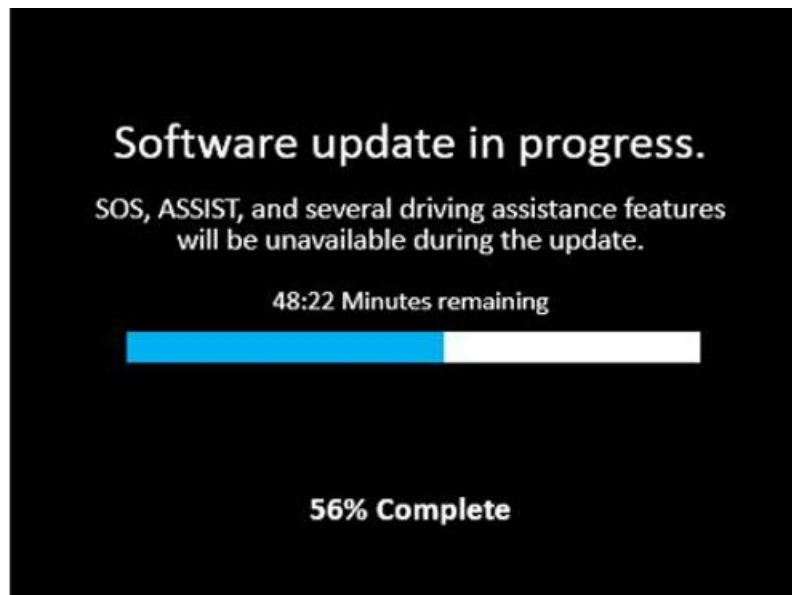
Fig. 8
Software Update In Progress

14. The radio will reboot and the update will begin. The update should only take 25 minutes, the timer on the screen may display the incorrect time remaining, (Fig. 8) .

NOTE: The completion indicator may not reach 100%, even though the software update has been completed. Once the software update has finished, the radio and display screen will turn off.
